# **The Appleton Wetland; Its Decline, Cause and Recommended Action**

## **Appendix E: Analysis of Weir Photographs**

**Appleton Wetland Research Group  
of the  
Mississippi Valley Field Naturalists**

**August 11, 2014**

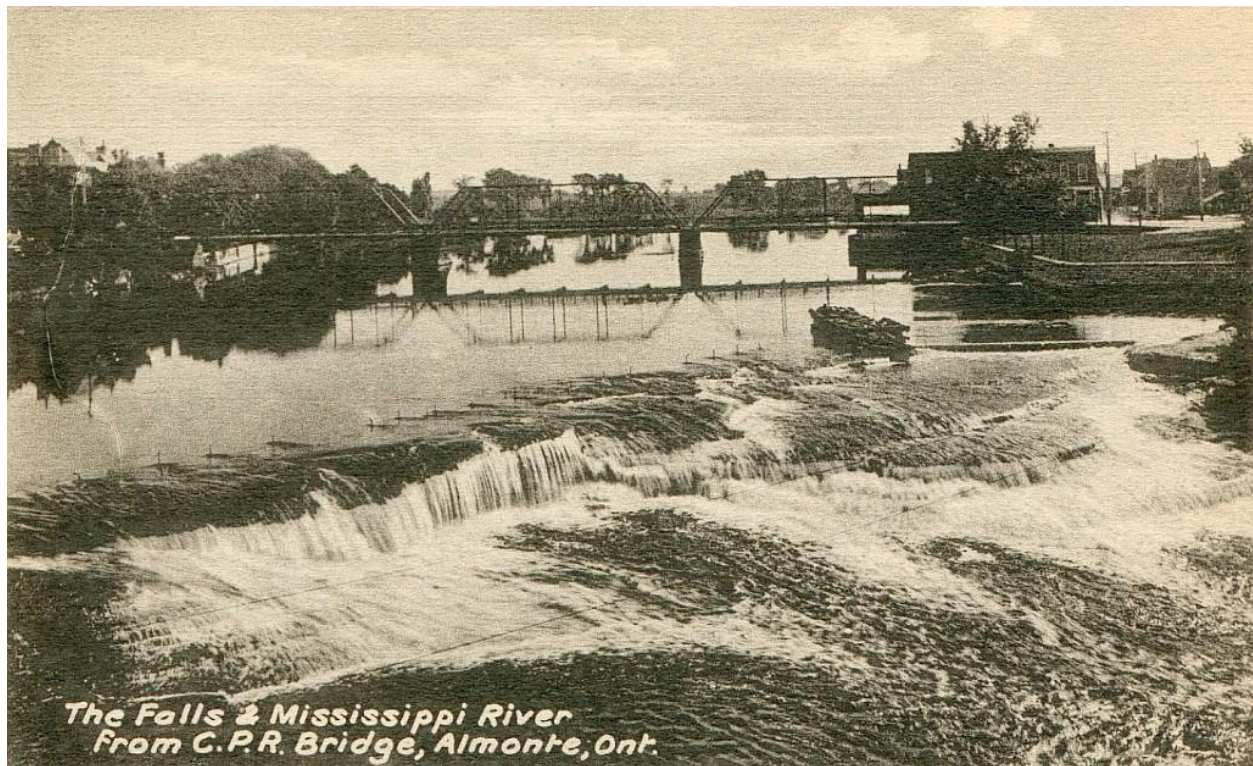
Figure E-1 Newton “upper falls.tif”

This image was provided by Robert Newton and is undated. To the right of the rock crib in the river is something that looks very much like the concrete weir section 1 that exists today. The trees have leaves on them, so it is summer and the water level is low – about the top of the section 1 weir. To the left of the rock crib is a row of pipes protruding above the water in about the location of the current weir section 2, although it does not appear that an actual weir section was in place then. The pipes were probably anchored in the rock shelf and were used to support flashboards. There is no evidence of flashboards on either of these two sections.

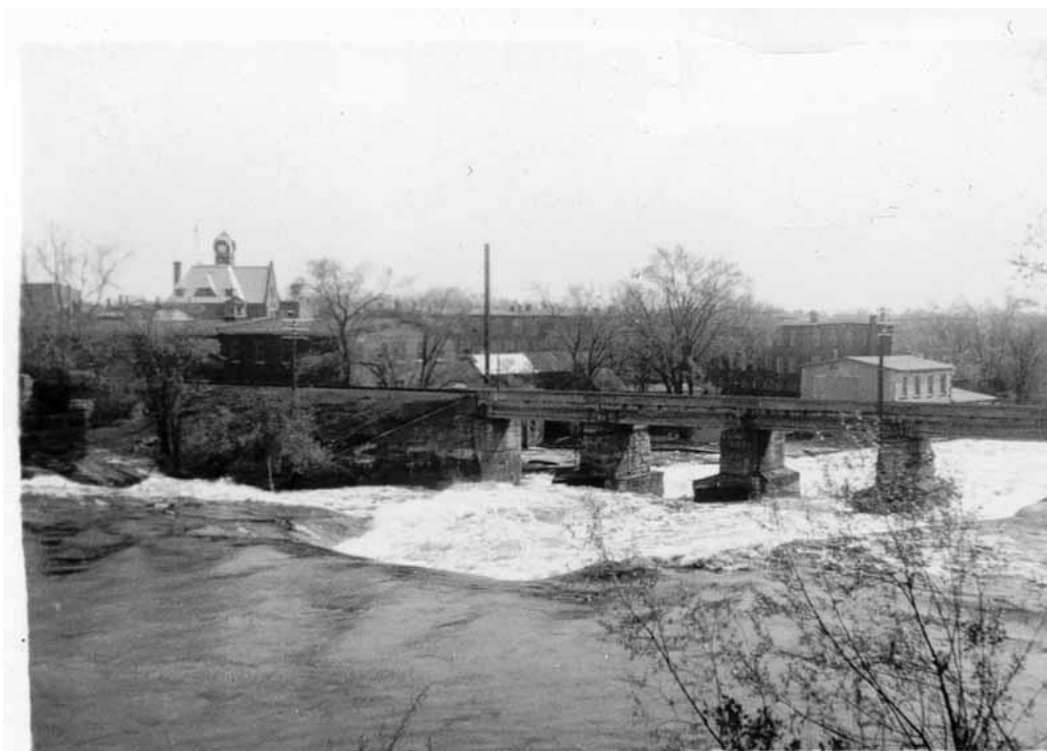
**Figure E-2 Dunn “upper\_falls\_towards\_lower\_falls.jpg”**

This image from the Michael Dunn collection is undated. The river is at flood stage, and judging from the emerging leaves on the trees, it is spring time. There is no evidence of flashboards, which is normal since they get broken off during flood stage. The straight edge of the falls at the right side of the image is an indication that weir section 3 is under the water.

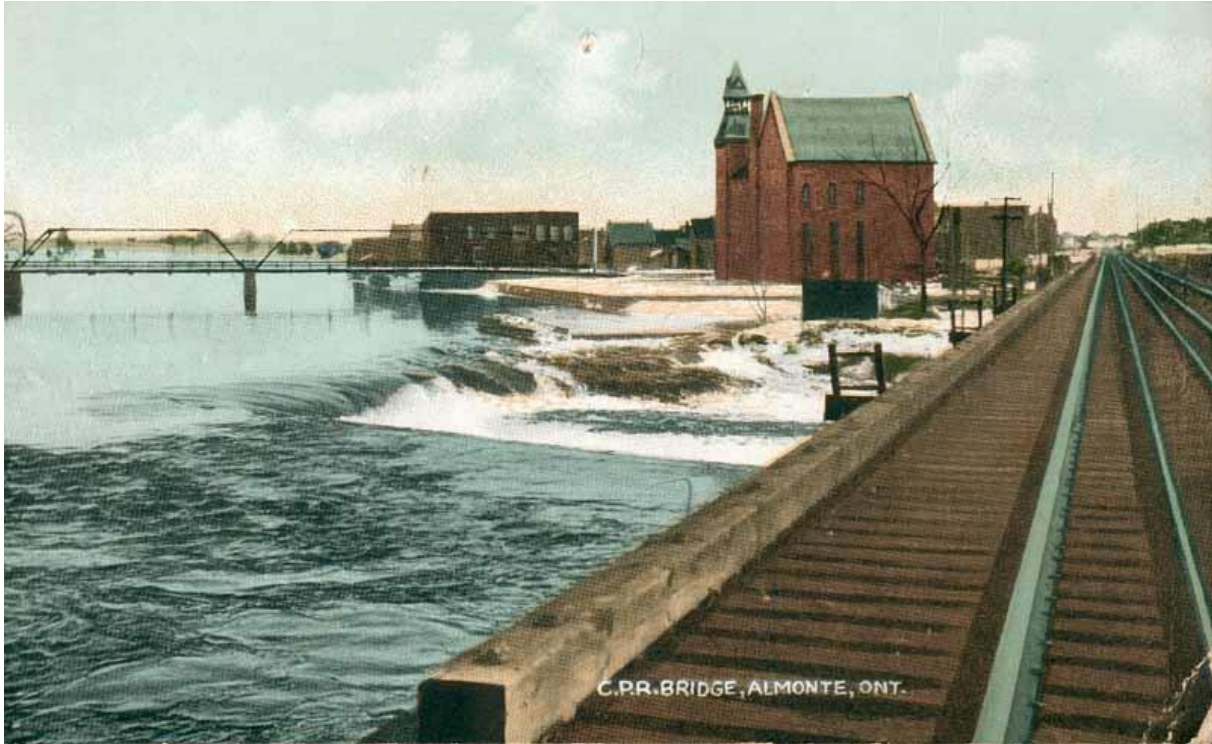
Figure E-3 Dunn “tinted\_view\_of\_cpr\_bridge\_towards\_town\_hall.jpg”

This image from the Michael Dunn collection is undated. There is some evidence of snow on the ground but no ice on the river – the picture was probably taken in November. As in the case of Figure E-1, there is no indication of flashboards anywhere, and in addition there is no sign of projecting pipes for supporting flashboards. The concrete weir section 1 can be seen across from the Old Town Hall, and the straight edge of the falls leading from the CPR bridge indicates the presence of weir section 3. A copy of this image has also been found on a postcard bearing a 1912 postmark indicating the photograph was probably taken within a few years prior to that date.

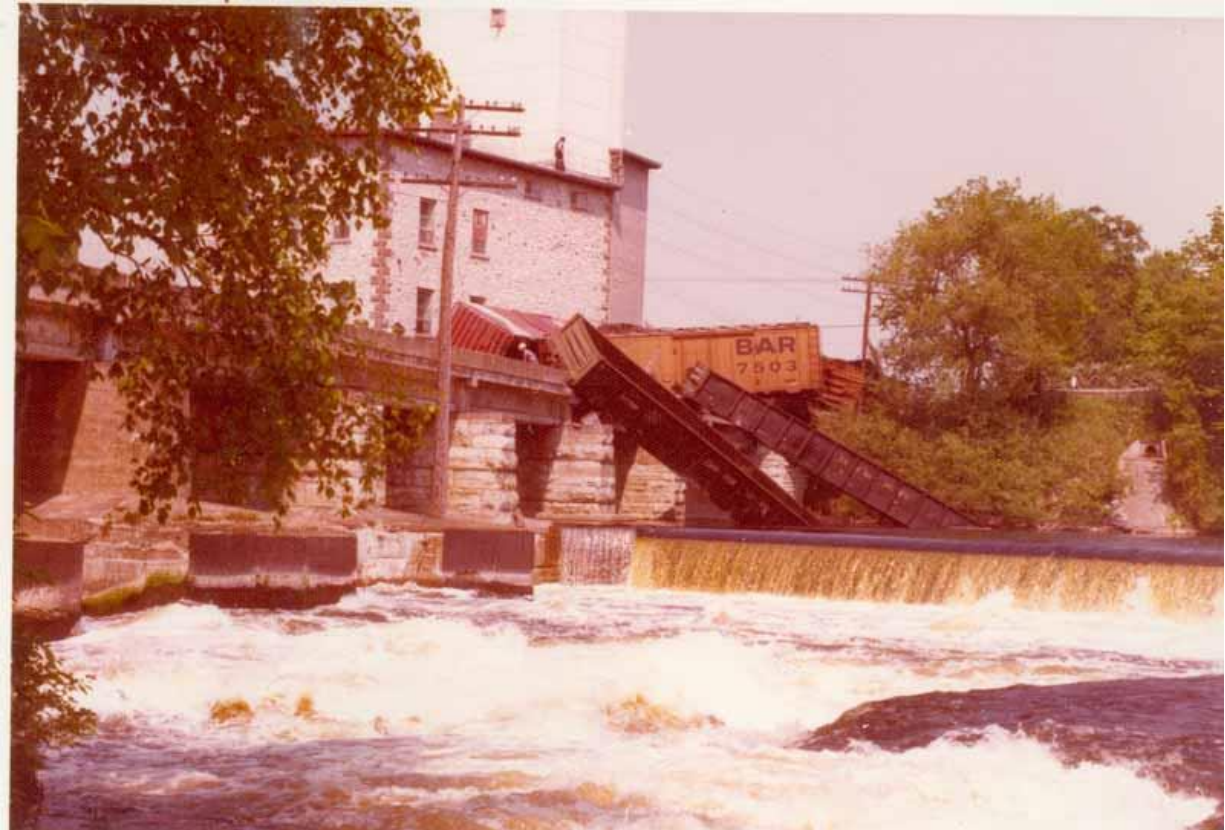
**Figure E-4 Dunn “train\_wreck\_1974\_no2.jpg”**

This image is from the Michael Dunn collection and can be dated as very shortly after the train wreck of June 5, 1974.

Environment Canada records show the river flow rate in 1974 was 57 cms on June 5 declining steadily to 25 cms on June 12. The general appearance of the falls is in accord with that range of flows, and the appearance of the water going over weir section 3 suggests that flashboards were present on the weir. The water level at the junction of weir section 3 and the fourth pier of the bridge is consistent with the flashboard height being 12 inches as indicated by others as the board height used in the Flour Mill Era.

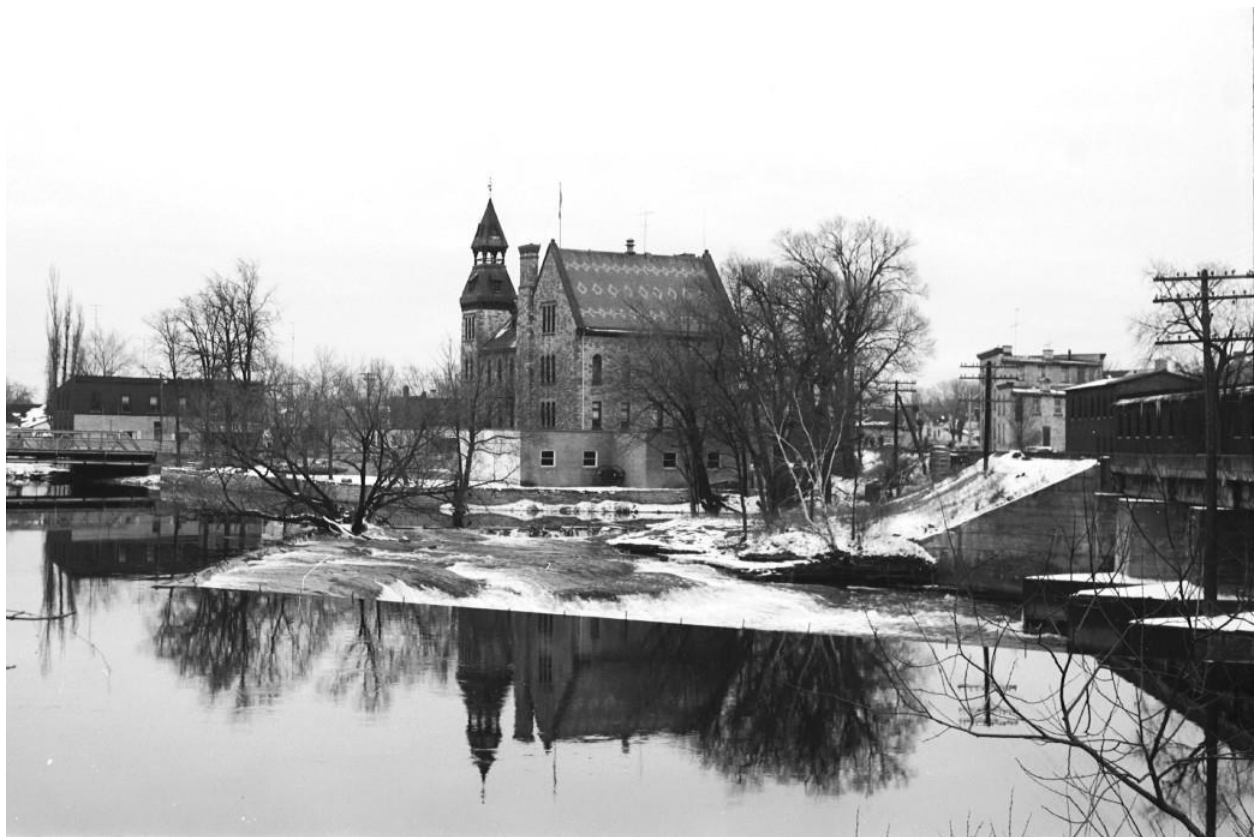
**Figure E-5 Seaman "AlScan604Nov73.jpg"**

This image by Al Seaman was included in a set of negatives of the Old Town Hall. The negative index was marked November 1973. The negative was scanned to produce the above digital image. There is a trace of snow on the ground, but no ice on the river suggesting that the image was taken in the second half of November. The image also shows the weir sections 1 through 3. There is definitely the appearance of flashboards on weir section 3 as shown by the pipe supports and the very sharp and straight edge of the waterline along the flashboards. Additional analysis of this image is contained in Figures E-6 through E-8 that follow.

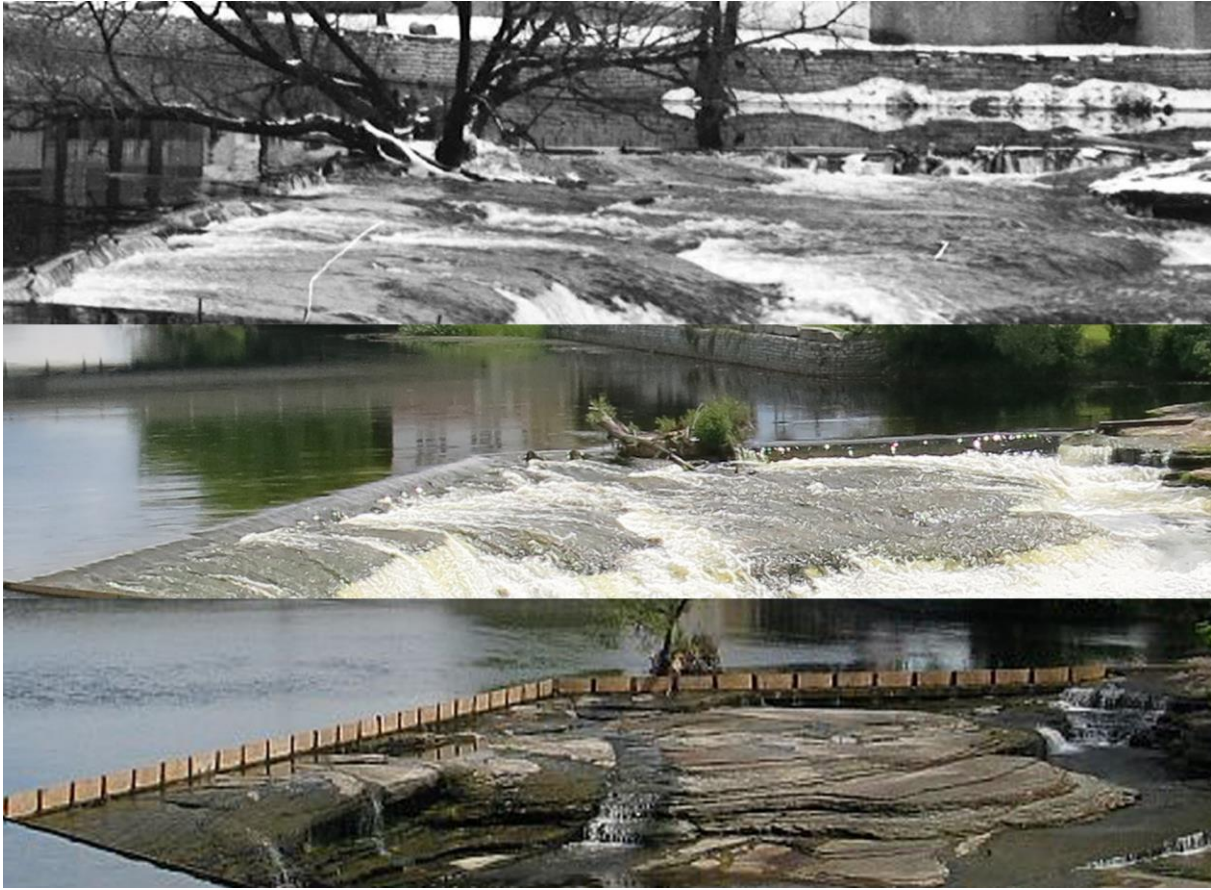
**Figure E-6 Seaman “CompositeNov73e.jpg”**

This image is a composite that combines crops from three separate images for comparison purposes. The top image is an enlarged crop from Figure E-5 above. The middle portion is a cropped enlargement from an image taken during the summer of 2013 when there were no flashboards on weir sections 1 and 2. The bottom portion is another cropped enlargement taken during the summer of 2012 when the flashboards on sections 1 and 2 were fully intact and 50 cm in height. The two reference photos were taken from very similar view points on the CPR bridge. The top image was taken from a slightly different location that is no longer accessible due to a dense growth of brush in the passing years. The top image looks more like the no-boards middle image, although the differences in flow rate and perspective make that comparison difficult. The bottom image certainly indicates that if there are flashboards in the top image, they are much lower than 50 cm in height.

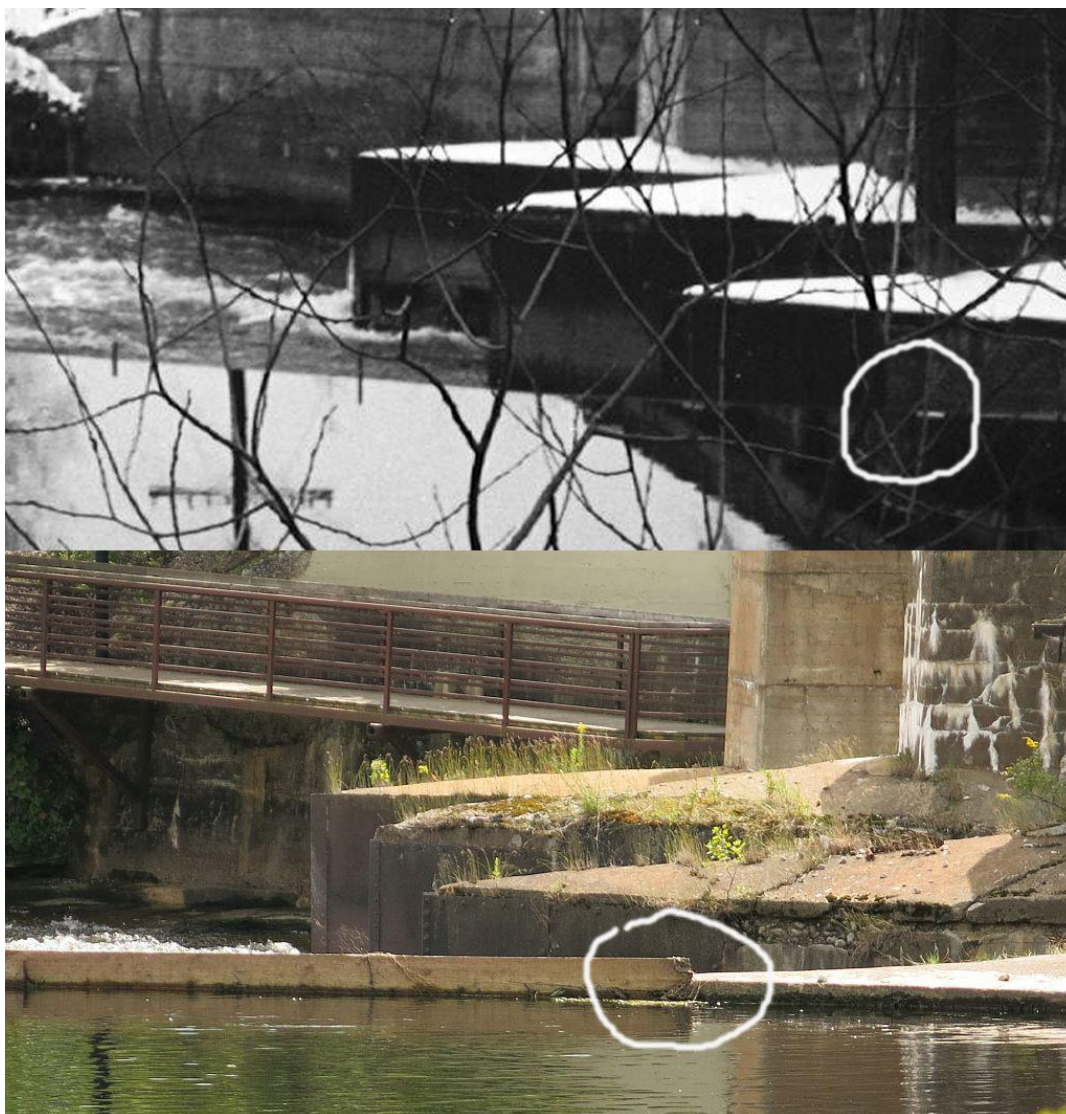
**Figure E-7 Seaman “Composite2Nov73e.jpg”**

This image is a composite that combines crops from two separate images for comparison purposes. The top image is an enlarged crop from Figure E-5 above. The bottom image is a cropped enlargement from an image taken during the summer of 2013. Both show the junction of flashboard on weir section 3 with pier 4 of the CPR bridge. In the top image, the clear line of the top of the flashboards meets the point of the fourth pier in the centre of the circle at the level of the top of the pier. In the lower image the current flashboards meet the pier at a point that is further back from the tip of the weir, and the boards extend above the top of the weir. The height difference looks consistent with the 12 inch (30.5 cm) boards claimed in that era compared to 40 cm boards of today as used on weir section 3.

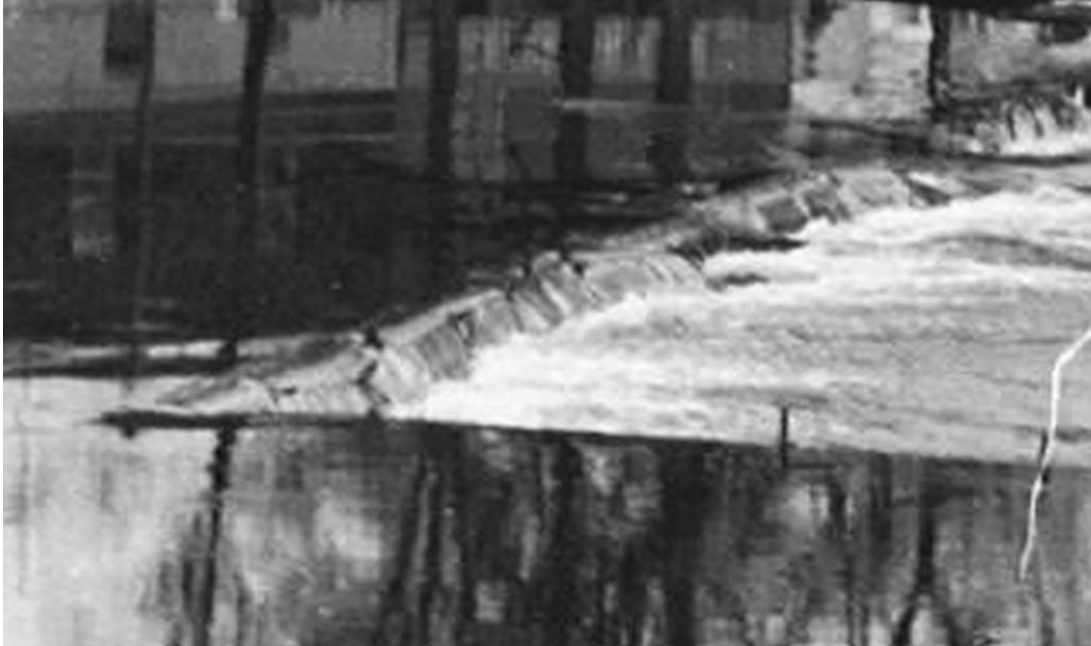
**Figure E-8 Seaman “AlScan604Nov73e2.jpg”**

This image is a cropped enlargement of a section of Figure E-5 showing the junction of weir sections 2 and 3. It is a bit difficult to define exactly the state of section 2, but it does appear that at the junction the flashboards on section 3 are higher than on section 2. That may be the result of missing boards or shorter boards. If the latter, it contradicts claims that section 2 had 14 inch boards while section 3 had 12 inch boards in this Era.

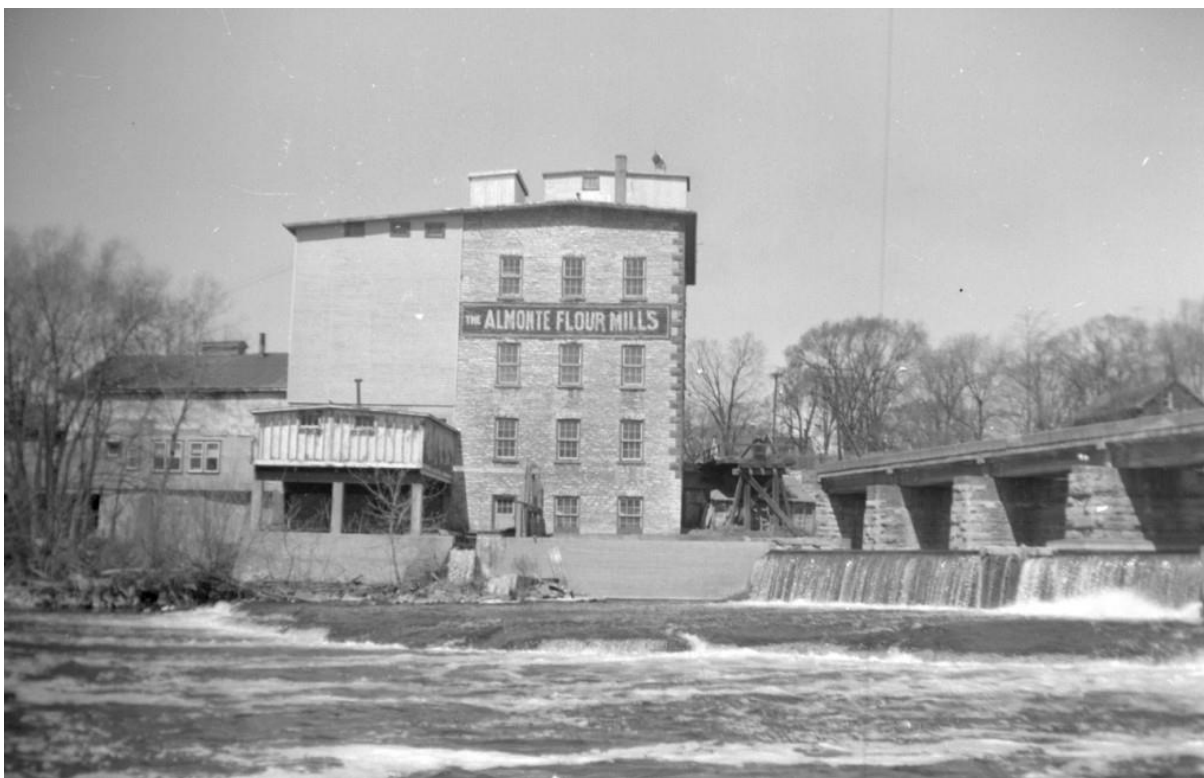
**Figure E-9 Newton "rear view of flour mill.tif"**

This image from Robert Newton is undated. From the appearance of the trees it seems to be early May with the leaves just starting to emerge. The spring flood has passed but flow rate is still quite high. On careful inspection, it can be seen that there is a short section of flashboards still on weir section 4 that was not broken off in the spring flood. This provides an opportunity for further estimation of flashboard height.

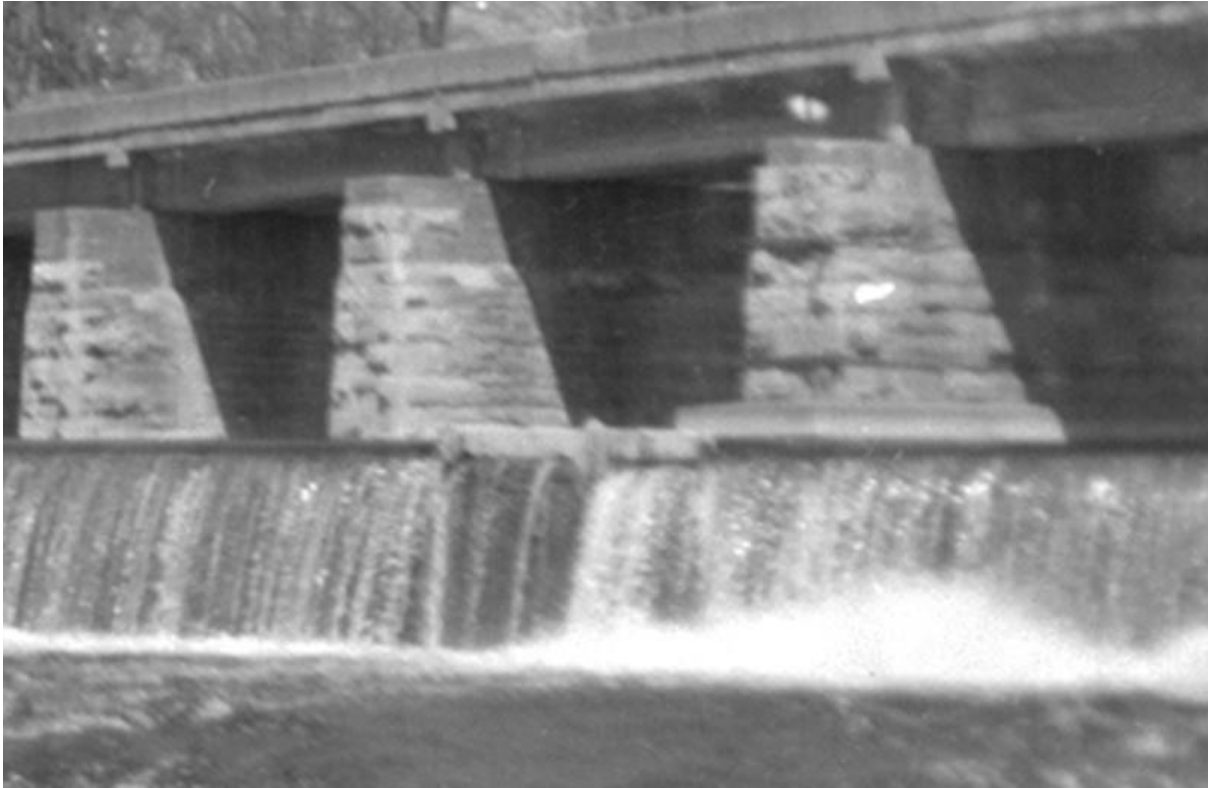
**Figure E-10 Seaman-Newton “rear view of flour mill-crop.jpg”**

This image is an enlarged crop from the previous Figure E-9, and shows a bit more clearly the remnant of flashboards on weir section 4. The next image, Figure E-11, shows this weir in 2012 with its flashboards having a confirmed height of 40 cm. Fortunately, both images have flashboards and the concrete weir in the same vertical plane. By measuring the pixel positions for the top of the boards, the junction of the boards and the weir, and the bottom of the weir in both digital images, the historic board height can be calculated. The weir height provides the image scale for each image, and the known 40 cm height of the current flashboard provides the calibration for the calculation. Since the measured points are in the same vertical plane, the measurements are not overly sensitive to differences in perspective or view point location. The results of several measurements on the images yield a board height consistently near 30 cm, equivalent to the 12 inch height claimed for the boards in this era.

Although this appears to be an image from early May and after the spring flood in some unknown year, we have no event context. It may be a remnant left after the most recent flood and before flashboards were all replaced later in that spring. On the other hand it may have been a remnant from several years before after a period in which no flashboard maintenance was done.

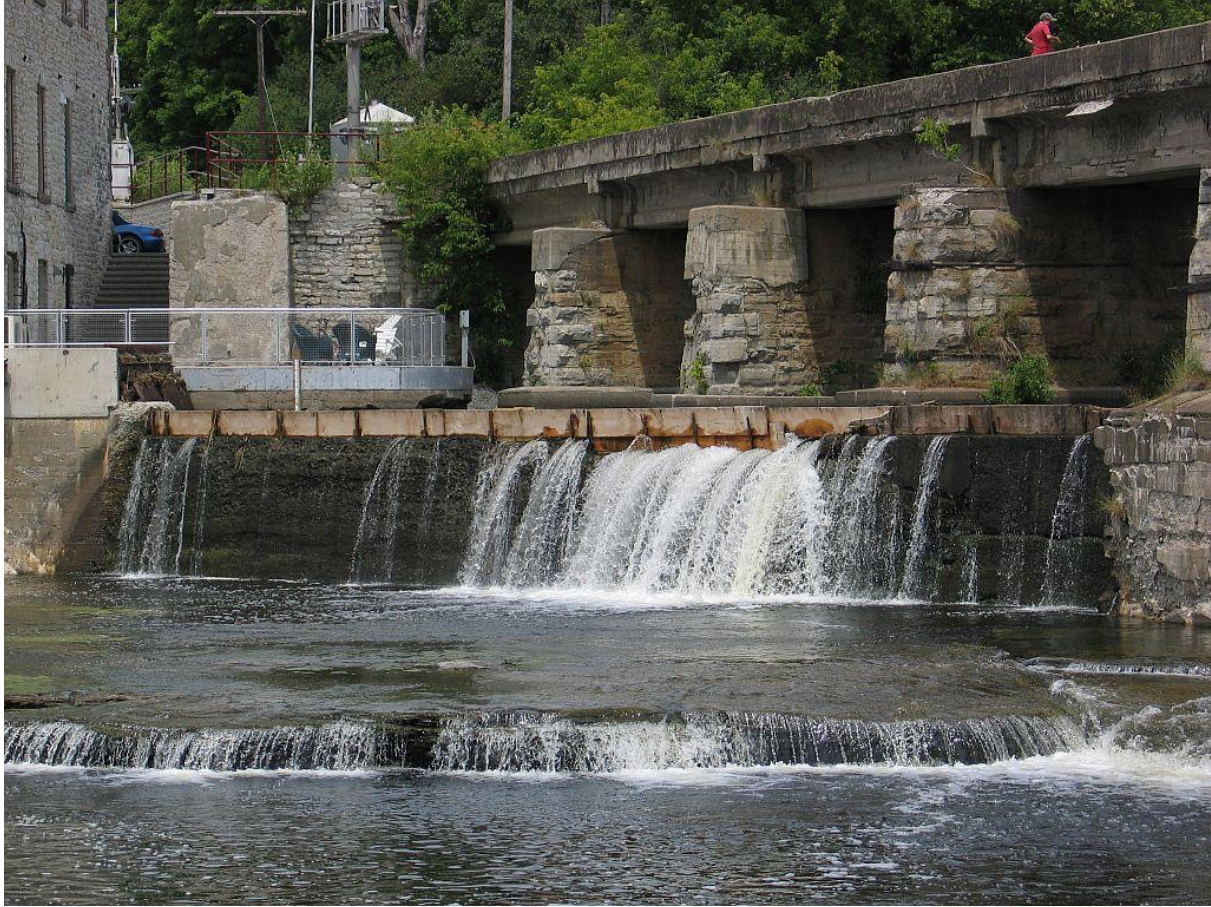
**Figure E-11 Seaman “189\_8924e.jpg”**

This image was taken during the summer of 2012 and shows weir section 4 with flashboards on top. The boards have a stated height of 40 cm, and this image has been used as a reference to provide flashboard dimensions from other images taken at different times. The approach is described in the description following Figure E-10.

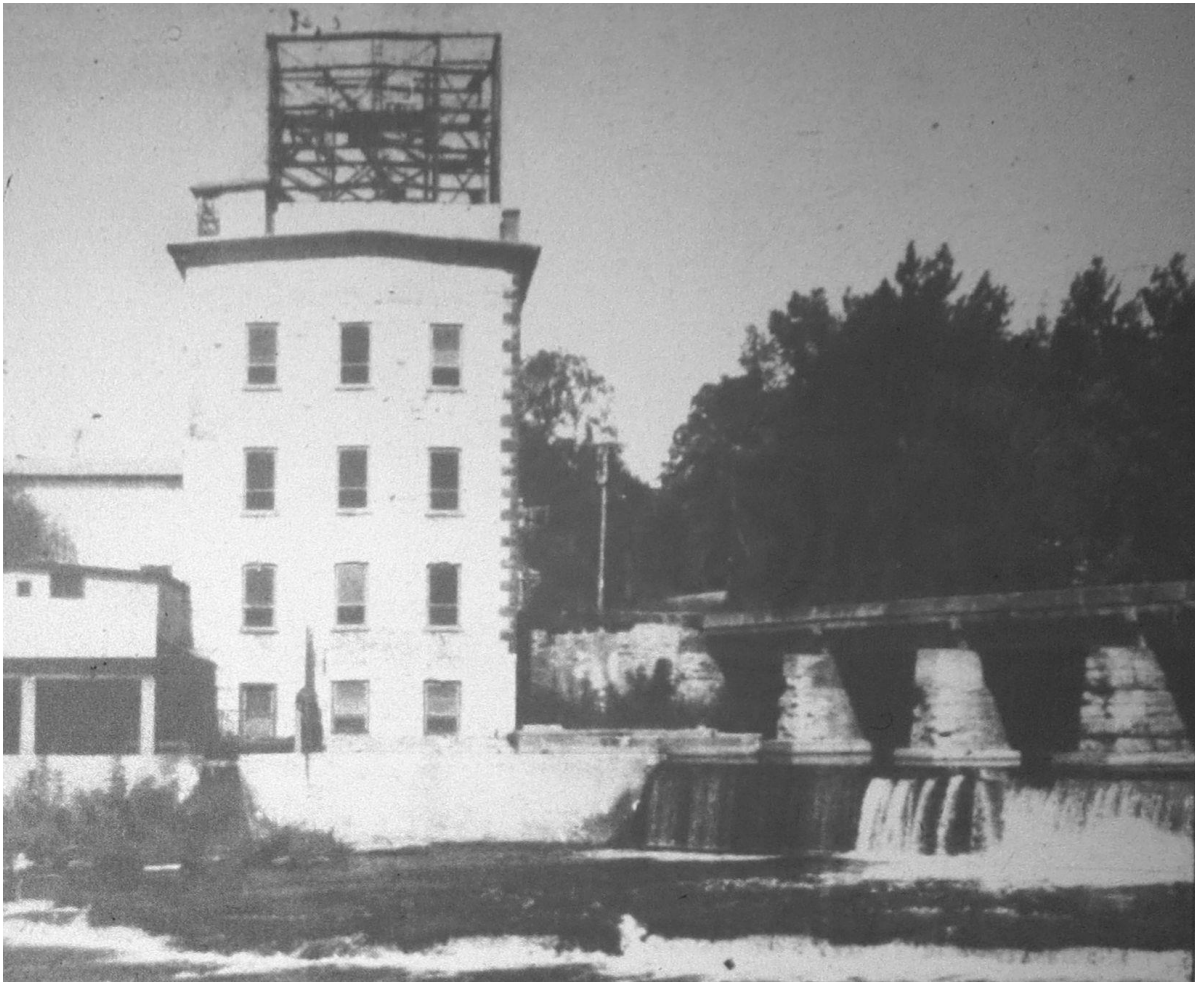
**Figure E-12 Seaman “GazetteMill1992-IMG\_0562.jpg”**

This image was discovered in the 1992-10-21 issue of the Almonte Gazette showing the Flour Mill and weir section 4. Since this was a half tone printed view of the original photo, and it has since been microfilmed, and then photographed from the screen of a microfilm viewer, image quality is very poor. It is very difficult to accurately determine the position of the junction between concrete weir and flashboards, and the position of the bottom of the weir. The result is that attempts to estimate flashboard height using Figure E-11 as a reference produce very erratic results ranging from 30 to 50 cm. The most that can be confirmed is that flashboards were in place in 1992 near the start of the Generator Station Era.

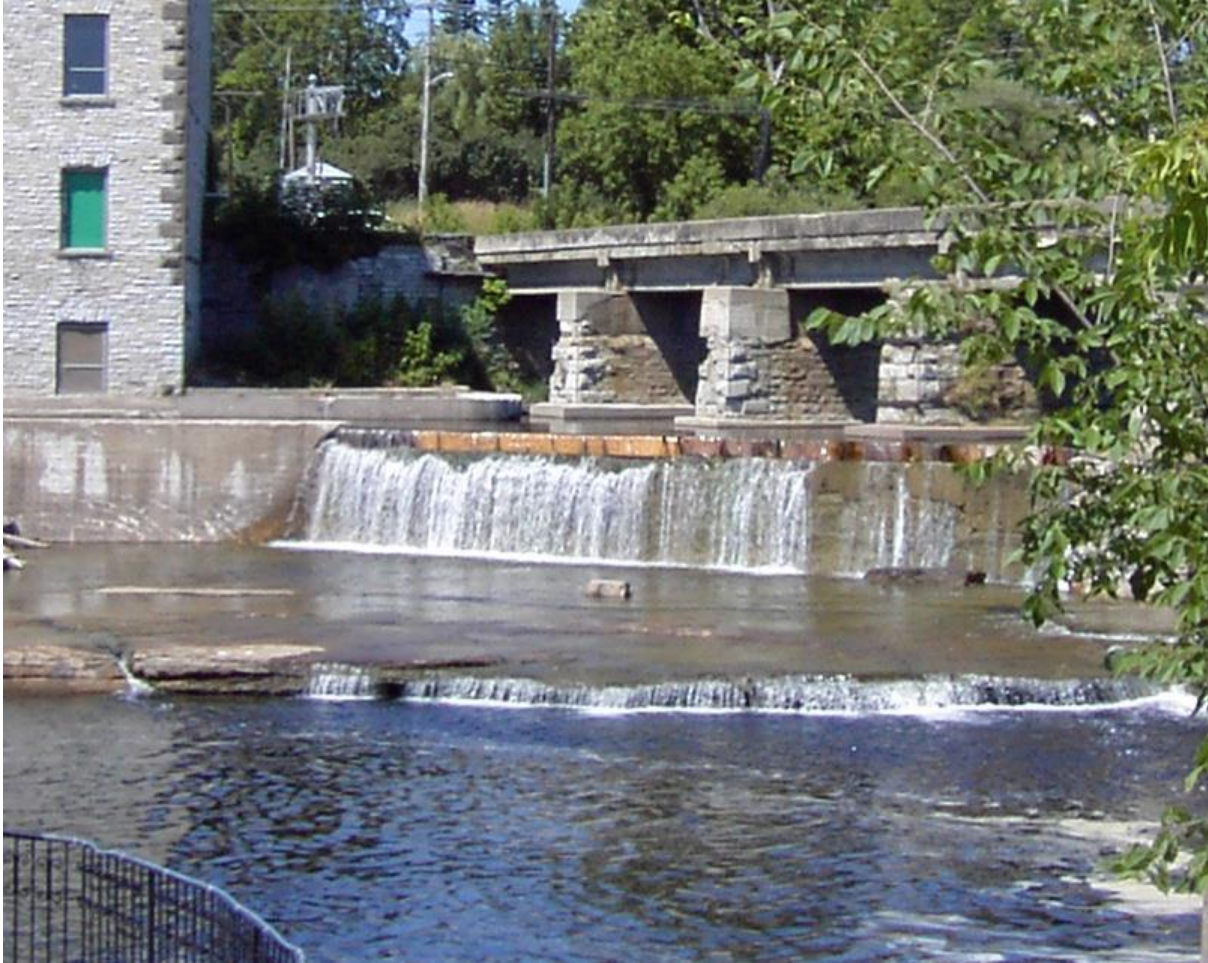
**Figure E-13 Fahie “18AP-Flour\_Mill\_10x8\_80dpi.jpg”**

This image was provided by Steve Fahie and is dated August 10, 2002. It is a crop from a larger image. Using previously mentioned measuring techniques in conjunction with Figure E-11 as a reference, flashboard height was determined to be very close to 40 cm in this image.

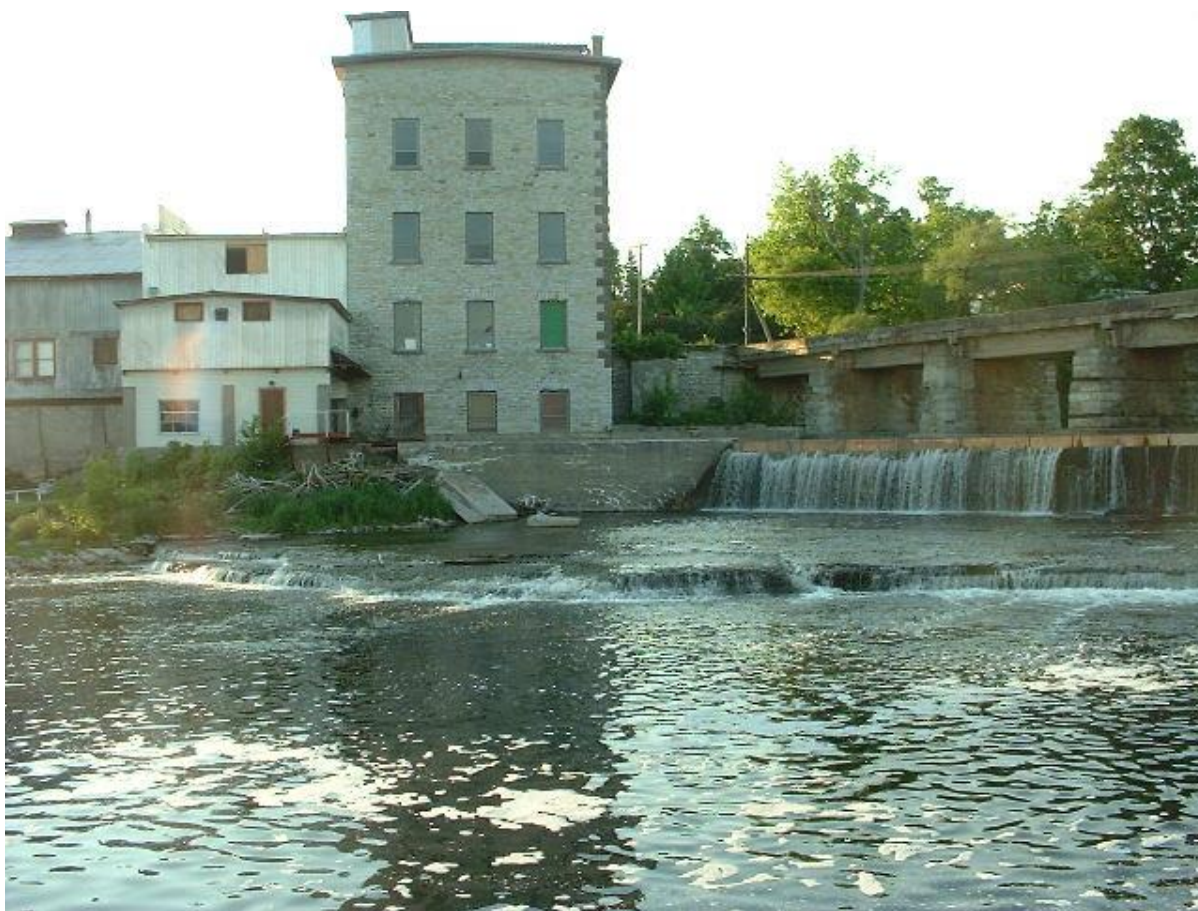
**Figure E-14** Caughey “DSCF0491 2001-05-31.jpg”

This image was provided by Mike Caughey and is dated May 31, 2001. Using previously mentioned measuring techniques in conjunction with Figure E-11 as a reference, flashboard height was determined to be very close to 40 cm in this image. This is the earliest solid confirmation that higher flashboards were in use after conversion of the old mill to power production.

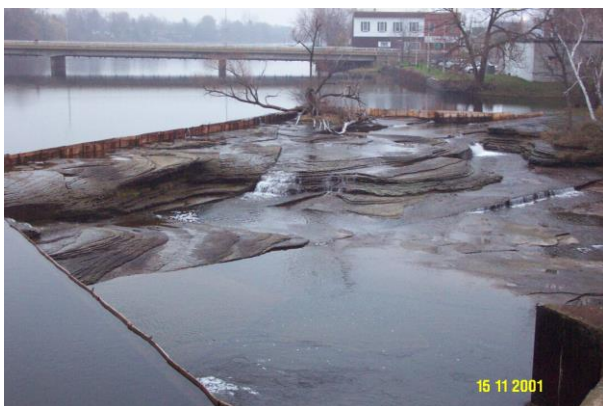
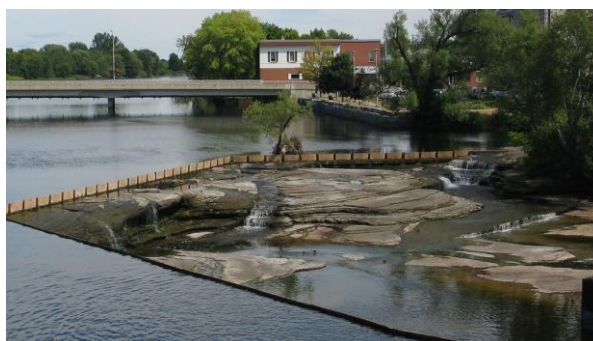
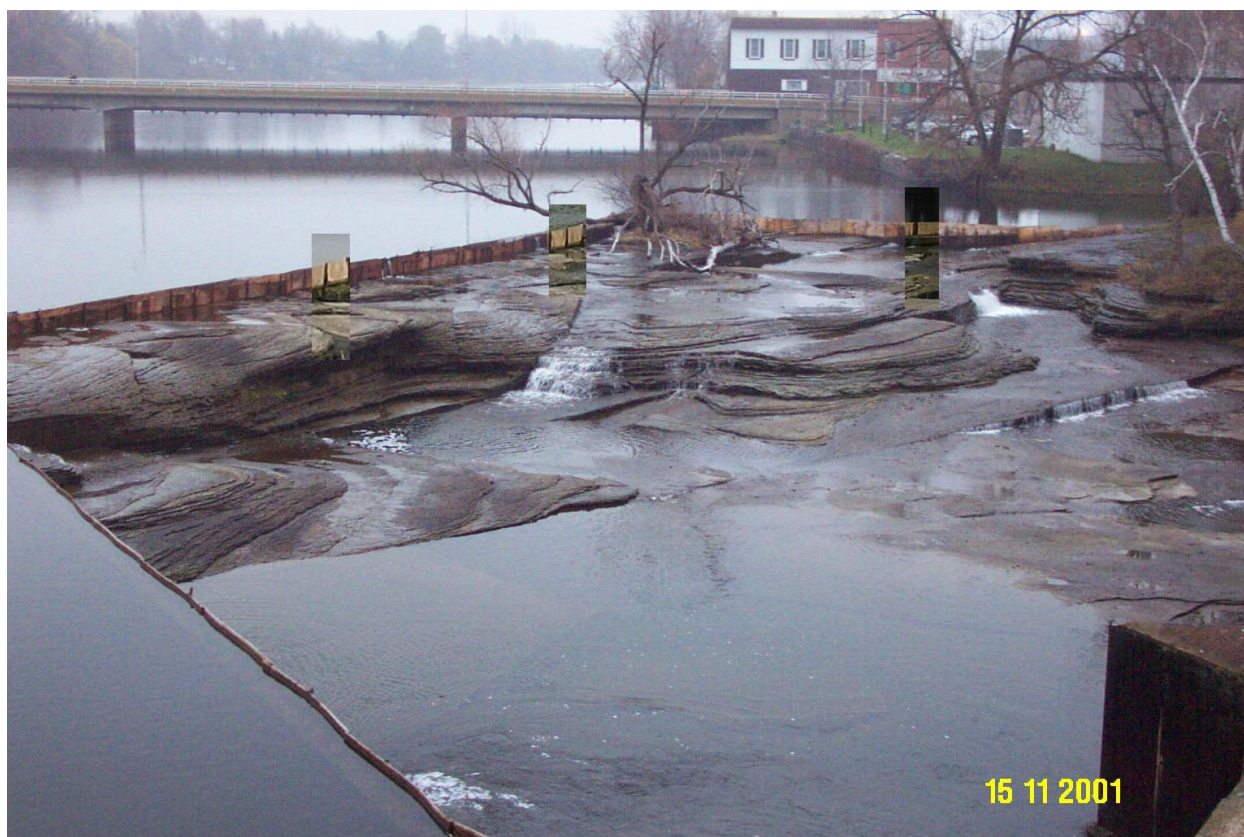
The Figure E-15 was included in an email to the SAC by Jim Fraser of MNR and is dated on the image as November 15, 2001. The Figure E-16, taken July 12, 2012, is the closest image on hand that was taken from a similar view point and suitable for comparison. Unfortunately there are no vertical features in the same plane as the flashboards, so the technique used previously is not applicable. In addition since the view points are different, the two images are not directly comparable. The best option was to crop selected portions of the flashboards along with a short section of the rocks below from the 2012 image and overlay them on the 2001 image. After

adjusting the position and scale of the rocks on the cropped images to match the same rocks in the 2001 image, the flashboard portions of the cropped images are in line with the size and position of the boards in the 2001 image. The conclusion is that in 2001 the flashboards on weir sections 1 and 2 were the same as in 2012 – that is, 50 cm. That is consistent with the findings of MNR for this image.
