The Appleton Wetland; Its Decline, Cause and Recommended Action

Appendix G: MVFN 2011 Tree Project

**Appleton Wetland Research Group
of the
Mississippi Valley Field Naturalists**

August 11, 2014

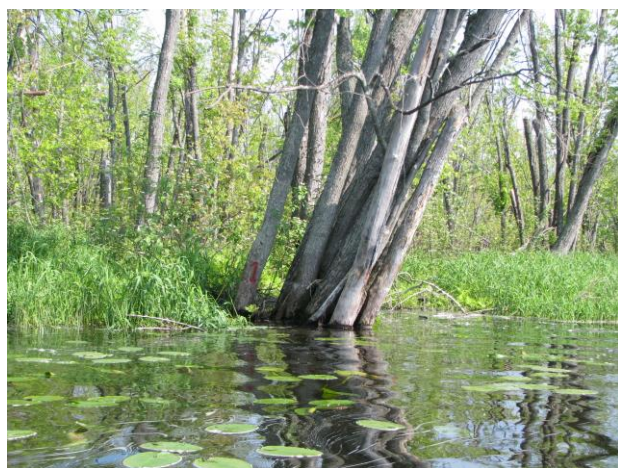
Figure G-3 Tree 1

The images that follow show the six tree stations as set up on May 31, 2011.

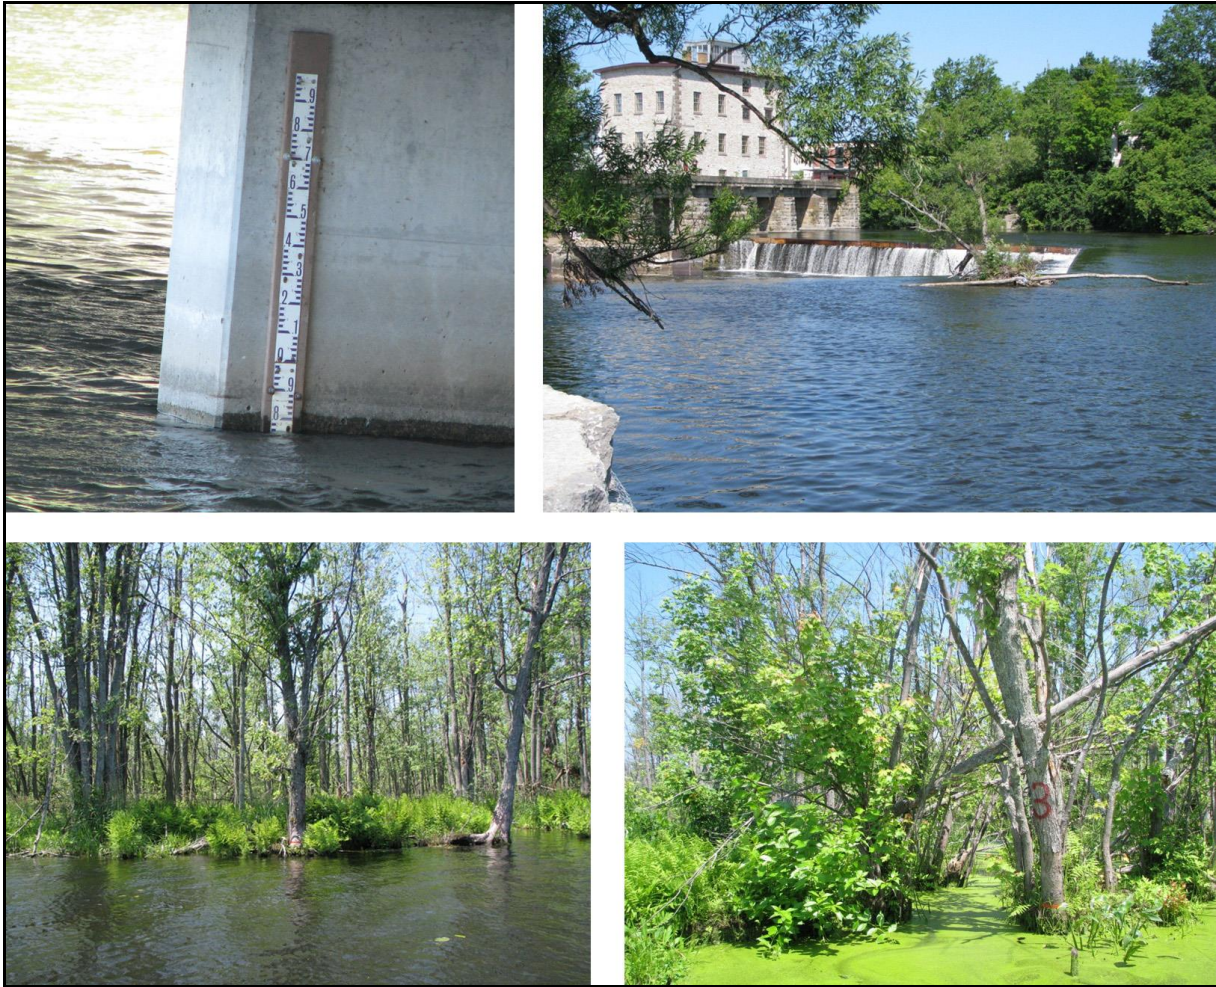
- All Tree water levels were 20 cm below the bottom of the ribbons.
- Almonte bridge staff gauge reading was 117.76 masl (6 cm below the May 31 reading).
- All flashboards on the weir were installed.
- Appleton Stream Gauge registered 21.1 cms.
- The following composite image from June 30 illustrates some of the above.

Figure G-9 Composite image from June 30, 2011

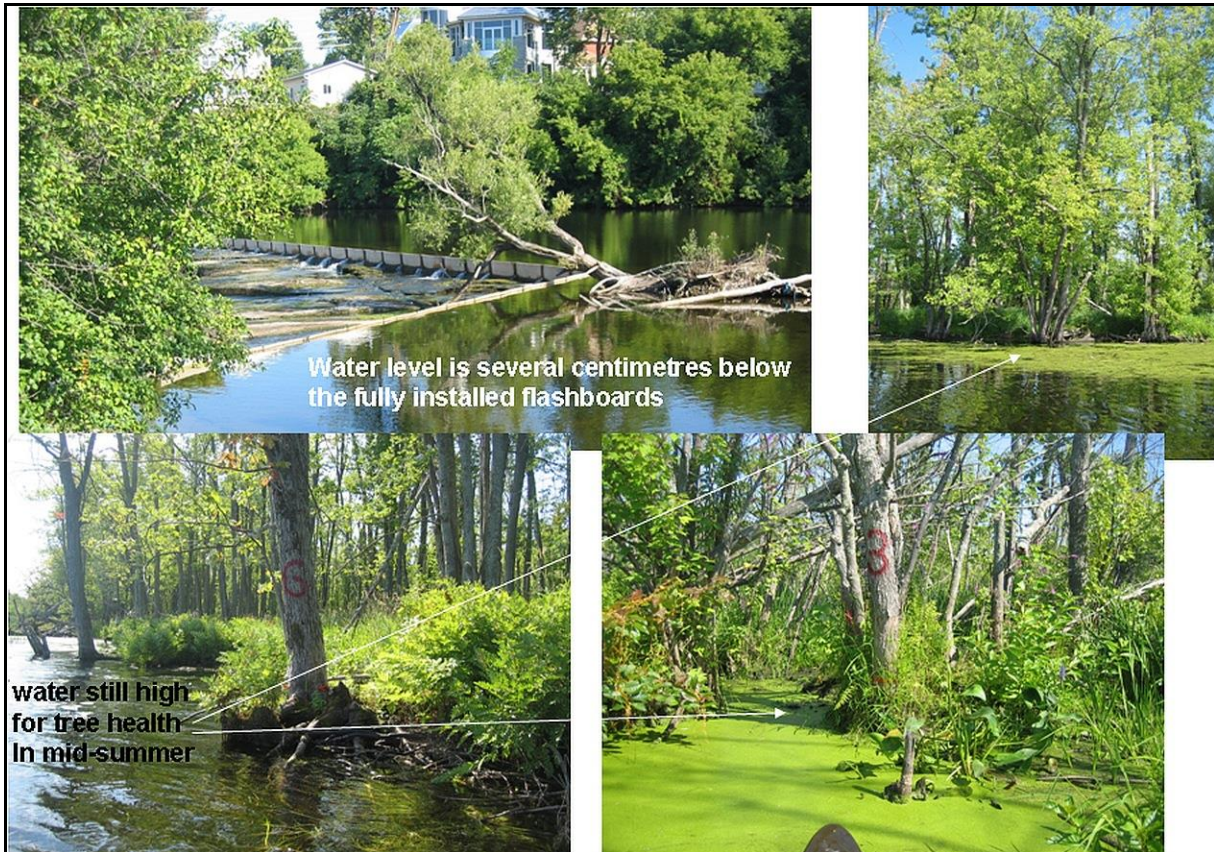
- All Tree water levels were 38 cm below the bottom of the ribbons.
- Almonte bridge staff gauge reading was 117.62 masl (20 cm below May 31 reading).
- All flashboards on the weir were installed.
- Appleton Stream Gauge registered 9.54 cms.
- The following composite image from August 16 illustrates some of the above.

Figure G-11 Composite image from August 16, 2011

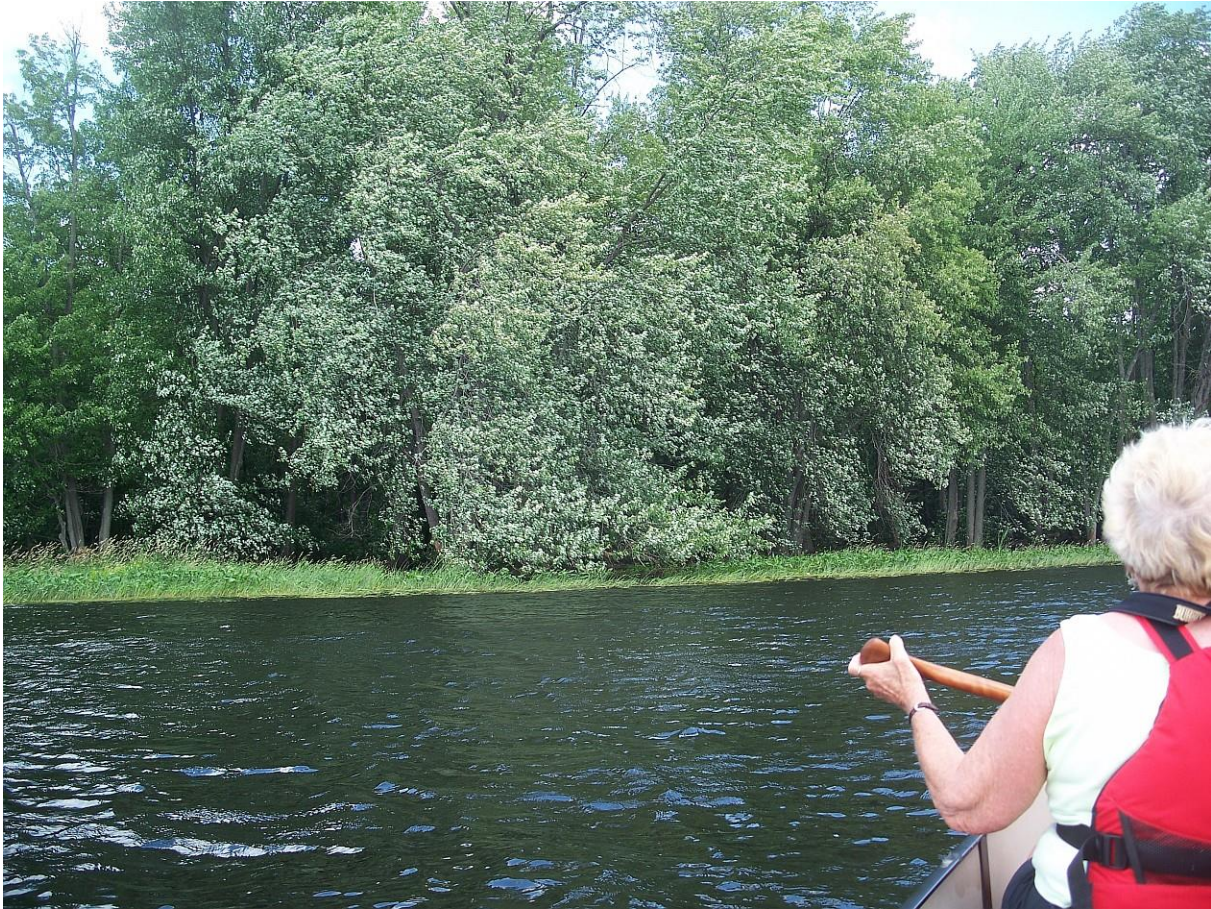
The Innisville and Mud Lake Wetlands above Mississippi Lake are known to be healthy maple swamps. The yearly water level cycle follows normal seasonal water flow fluctuations without human intervention. The spring flood is followed by dry summer conditions and the trees are in good condition. The Innisville Wetland is shown below as photographed on July 10, 2014, at a location about 200 metres upriver from the Ferguson Falls boat launch, on the north side of the Mississippi River.

Figure G-15 The Innisville Wetland on July 10, 2014 (CB-100_2807.jpg)
