# **The Appleton Wetland; Its Decline, Cause and Recommended Action**

## **Appendix J: The Vanishing Island**

**Appleton Wetland Research Group  
of the  
Mississippi Valley Field Naturalists**

**August 11, 2014**

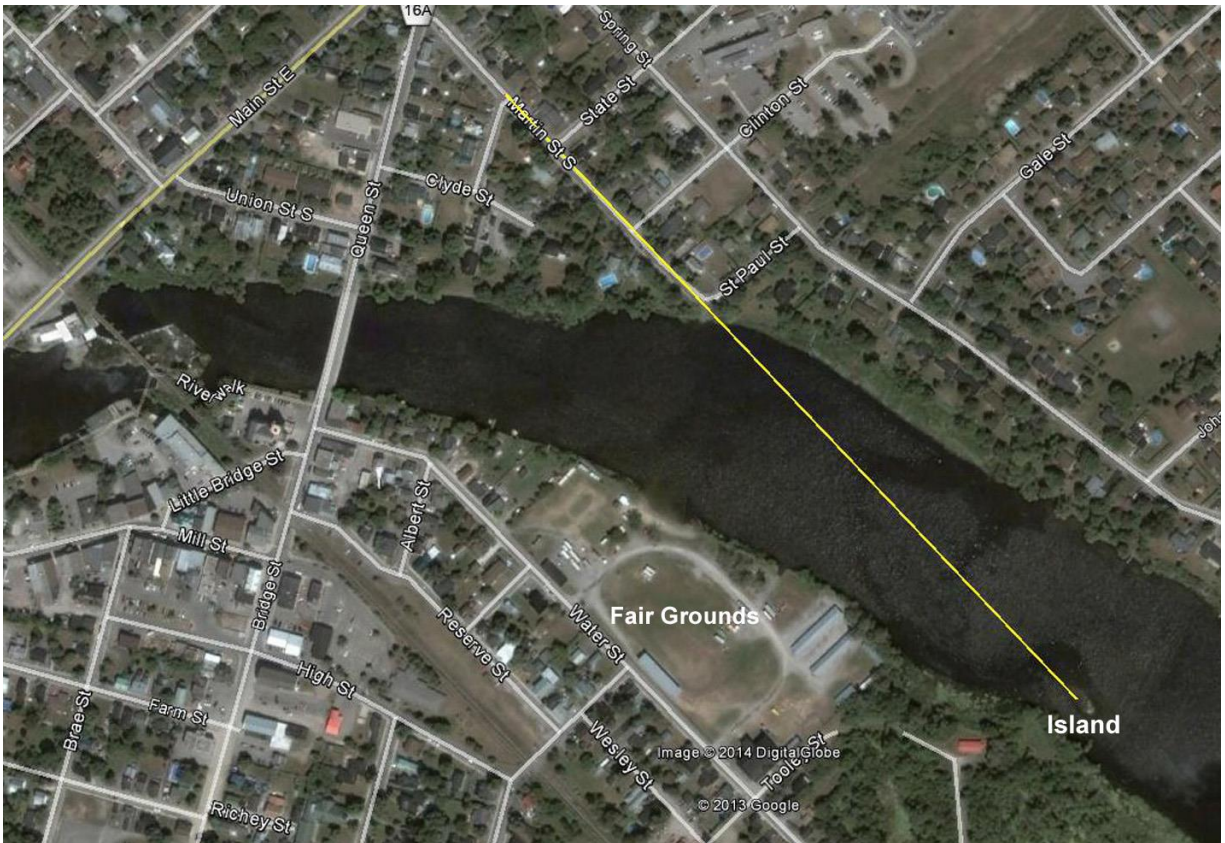
There is a strong memory, on the part of many people, of a small island just above the Fair Grounds in Almonte. This island always disappeared in the spring flood, but then later in the low-flow summer period it was usually quite visible up until around the year 2000. This was particularly noticeable while driving southeast on Martin Street South and approaching St. Paul Street where there is a clear view of the river. The small island was straight ahead down Martin Street as shown on the Google Earth image below. The yellow line projected from Martin Street does point directly at the island.

**Figure J-1 Google Earth view of Martin Street South and island**

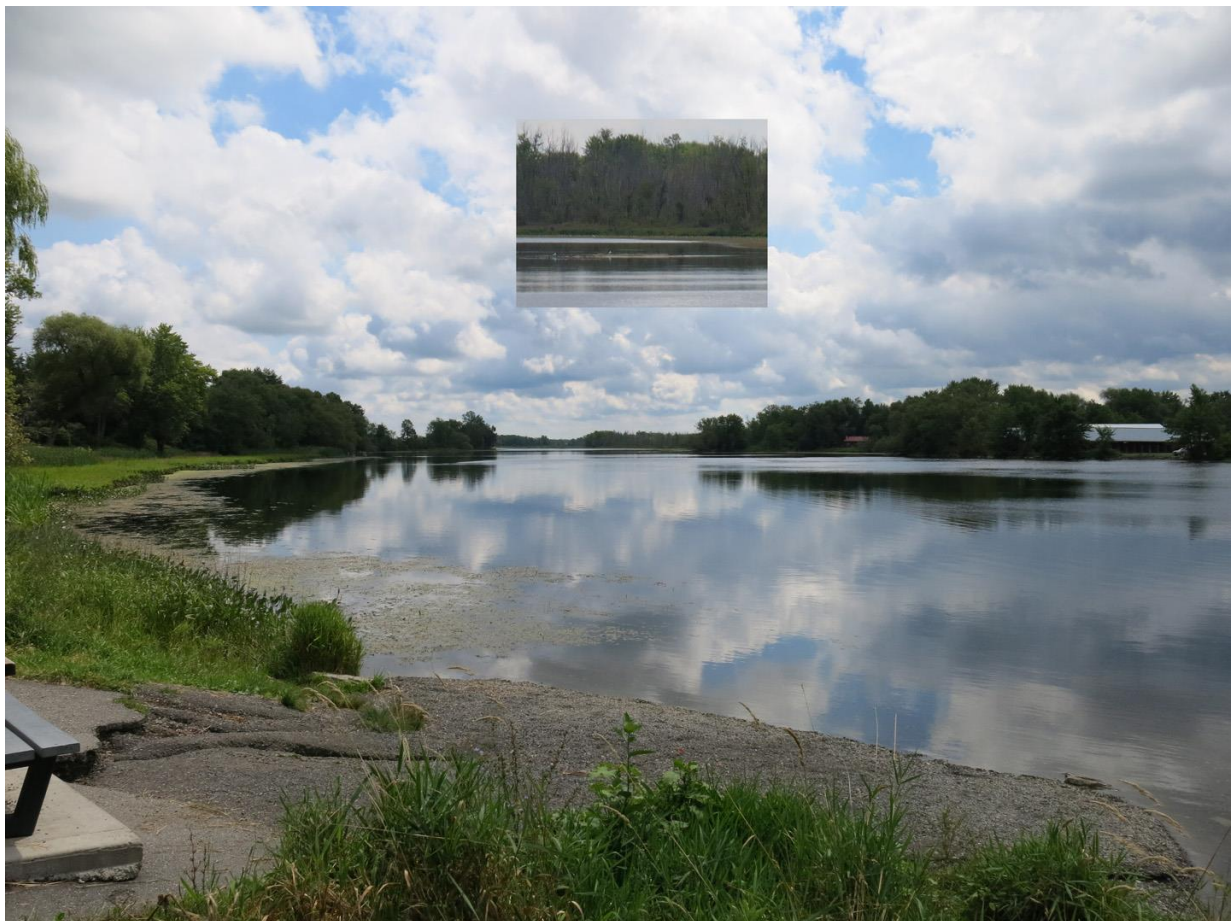
For comparison the image below was taken from the small pavilion at the intersection of Martin Street South and St. Paul Street on August 13, 2013 at 12:29 PM. At the time the river water level was 117.58 masl as measured at 222 Spring Street. Observing the shoreline and foliage, the image does appear to resemble very closely the similar features in the 1890 image. A second image was taken at the same time with a zoom lens, and a cropped section from the island portion of that image has been pasted at the top of the normal image. Just barely visible is a faint outline of just the top of the island. It is indeed the island – further enlargement will show two birds standing on the rock. The difference in the images is that the 2013 image was taken with a water level of 117.58 masl while the 1890 image was probably taken with a water level of 117.20 masl, the level deduced for the 1970 to 1990 era from measurement of the rock ridge adjacent to the island as detailed in Appendix I. The difference in level is at least 35 cm, an amount that would be quite visible.

**Figure J-3 The same river scene in August 13, 2013 (AI-IMG\_0348e2.jpg)**

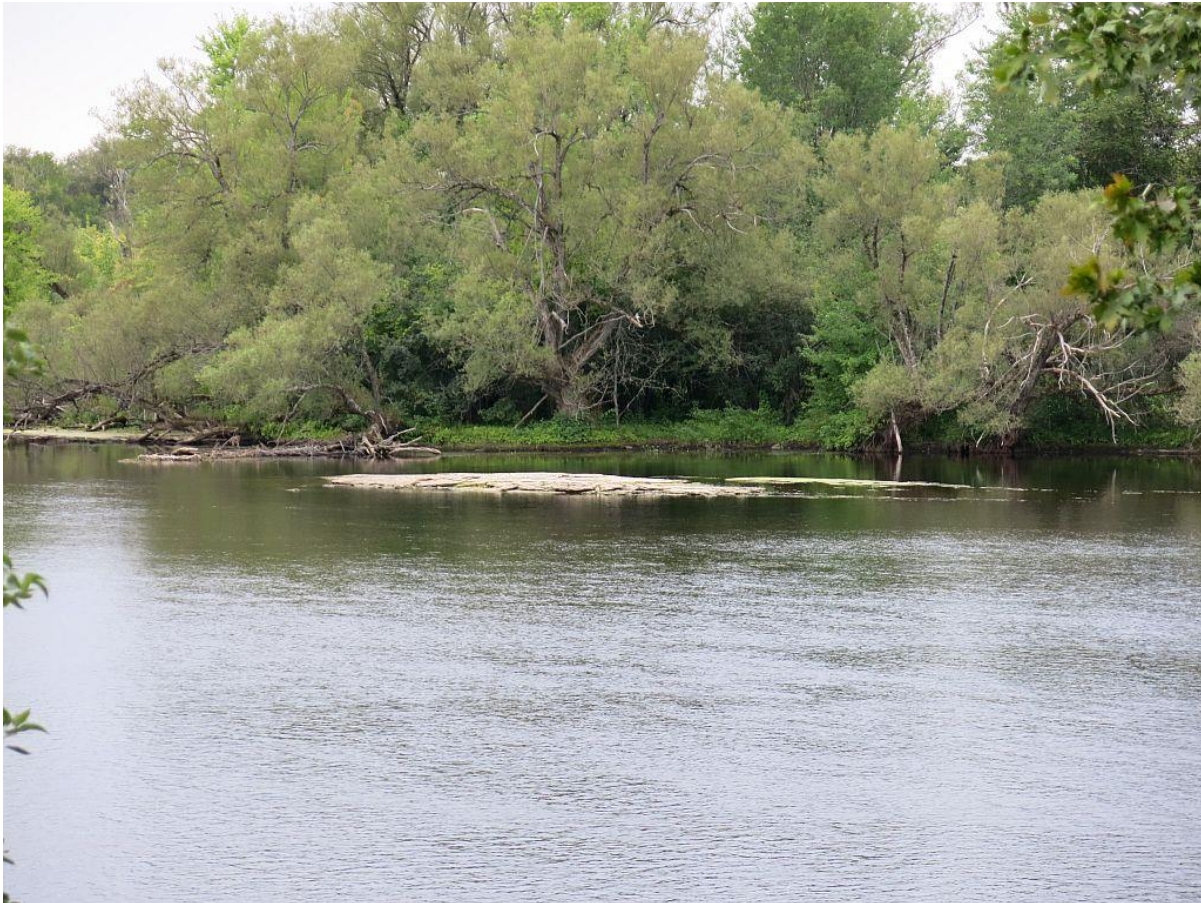
In conjunction with the program of coordinated water level measurement during the summer of 2013, as described in Appendix H, in addition to the water level measurements at the riverfront of 222 Spring Street, we also took photos of the island from a the same view point on the side yard of that property. The image below is an example of an image at the lowest water level recorded. It was taken on August 25, 2013 at a water level of 117.49 masl measured at Spring Street.

**Figure J-4 The island from 222 Spring Street (AI-IMG\_0396e.jpg)**

In this image the island is quite visible, but it is not as high as it seemed to be from recollections of earlier years in the 1970s to 1990s. The estimate is that the water would have been about 30 cm lower with the result that the island would appear 30 cm higher.
