The Appleton Wetland; Its Decline, Cause and Recommended Action

Appendix K: Wetland Inspection

Wetland Inspection

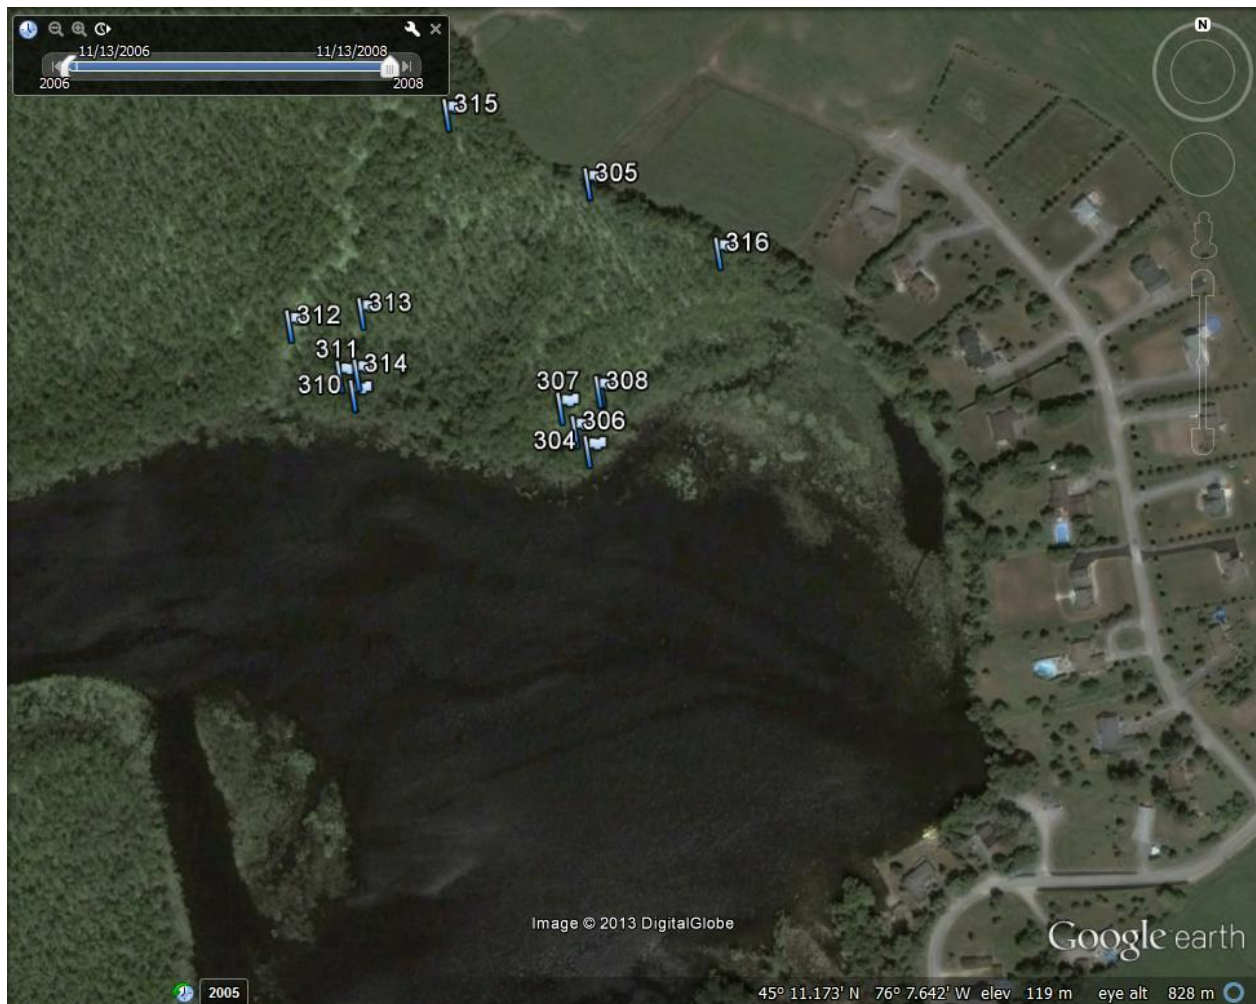
Figure K-1 Google Earth image of wetland with waypoints added

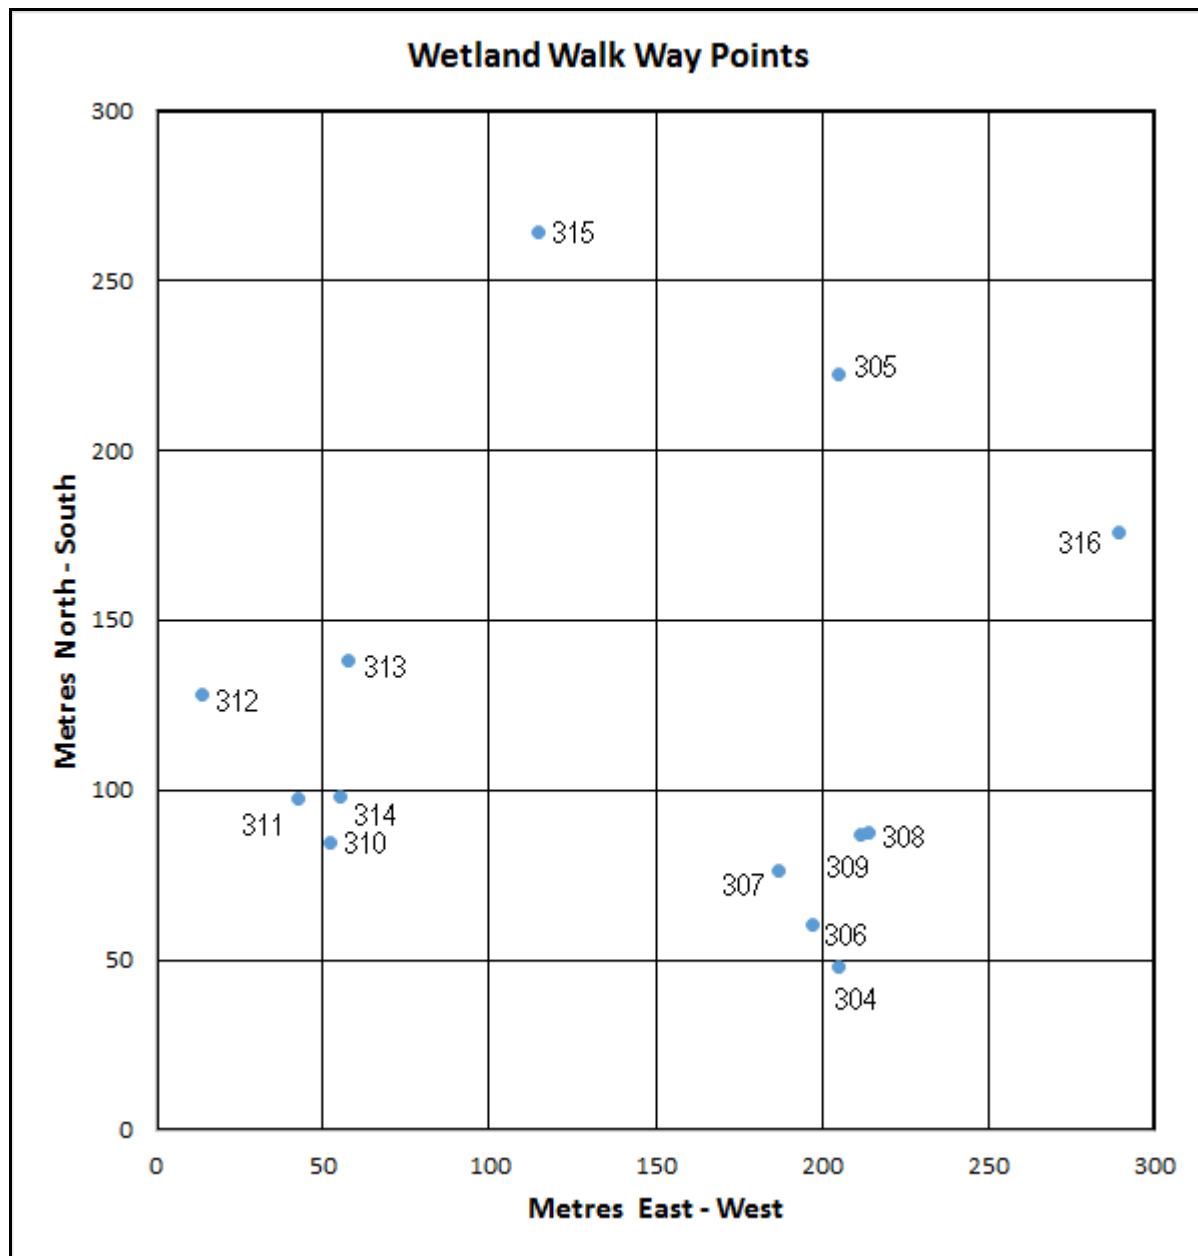
To provide a clearer view of the distances between waypoints, the GPS data was converted to a grid chart 300 metres square. The origin of the chart has been selected to display all waypoints conveniently. It is shown below.

Figure K-2 Chart of waypoint relative positions

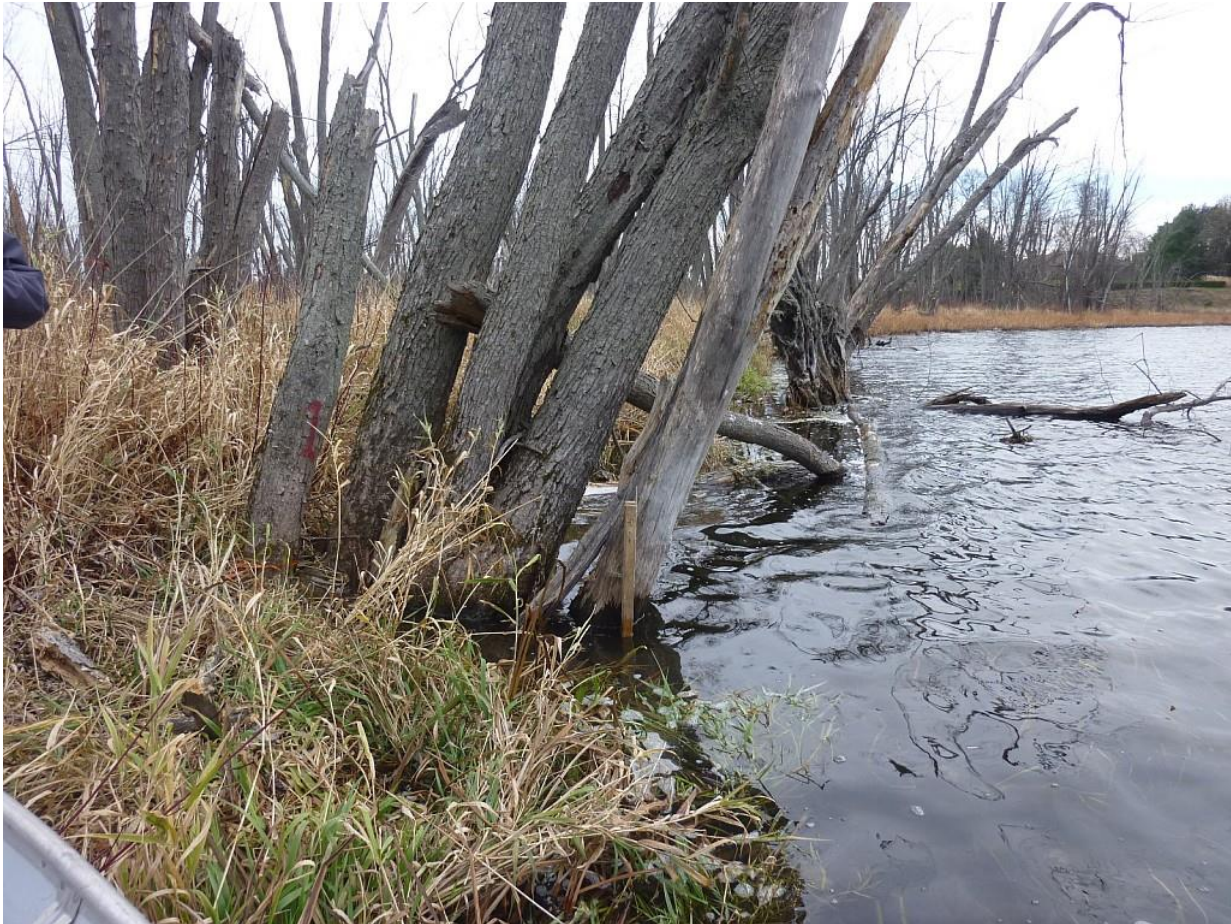
This is actually the position of Tree 1 from the 2011 MVFN Tree Project, and was the point of departure for the first series of measurements. The only data recorded at this location was the reading of water level on the stake gauge. At 10:20 AM it read an average of 56.5 cm (there was a slight ripple in the water, about ± 1 cm). The level is equivalent to 117.80 masl.

Figure K-3 WP304 - Tree 1

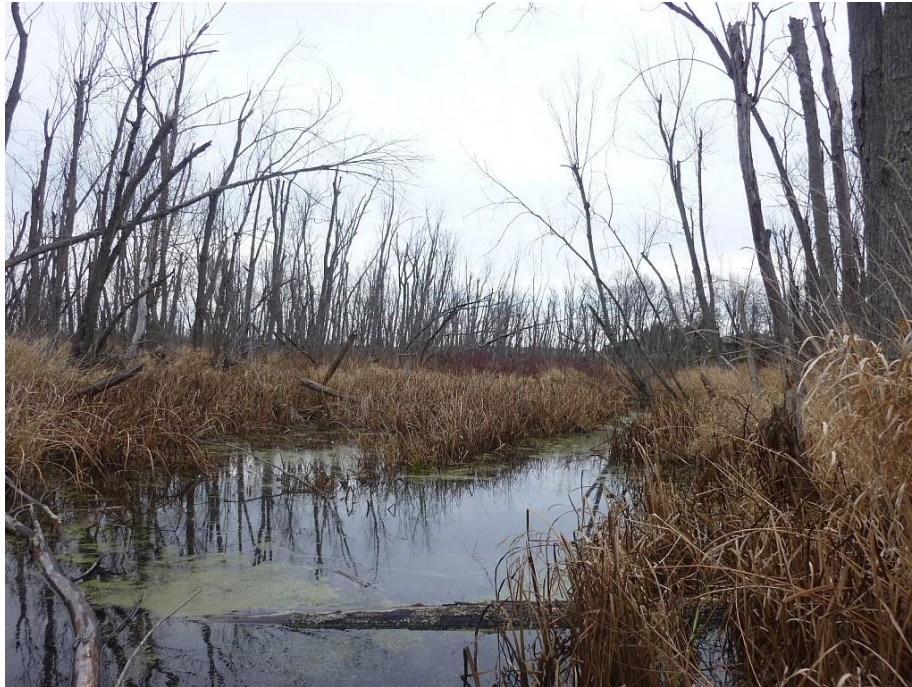
Hummock with stressed trees. Open water was some distance from trees, but we dug a small hole near trees. The water in the hole was about 15 cm below ground level, and about 23 cm below the base of the tree.

Figure K-4 Dead and stressed trees along drainage channel near WP306

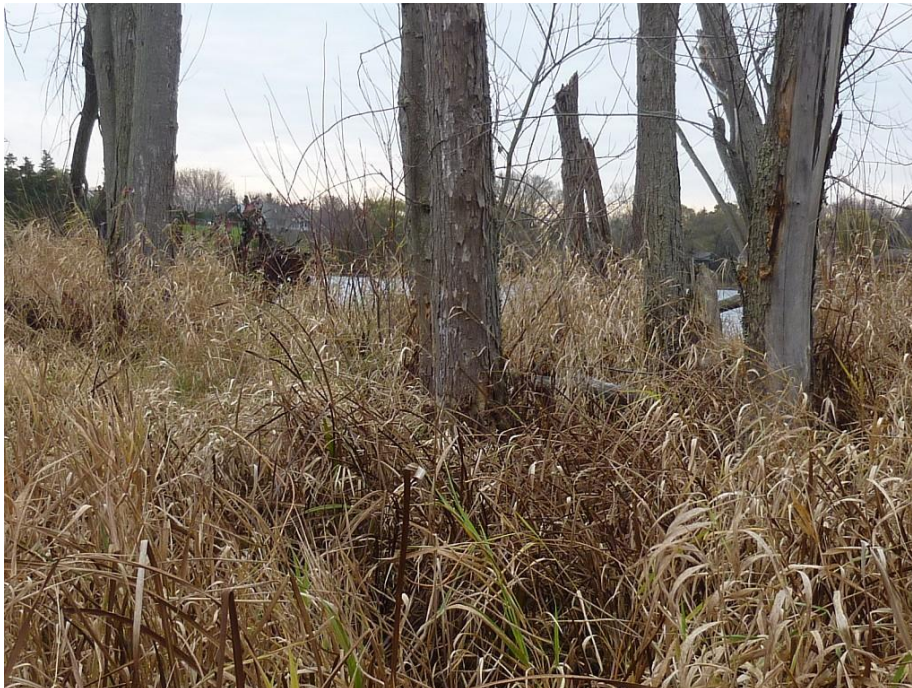
Figure K-5 Dead trees and ground vegetation near WP306

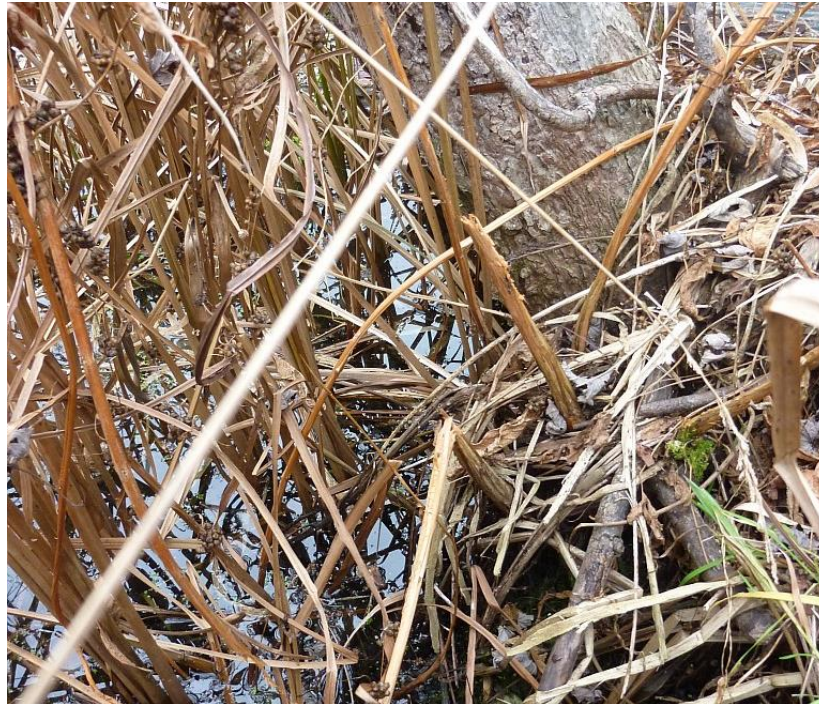
WP307

Hummock with stressed trees. Nearby ground level was 14 cm below water level. Base of roots was 18 cm above water.

Figure K-6 Base of trees with water below

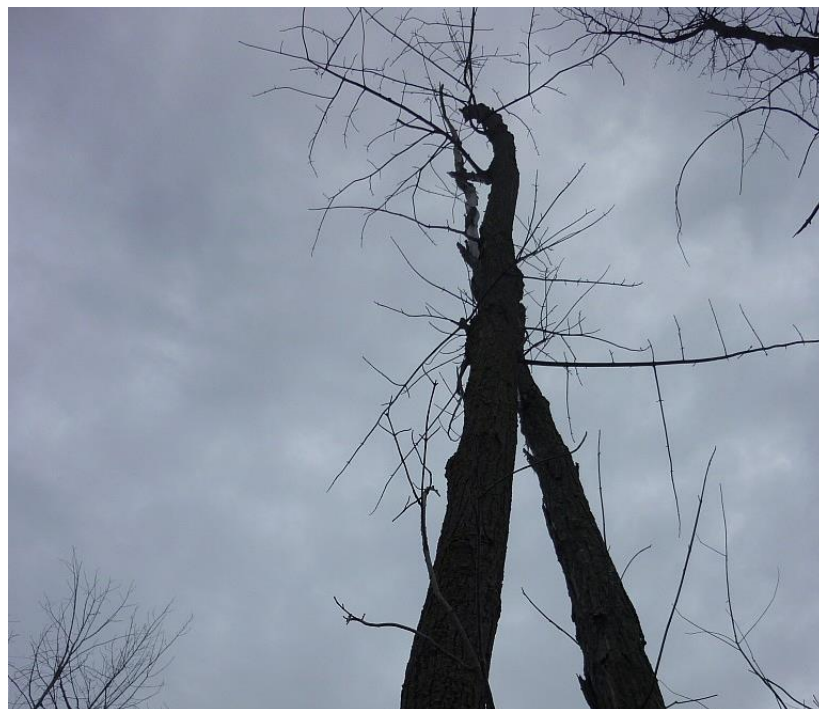
Figure K-7 Thin crown of stressed trees

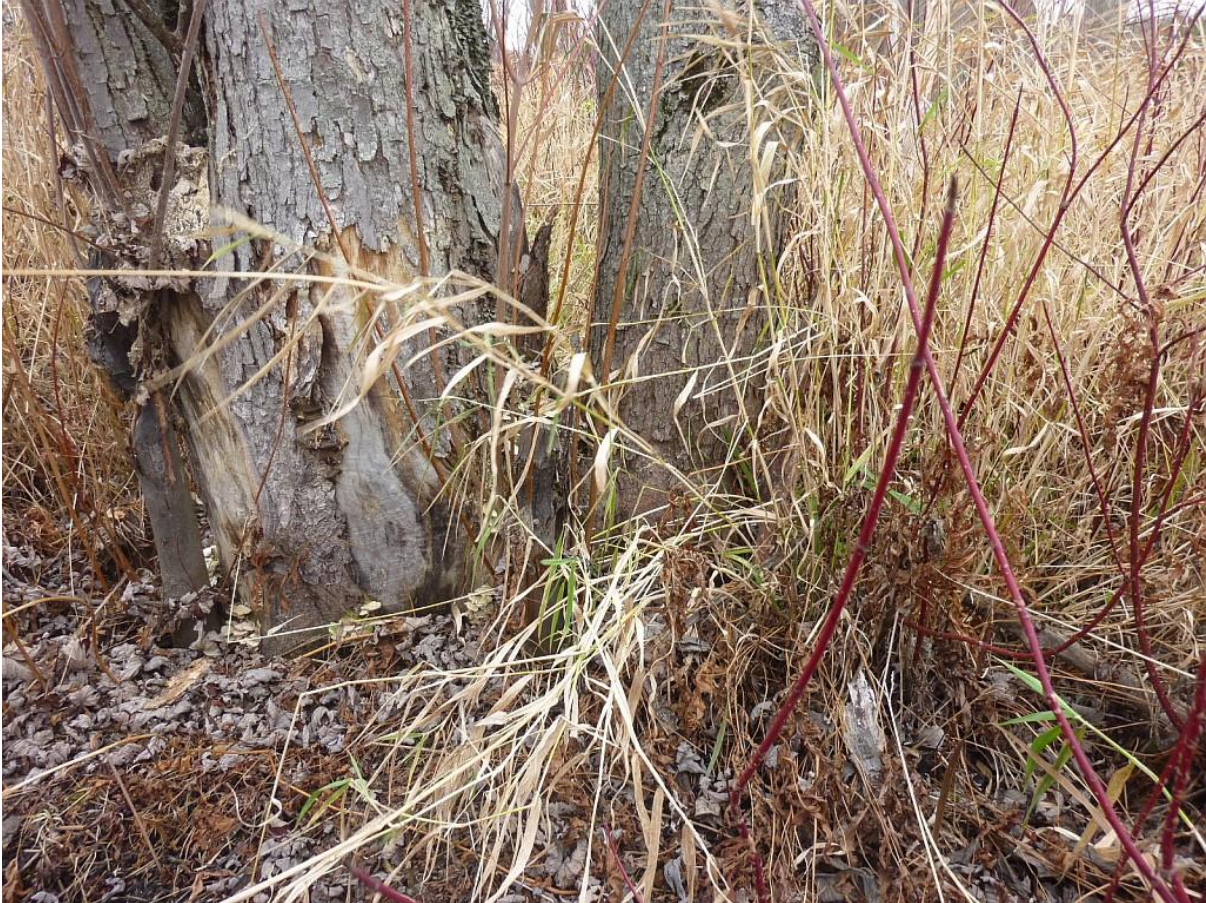
WP308

Hummock with dead trees. Nearby ground level was 18 cm below water level. Base of roots was 20 cm above water.

Figure K-8 Hummock with tree bases

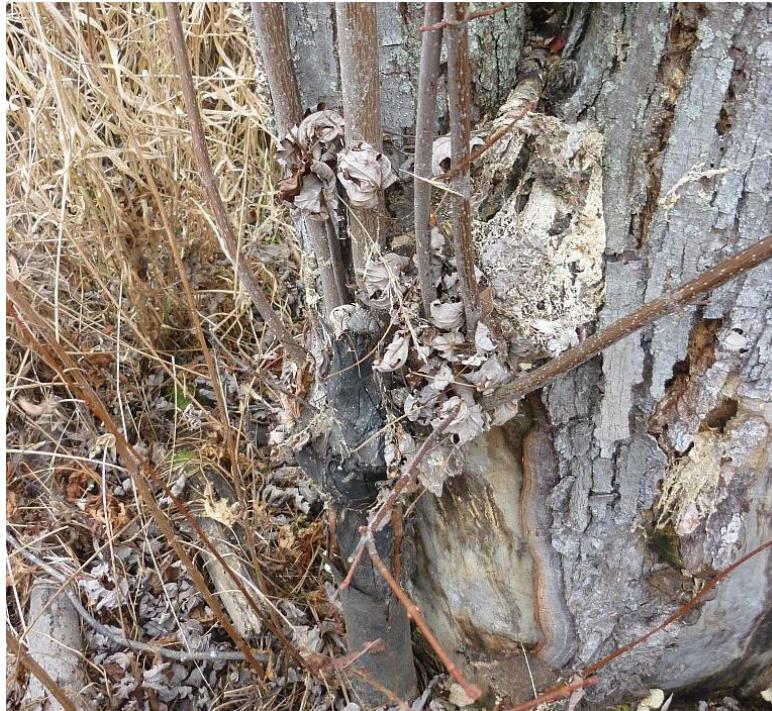
WP309

Hummock with one dead tree and one stressed. Nearby ground level was 10 cm below water level. Base of roots was 18 cm above water.

Figure K-9 Hummock with trees – note new shoots

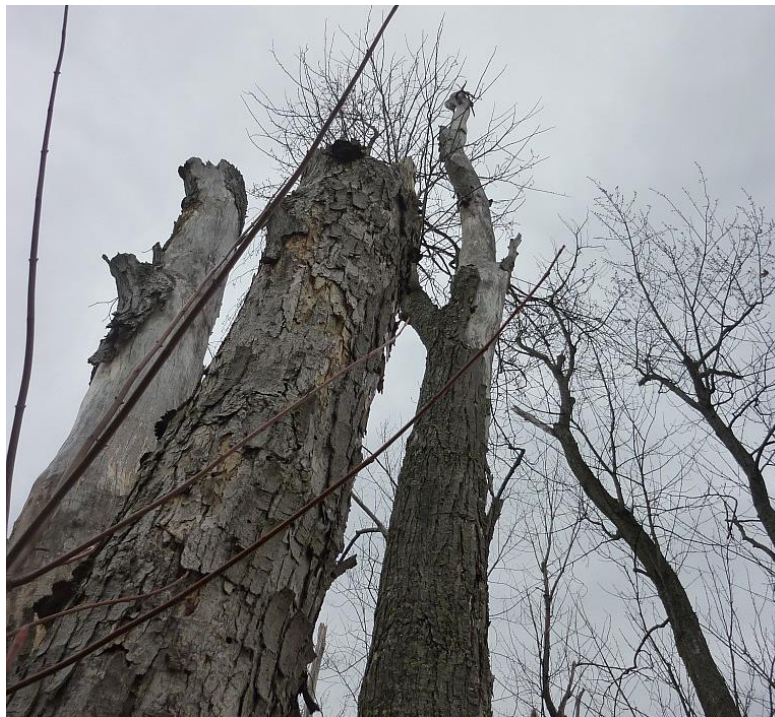
Figure K-10 Dead trunks and surviving tree with stressed crown

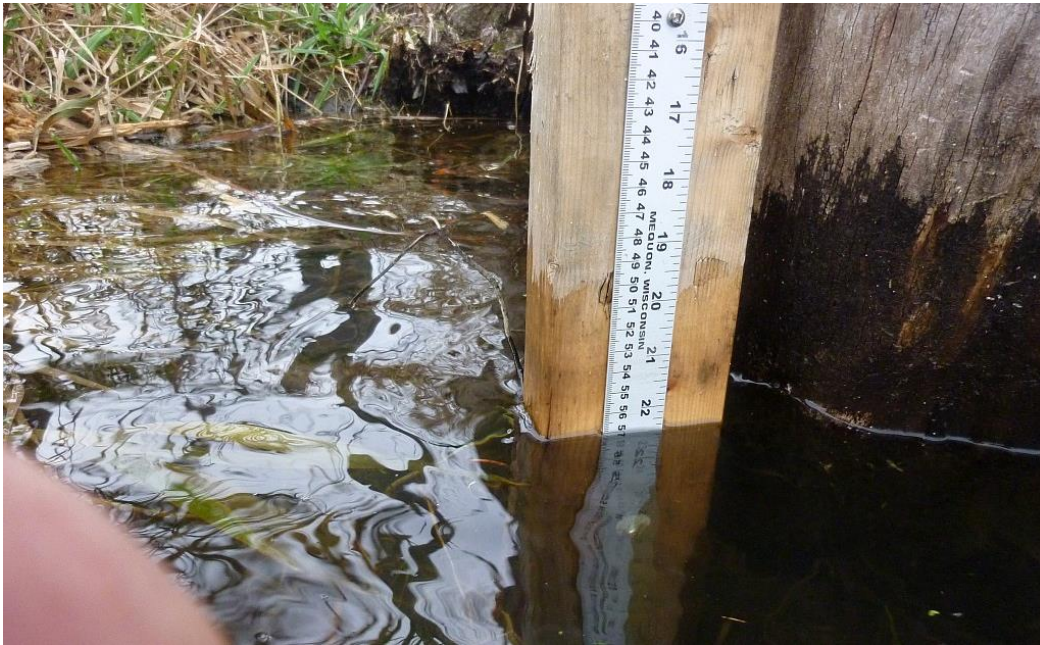
Returned to the boat at the starting point. Before leaving WP304, the water level was checked again, giving a reading about 57.0 cm on the stake gauge, essentially unchanged from the 117.80 masl level an hour earlier.

Figure K-11 Recording water level at stake gauge

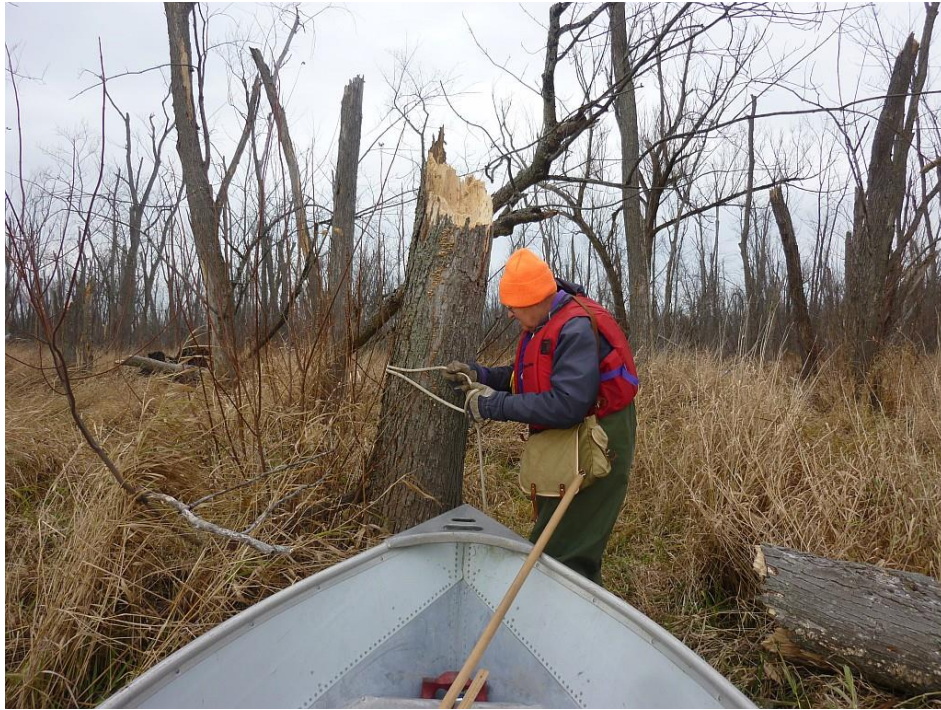
Figure K-13 Arriving at WP310

This location marked the starting point for a second circle walk about 11:00 AM. It was selected only as an easy point to land a boat, and is actually fairly close to the Tree 2 of the MVFN 2011 Tree Project.

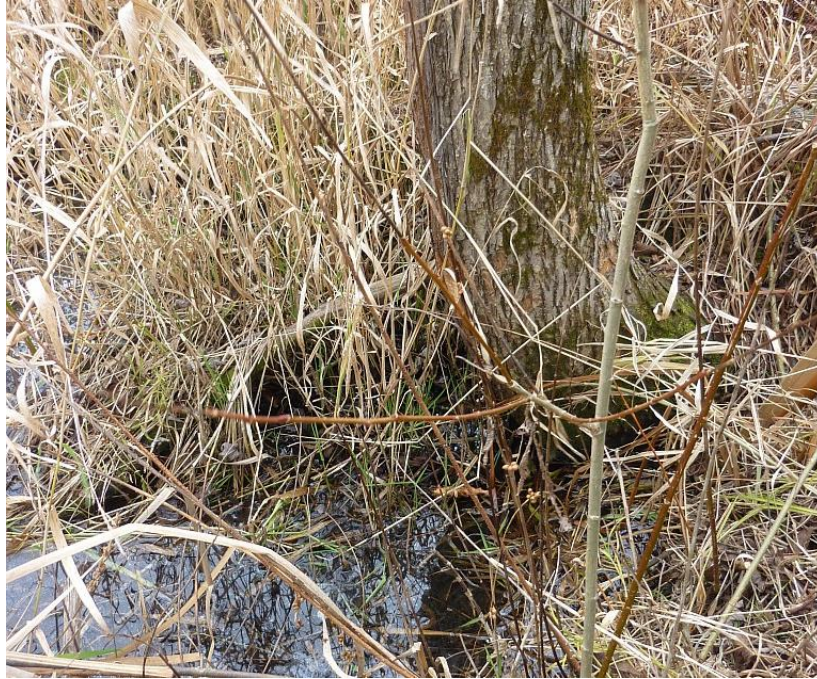
Hummock with dead tree. Nearby ground level was 8 cm below water level. Base of roots was at water level. Ground uneven and these measures are subject to error.

Figure F-15 Dead tree at WP311

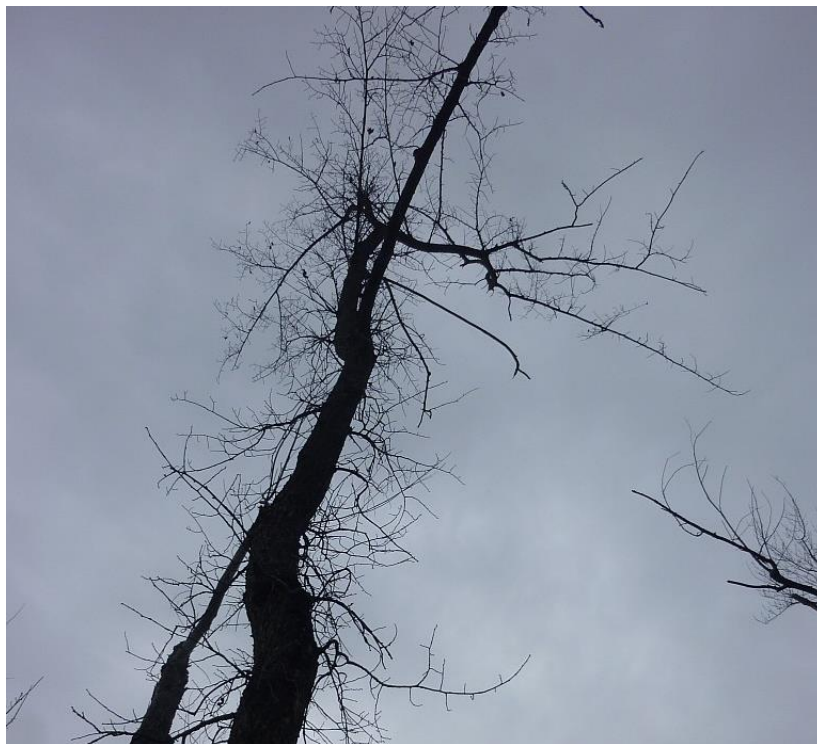
Figure F-16 Stressed tree crown – some of it looks dead

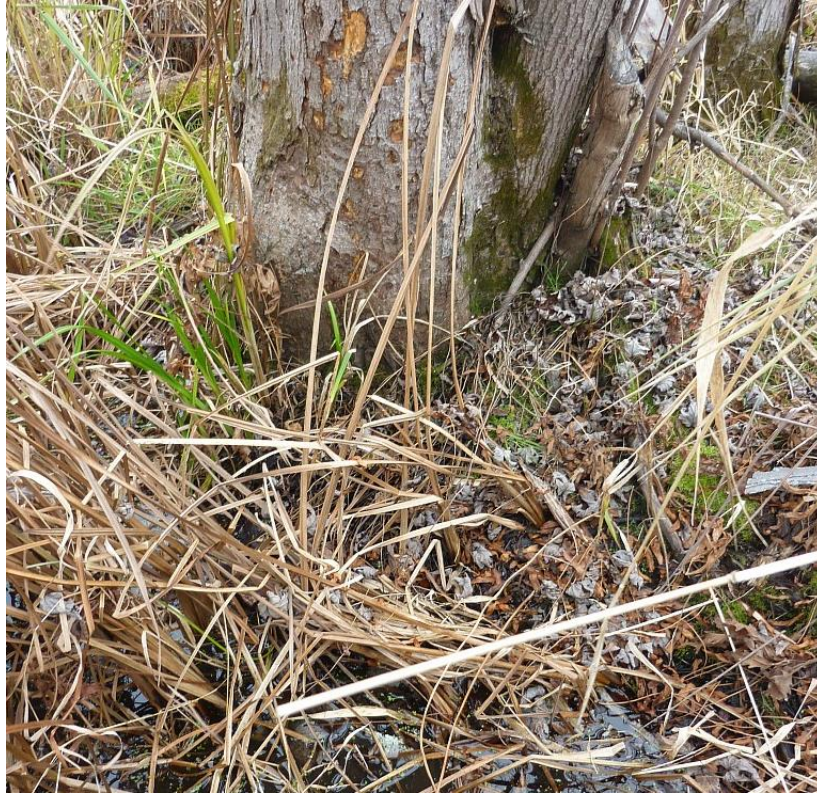
WP312

Hummock with live tree. Nearby ground level was 19 cm below water level. Base of roots was 20 cm above water.

Figure K-17 Hummock with tree base – note new shoots on right

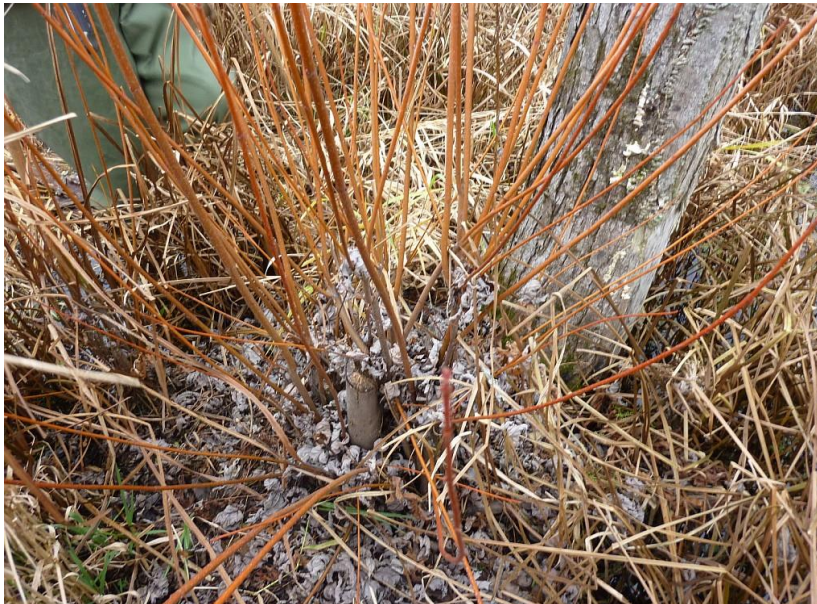
Figure K-18 Near WP312 – many new shoots starting

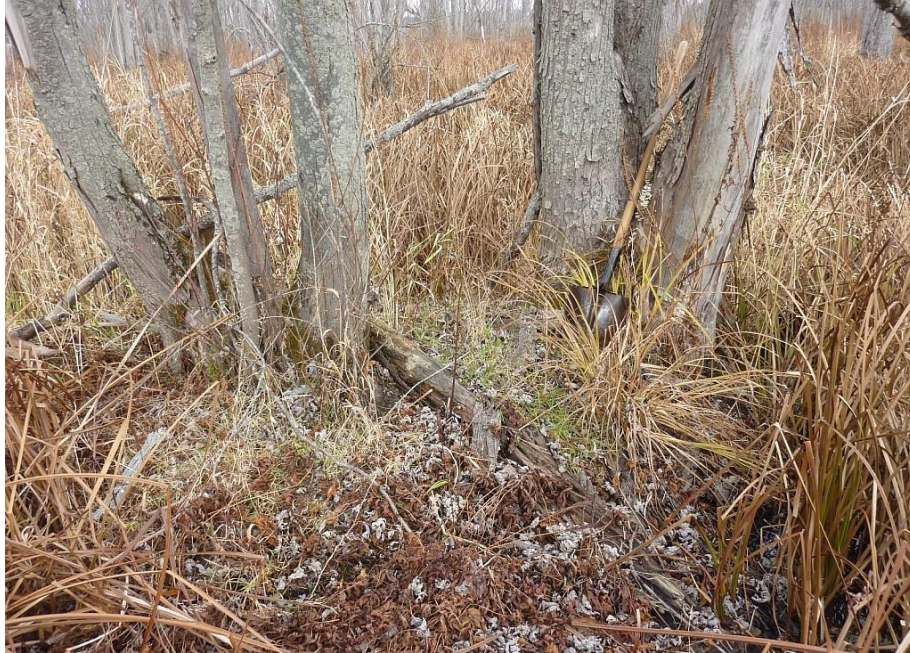
Hummock with live and stressed trees and also new shoots. Nearby ground level was 10 cm below water level. Base of roots was 18 cm above water.

Figure K-19 Large hummock at WP313

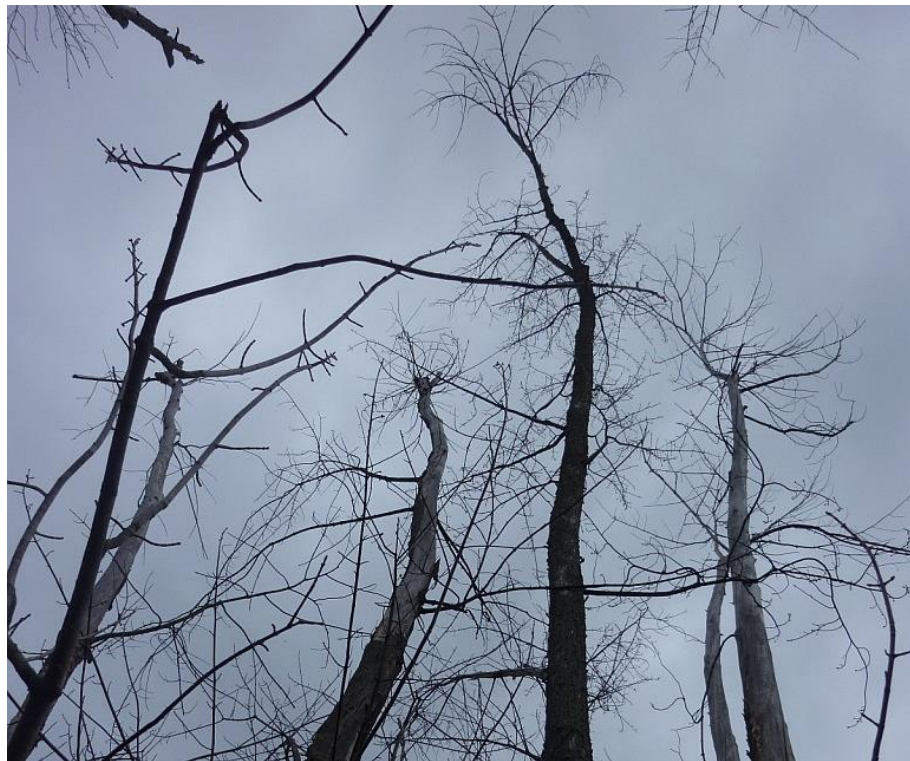
Figure K-20 Tree crowns at WP313 – dead on left, stressed on right

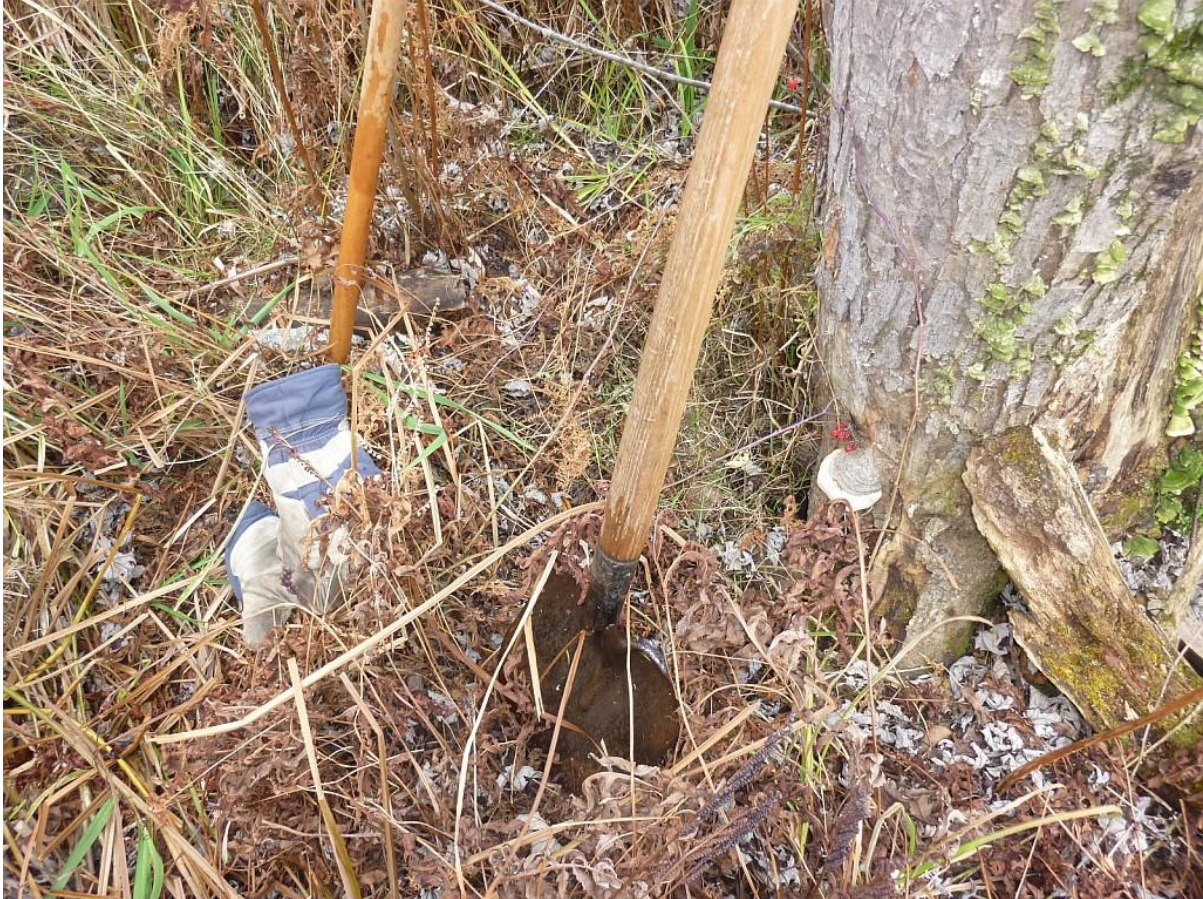
Hummock with stressed trees. Nearby ground level was 12 cm below water level. Base of roots of edge tree was 12 cm above water.

Figure K-21 Tree at WP314

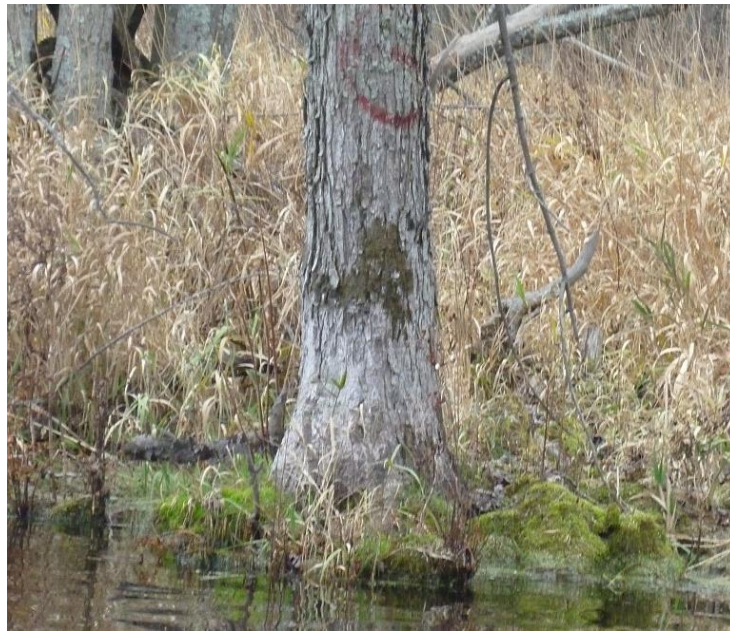
Figure K-22 On return trip – Tree 6 with water at tree base

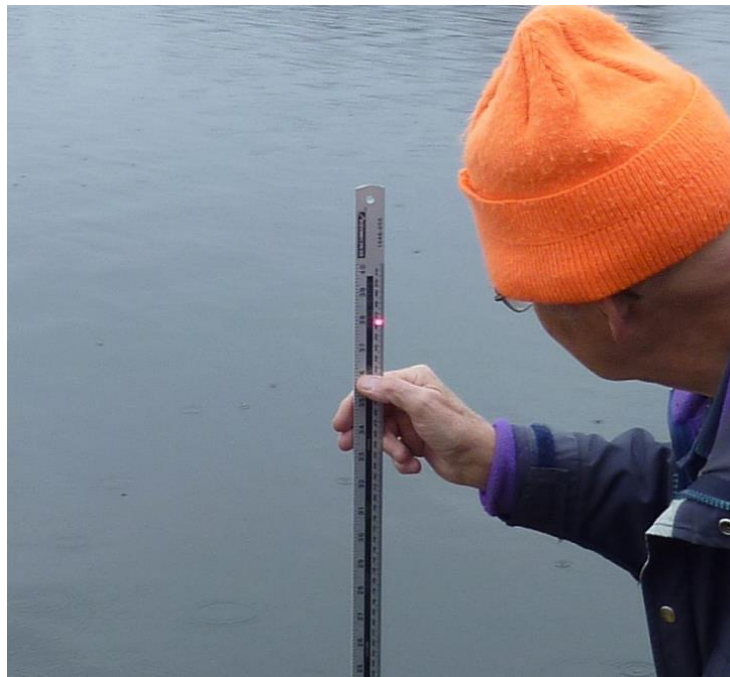
Return to starting point of second loop around 12:20 PM and subsequently return to the 521 River Road property. Did a water level check at this point at 1:05 PM yielding 117.785 masl. This is within reasonable agreement of earlier levels given the uncertainty due to the light chop in the water. Further level checks showed 117.78 masl at Spring Street at 1:25 PM and 117.78 masl at the Bridge Street bridge in Almonte at 1:40 PM.

Figure K-23 Taking water level at BM – note laser spot on scale

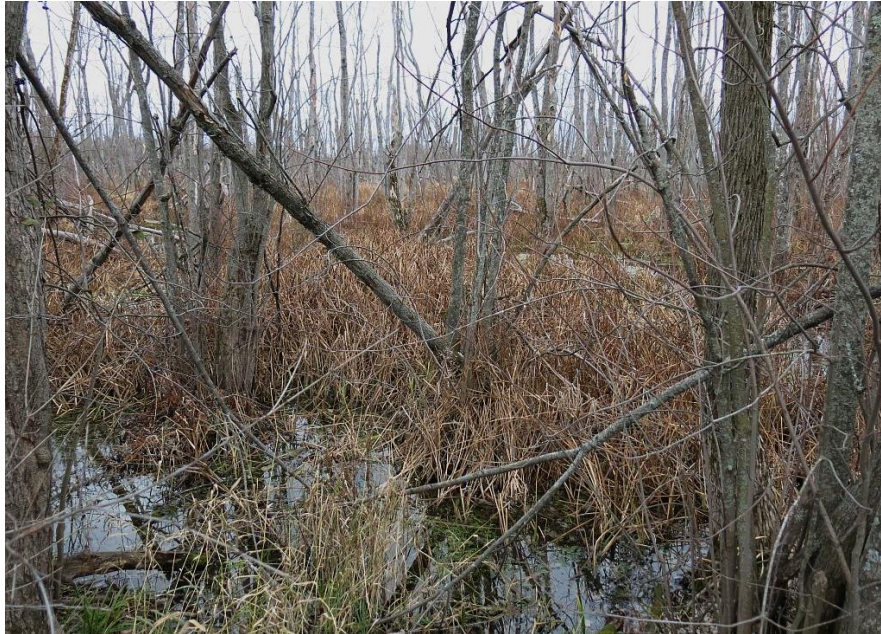
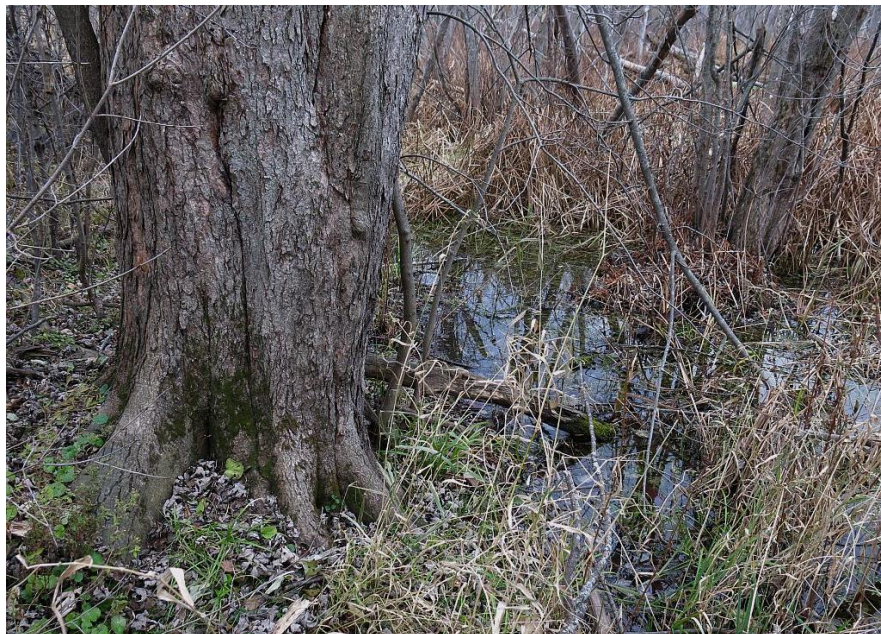
WP305

This waypoint was entered into the GPS unit to provide a target end point for the first walk. As previously noted, the terrain encountered made it impractical to travel through the wetland to WP305. On November 8, Al Seaman returned via the fields to the north of the wetland to take some photos here, and at WP315 and WP316, locations 100 metres west and 100 metres east of WP305. From the vantage point of dry land, the wetland here looked essentially the same as found the previous day; a mix of dead trees and trees having a stressed appearance surviving on scattered hummocks.

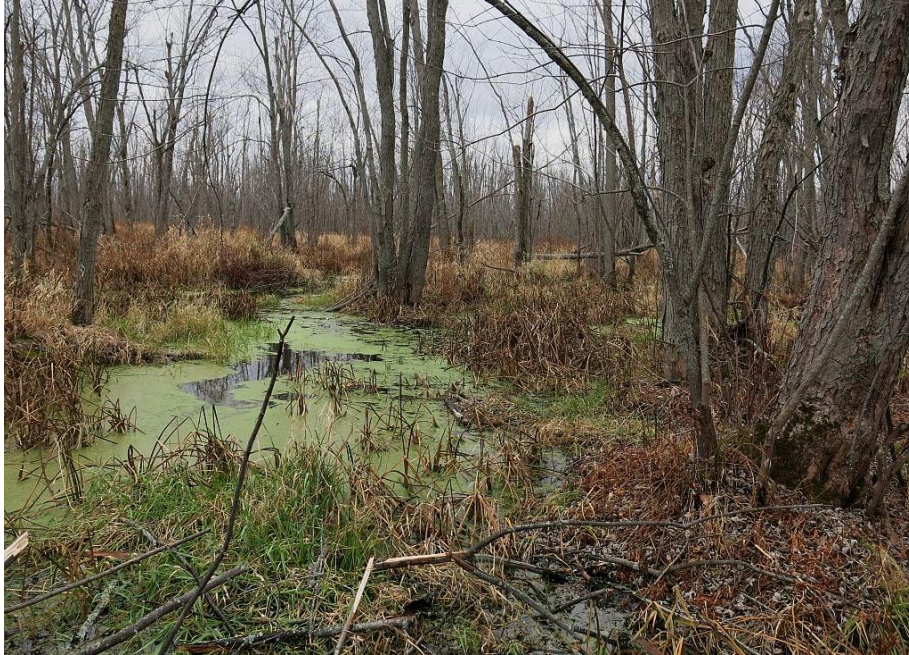
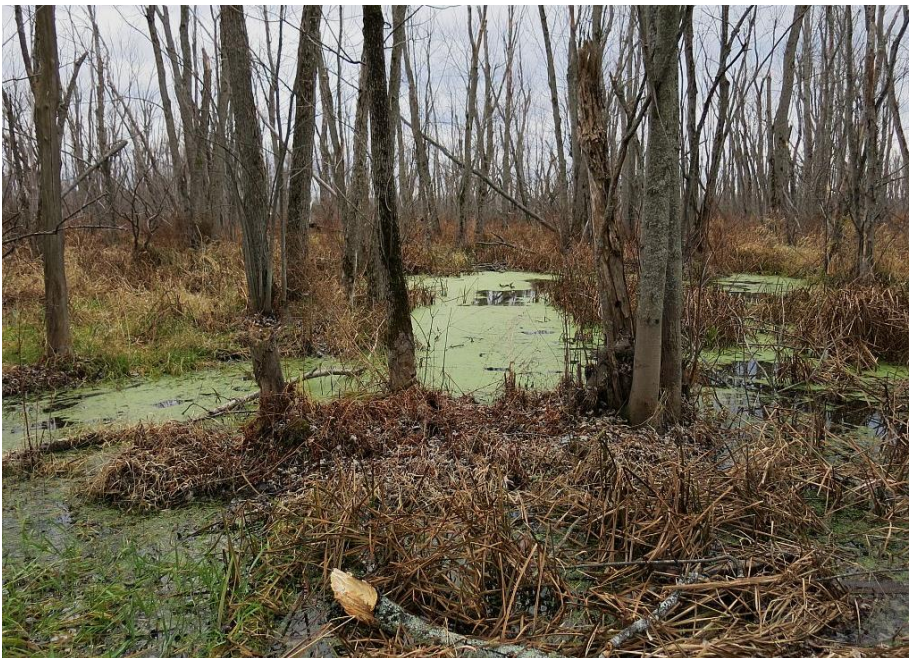
WP315

Location approximately 100 metres northwest of WP305. Photos show high water, stressed, and dead trees on hummocks.

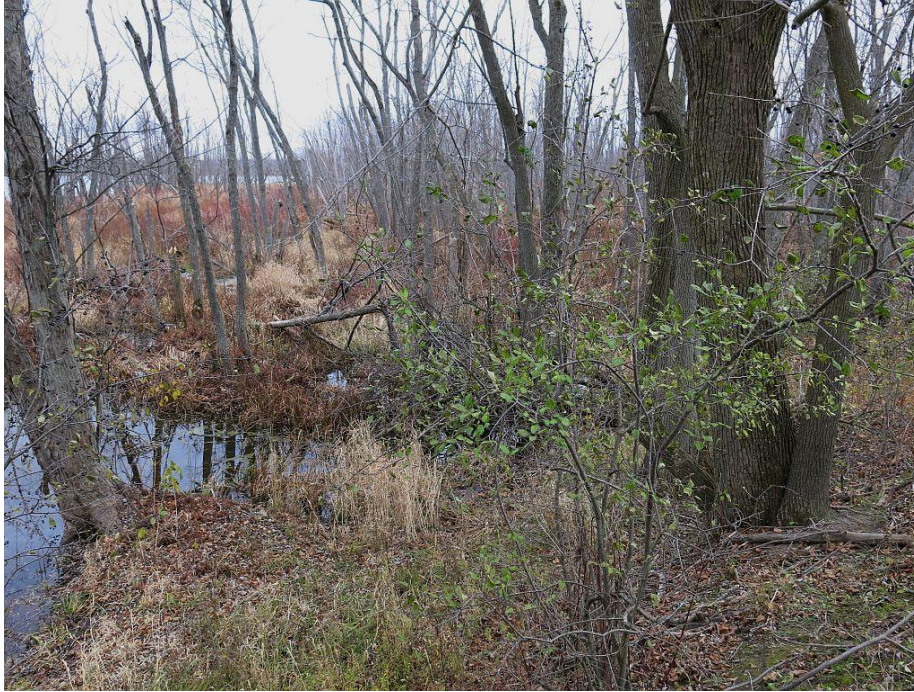
Figure K-28 At WP316 looking westward

Further images from November 8 approximately 100 metres southeast of WP305. Similar appearance to earlier photos, except the view point is now a fairly high bank above the wetland.

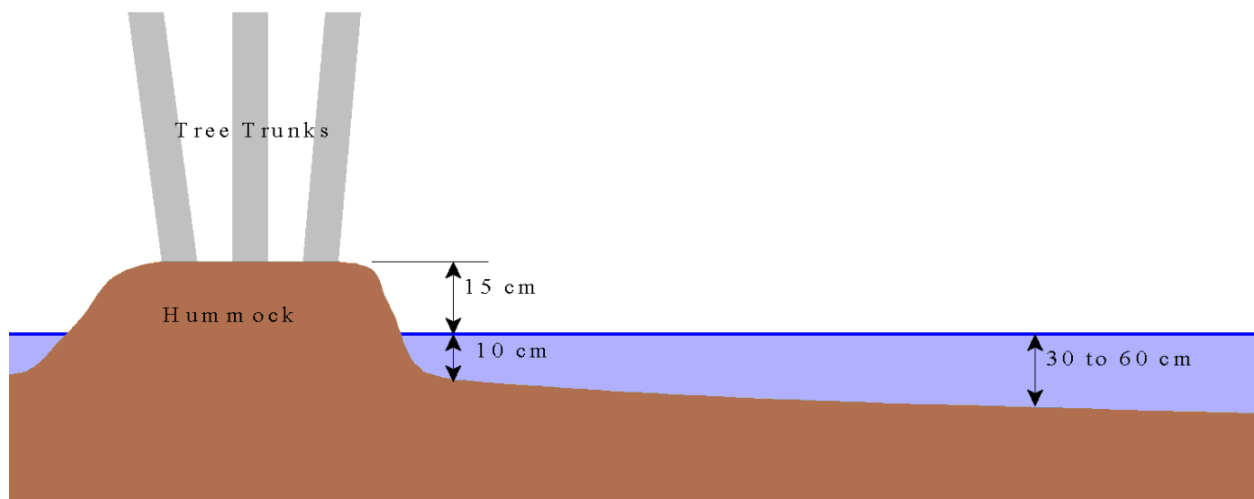
Regardless of the cause of the rough ground profile, it remains difficult to estimate what an average ground level would be in the wetland. As a first approximation it seems reasonable to take an average of the level difference from tree base to the water, and from the water to the ground level at the edge of the hummock for each of the way points recorded. The diagram below illustrates the result.

Figure K-30 Sketch of typical hummock profile and water level

Faced with the irregular ground profile at the hummock, the question is just what should be considered as “ground level”? Certainly, from the point of view of the tree root system, the narrow top of the hummock is not the right place. It seems rather that it should be at the bottom of the steep sided hummock where the ground changes to the gently sloping pond bottom between hummocks – that is, about 10 cm below the water level at the time of 117.80 masl. Based on discussion with Dr. Paul Keddy, for healthy tree growth, water level should be at least 25 cm below ground level. (See Section 3.5 of this report, *Characteristics of Maple Swamps*.) Applying that to the above measurements would give a desirable water level of 117.45 masl or less. We recommend rounding that number to the level of 117.40 masl as measured at the wetland to ensure the restoration of tree growth in the Appleton Wetland.
