# The Decline in the Silver Maple Wetlands of Appleton in Mississippi Mills, Ontario

An Environmental Problem Analysis  
by:  
Mississippi Valley Field Naturalists

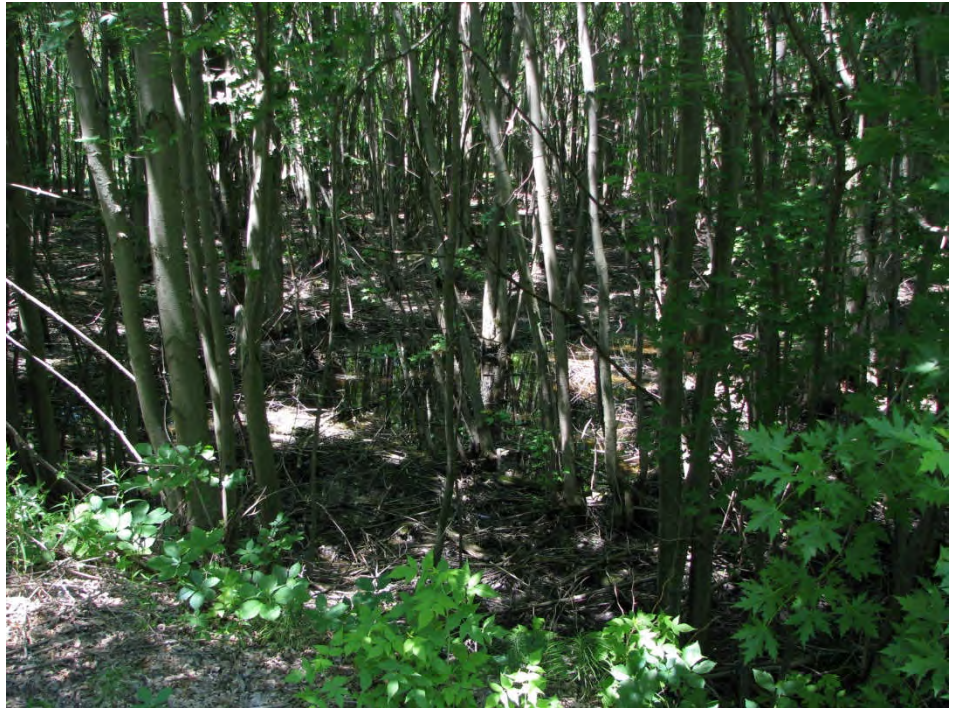
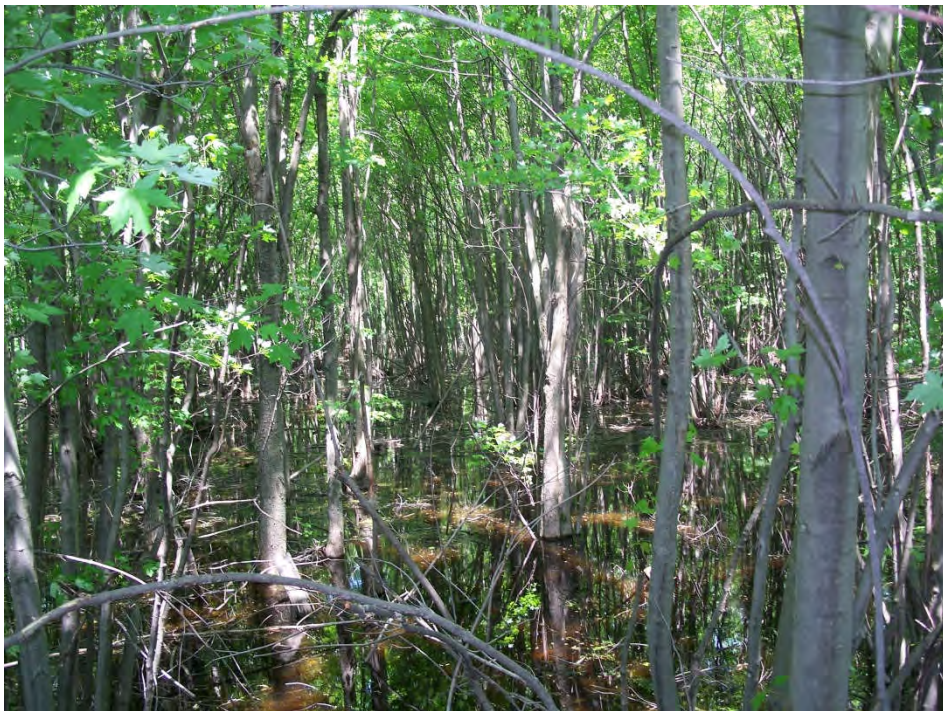
# Lavallee Creek Wetland

Same area

**June 30 2011  
Dry - No surface  
water**

**June 2 2011  
Flooded**

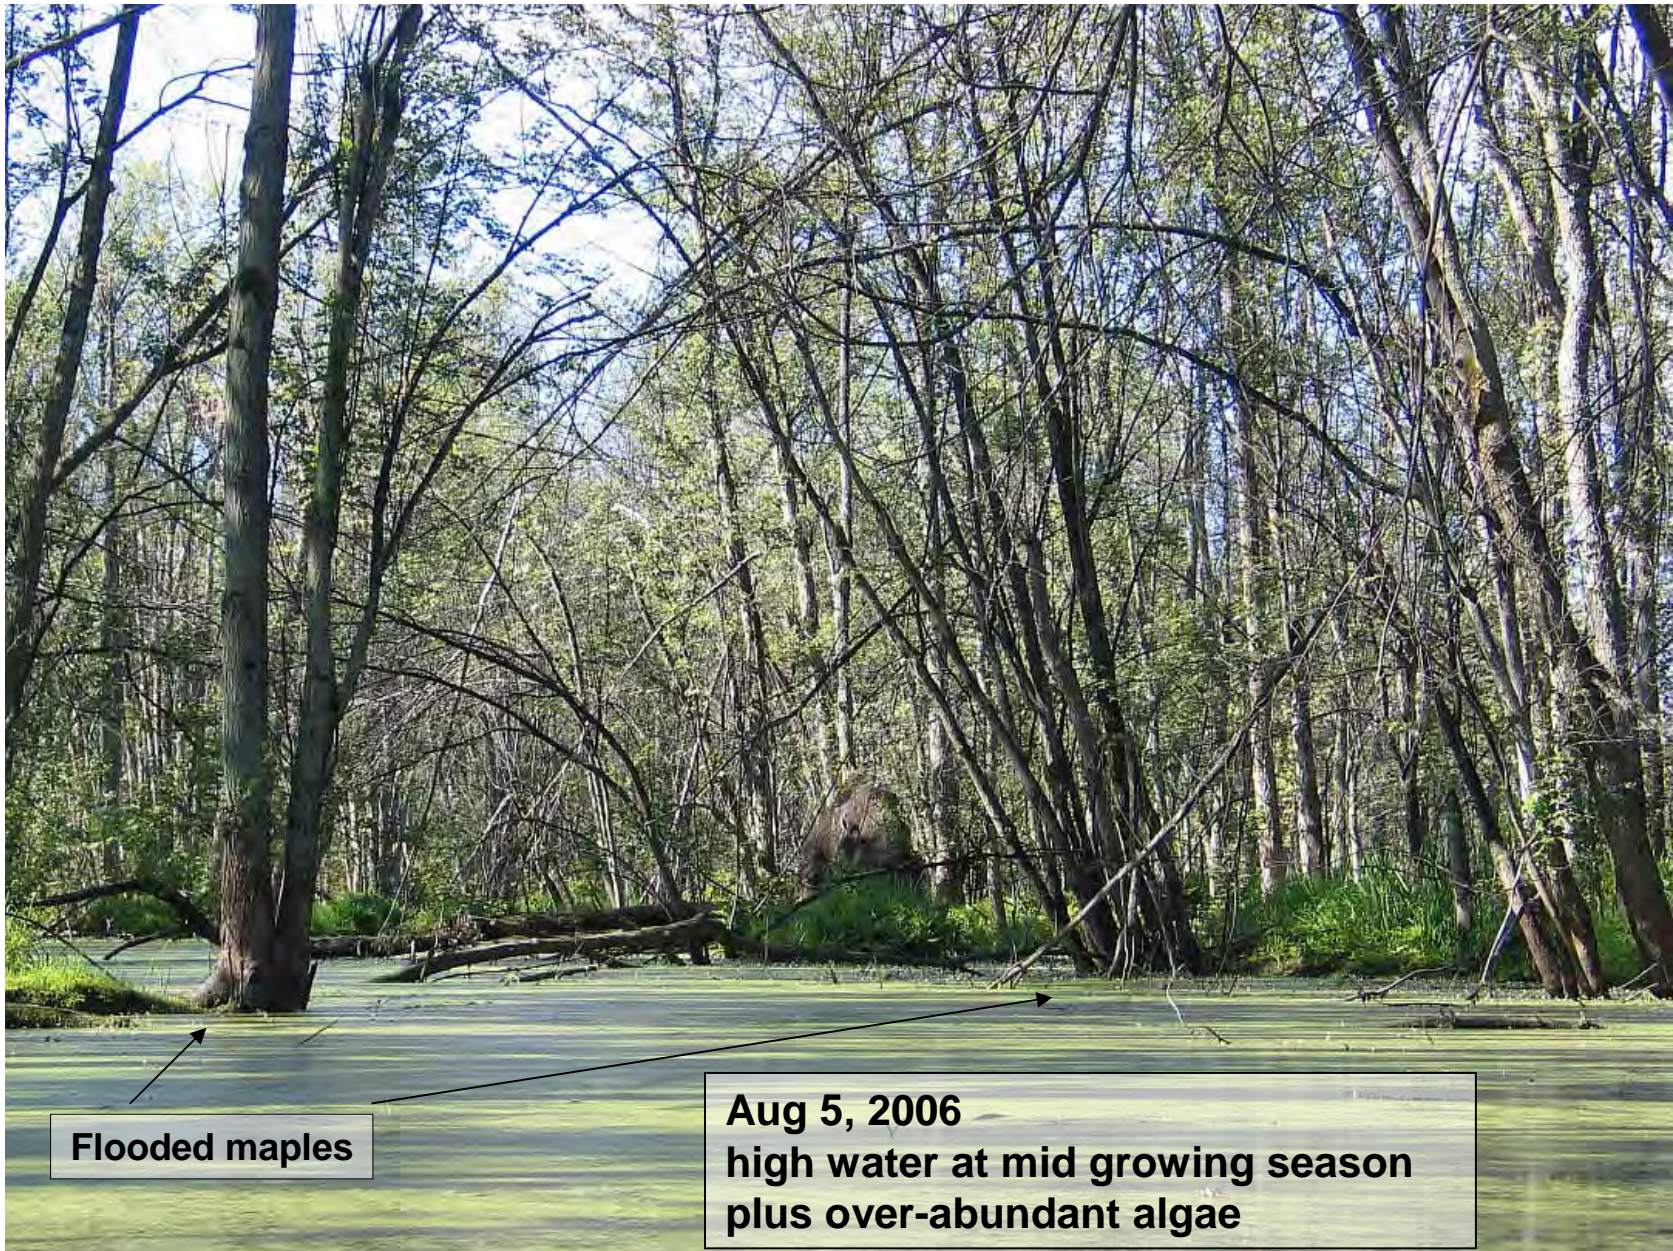
**Depicts toppled trees with lifted roots, thin canopy and dead branches**

**Flooded maples**

**Aug 5, 2006  
high water at mid growing season  
plus over-abundant algae**

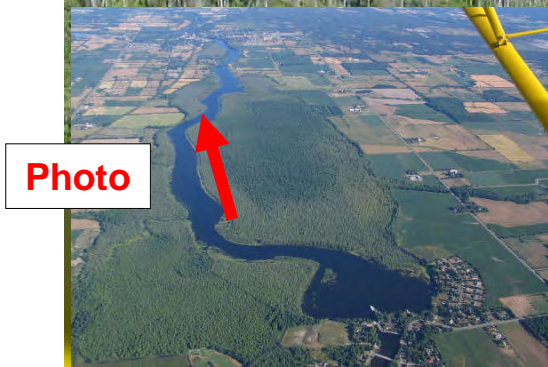
Jul 9, 2012

# Silver Maple die-back with some growth and suckering roots

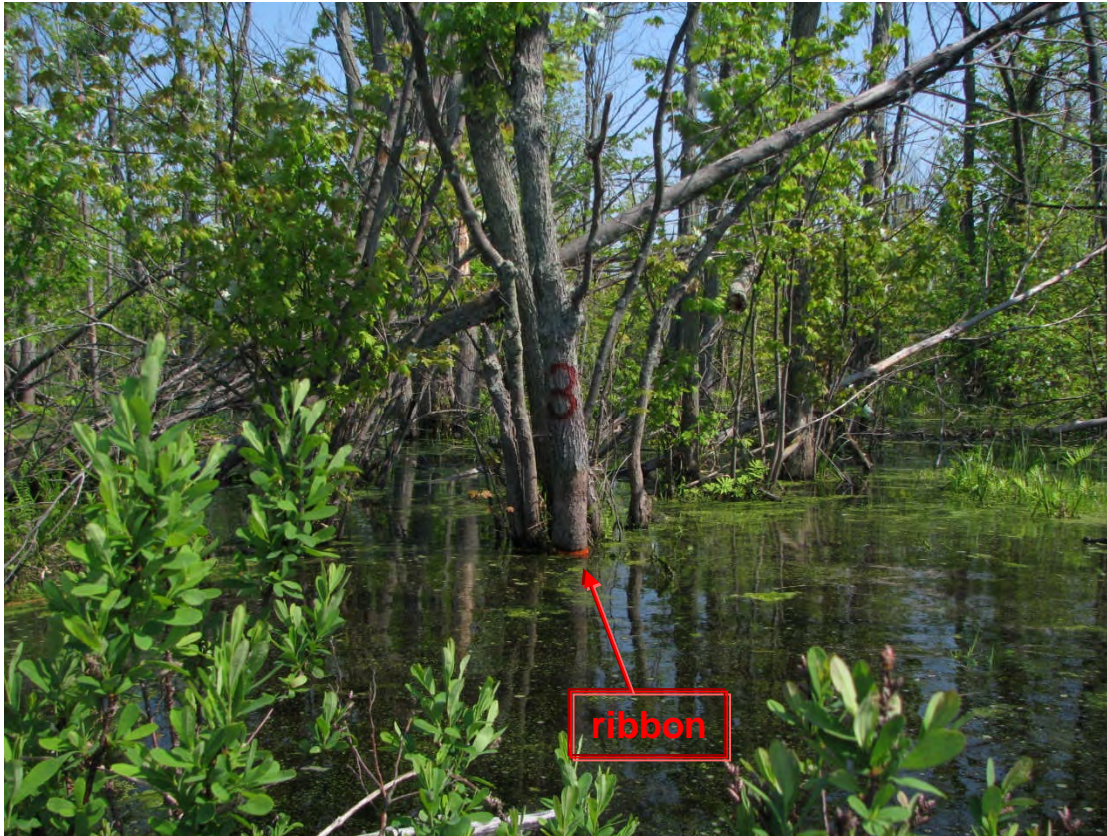
Our field observations and data indicate that increased water levels are the cause of the dieback. The trees are drowning.

**May 31, 2011**

**Aug 16, 2011** →

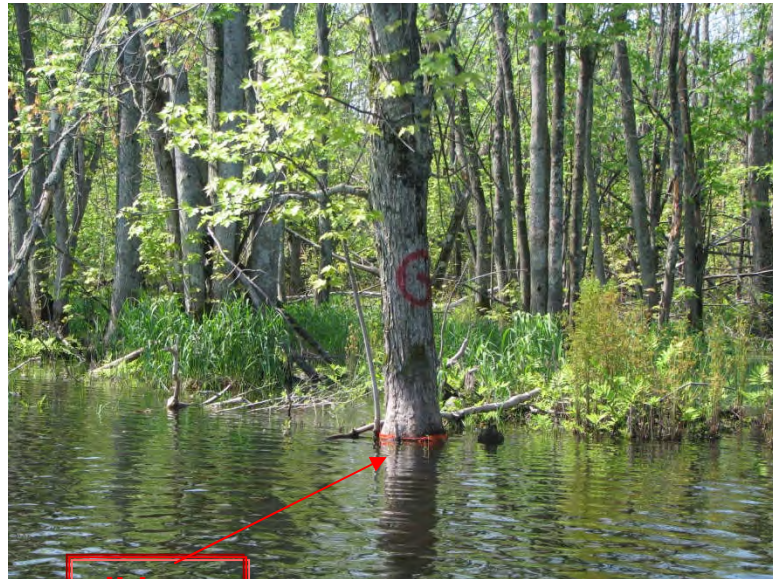
Project first day pictures from MVFN Ribbon Project showing May 31 2011 water Levels  
**Almonte Bridge gauge at 117.82 MASL**      **Appleton at 118.00 MASL**

ribbons

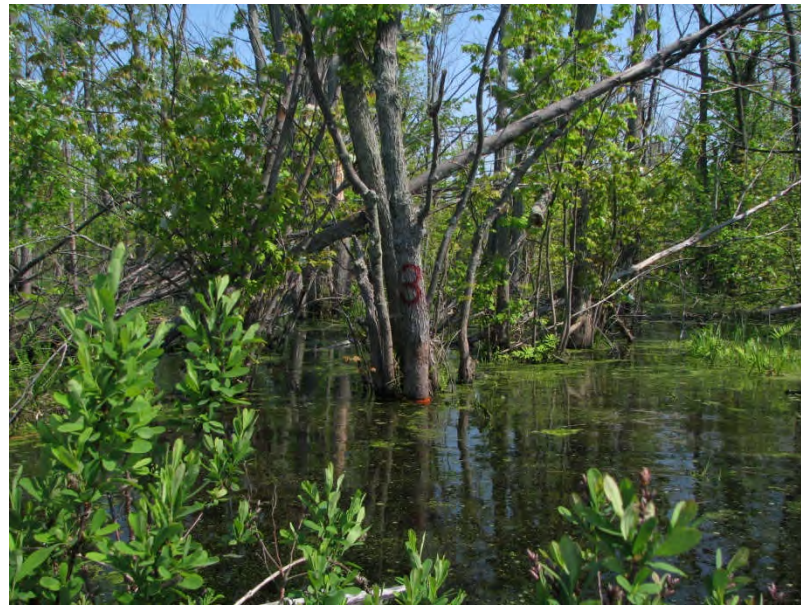
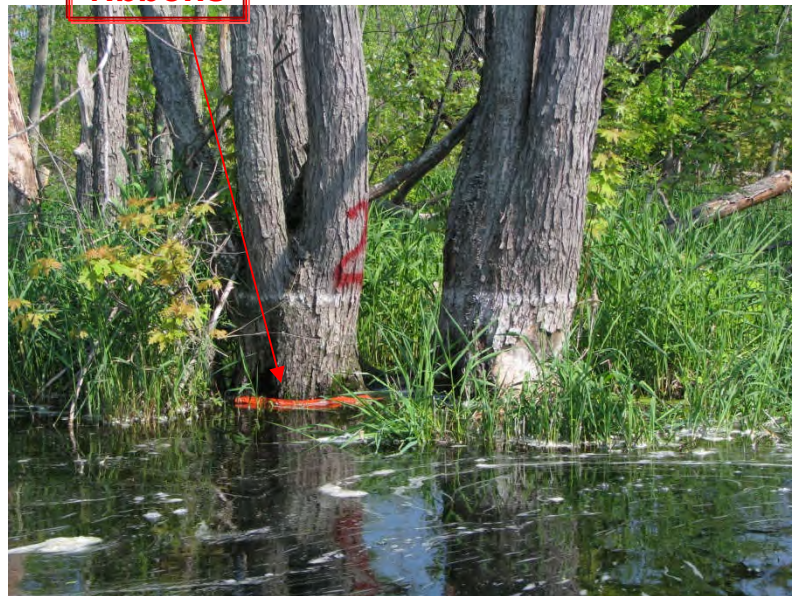
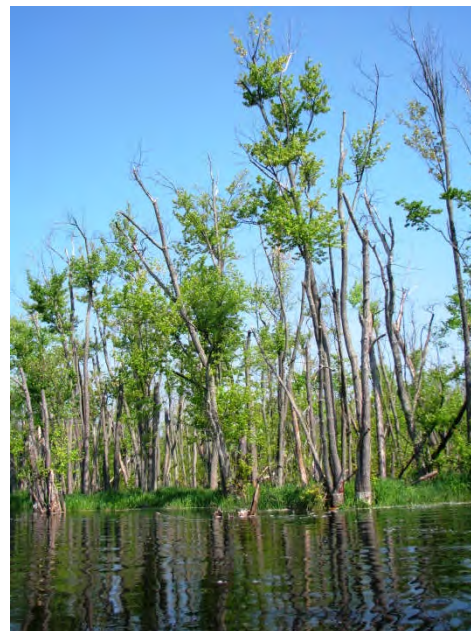
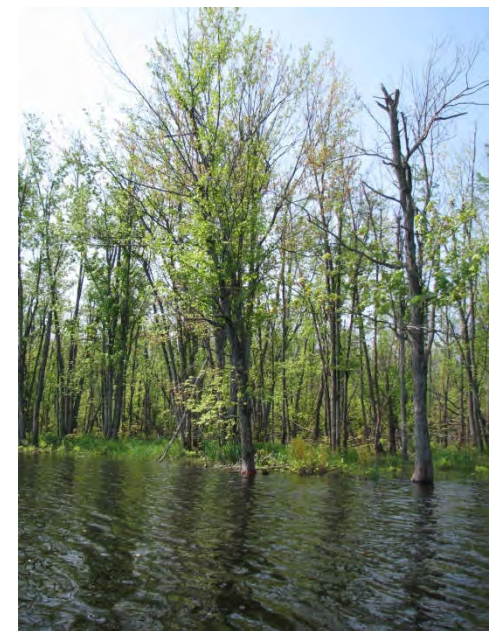
**Dead & dying Silver Maples**

**Pictures of MVFN Ribbon Project for June 30 2011 Water Levels**  
**Almonte Bridge gauge at 117.76 MASL      Appleton at 117.80 MASL**

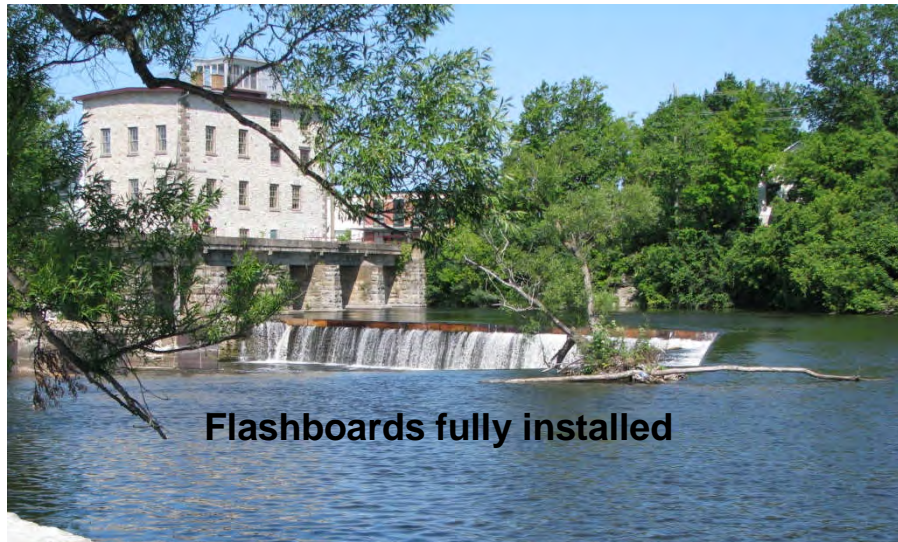
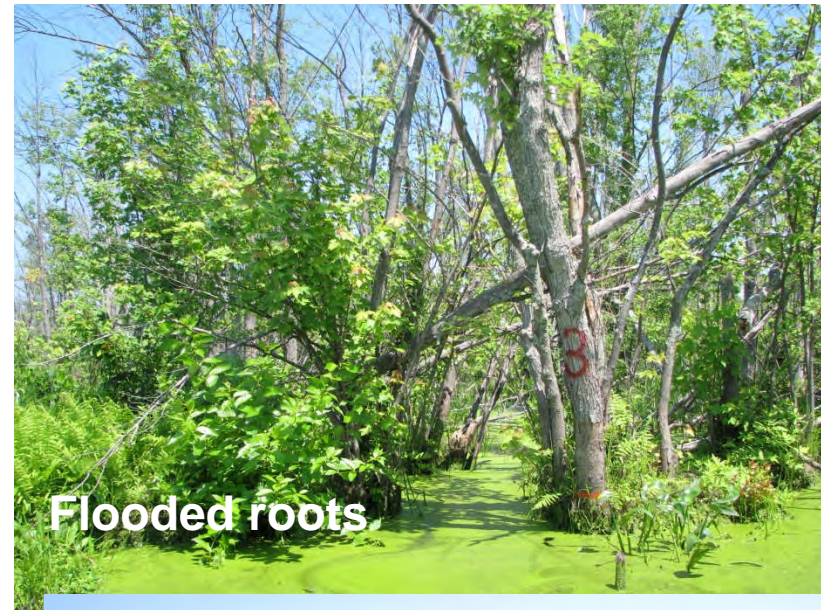
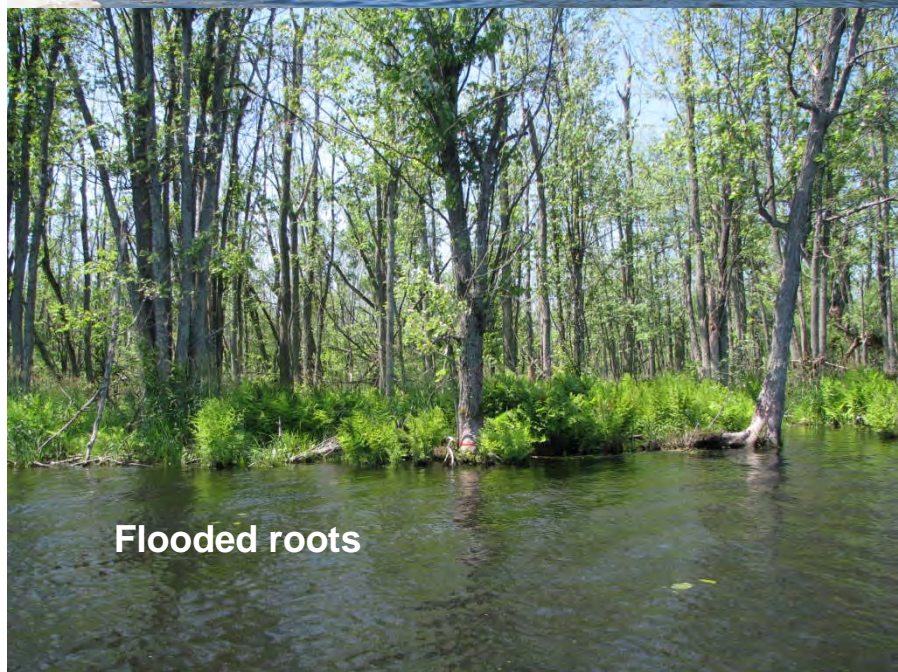
**Pictures of MVFN Ribbon Project for Jul 28 2011 Levels**

**Almonte Bridge gauge at 117.70 MASL**

**Appleton at 117.70 MASL**

**Note: Flat MASL  
with Appleton.  
CMS was at 7.15**

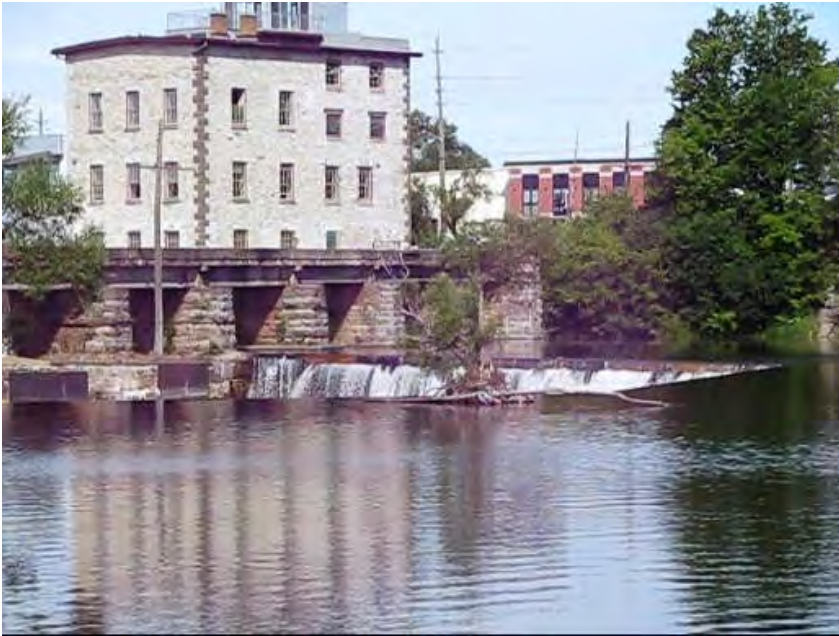
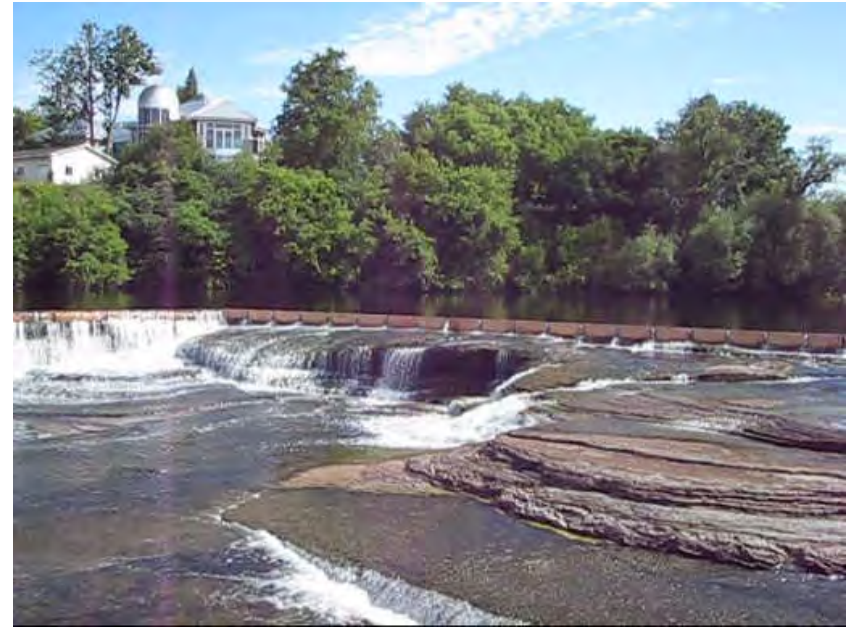
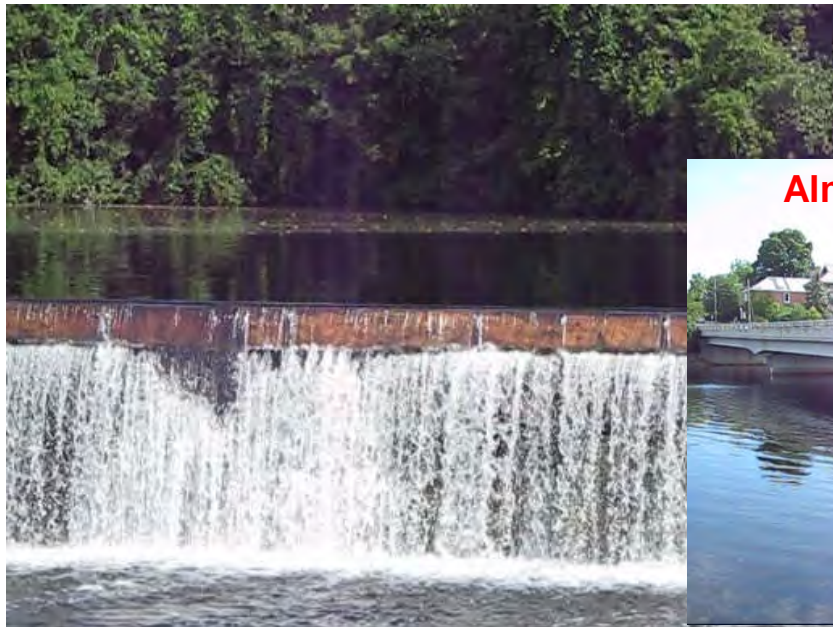
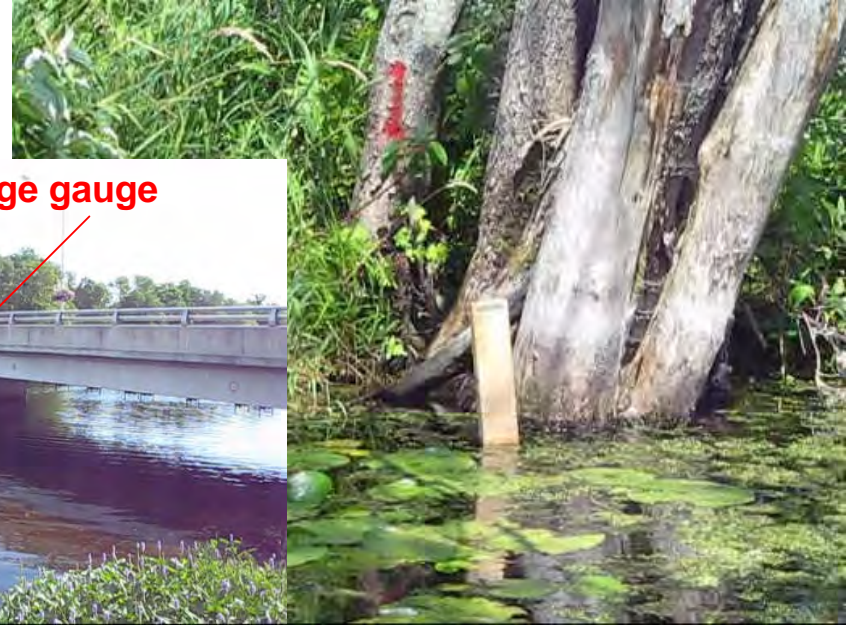
**Almonte Bridge gauge**

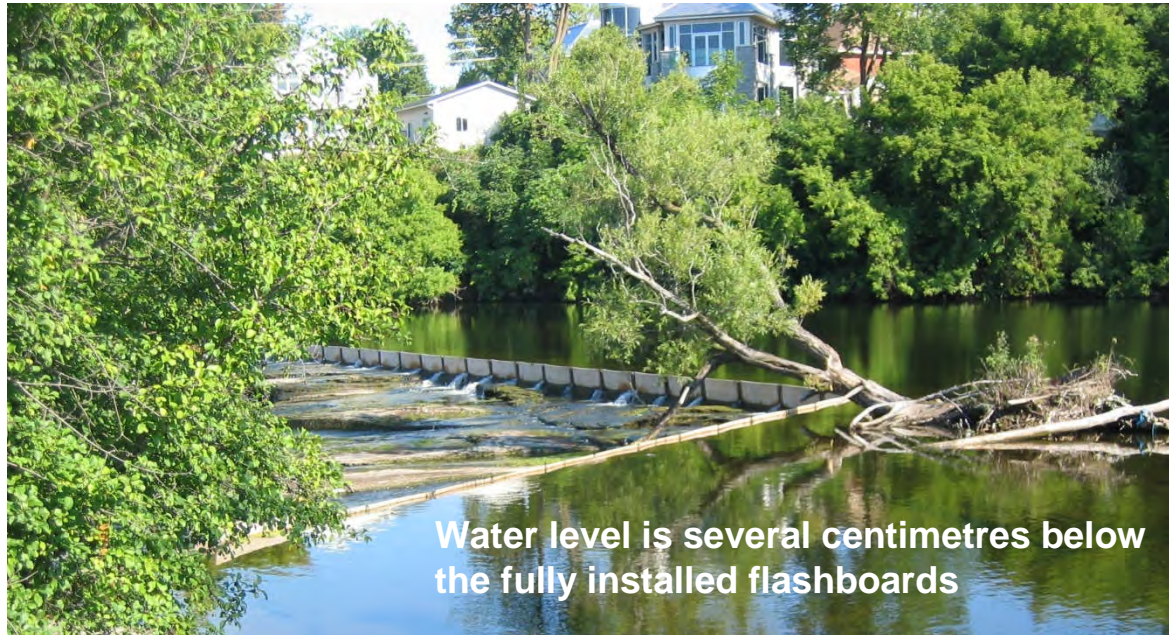
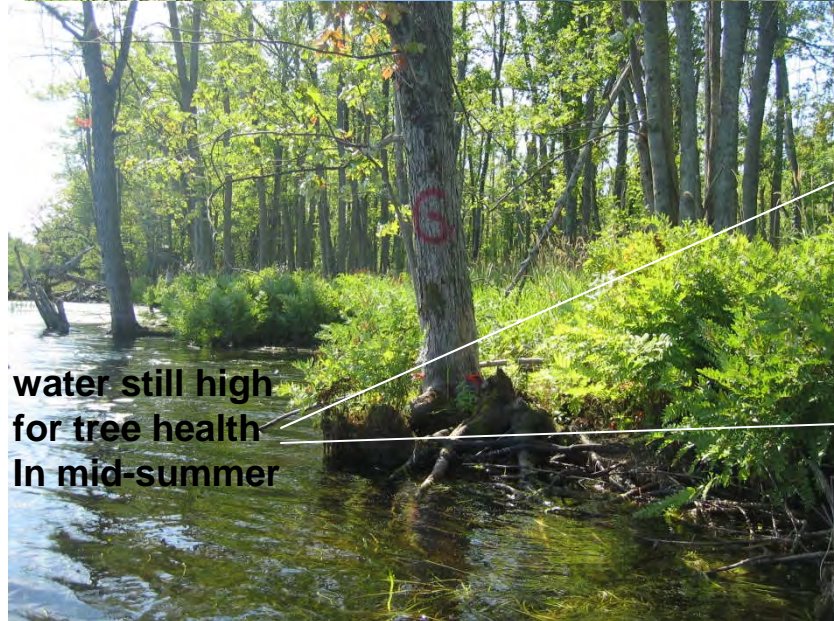
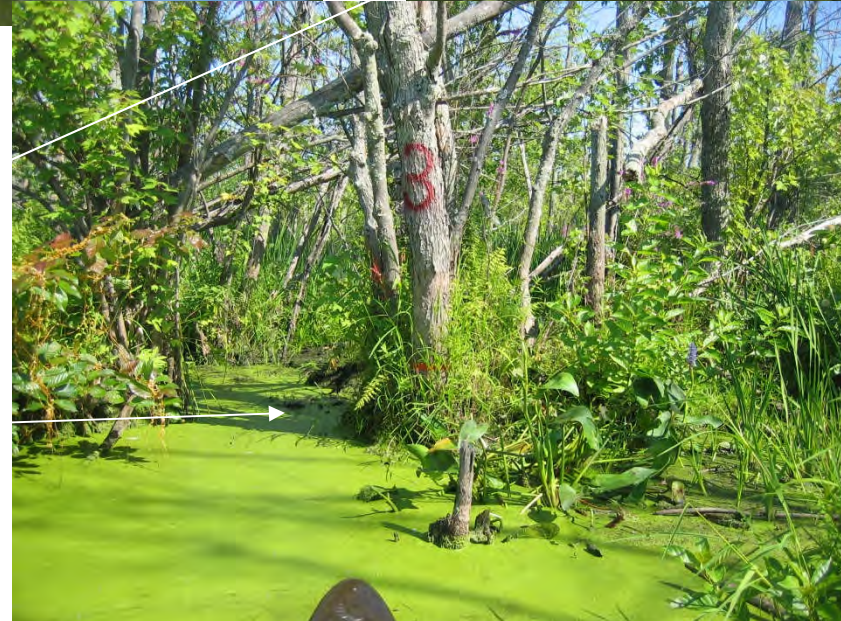
**Pictures of MVFN Ribbon Project for Aug 16 2011 Levels**

**Almonte Bridge gauge at 117.62 MASL**

**Appleton at 117.62 MASL**

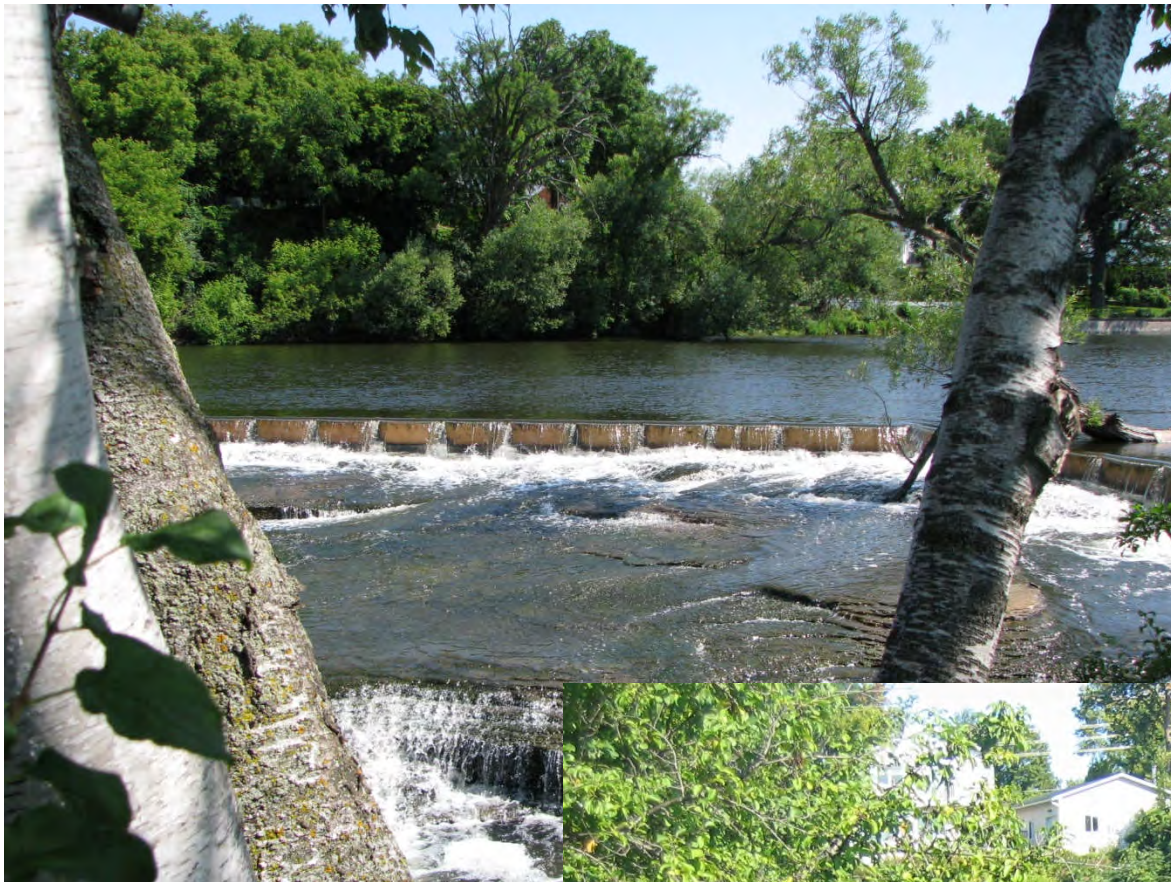
## Part of water level management at Almonte

**June 30, 2011**  
117.76 MASL

**Aug 16 2011**  
117.62 MASL

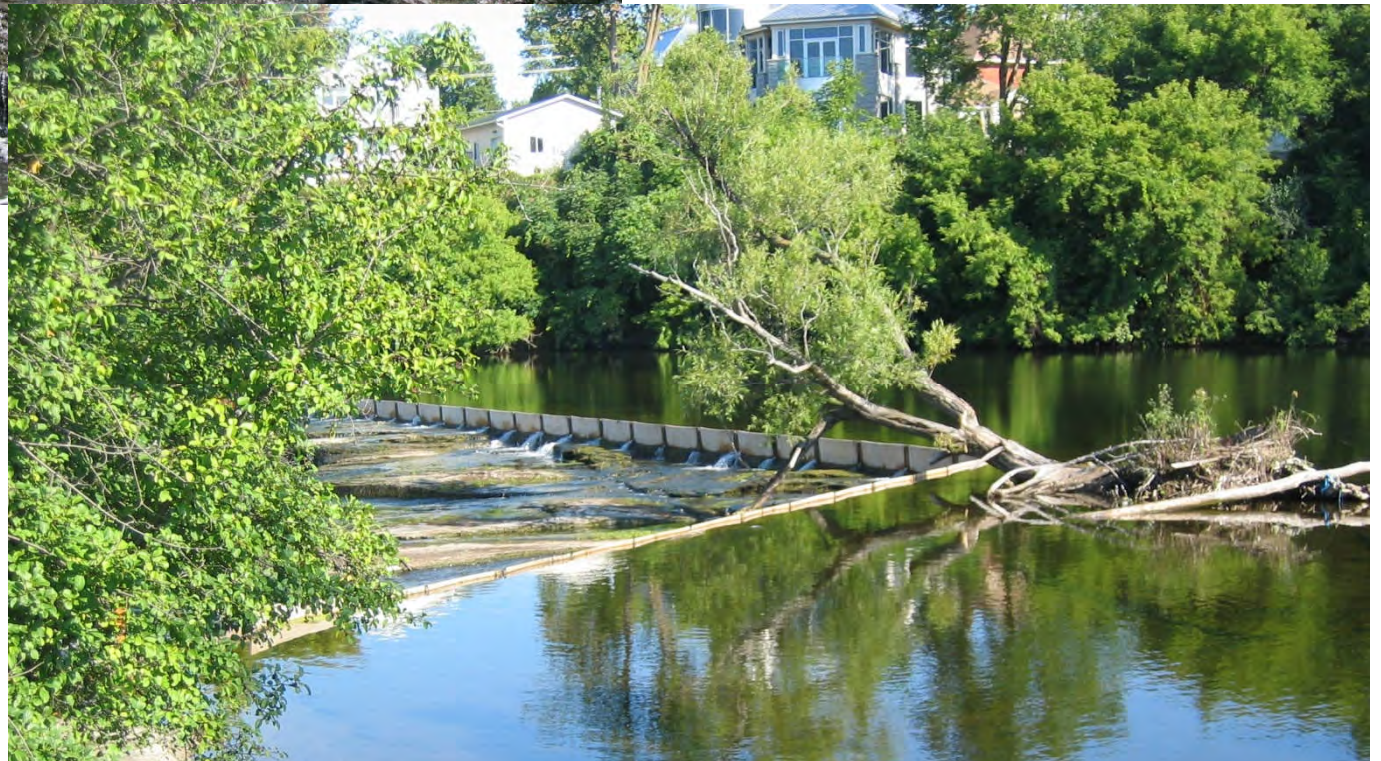
## Almonte Level at Bridge - 2011

growing season from late April to late October

- Our conclusion, based on clear research data, is that a change in water management levels prior to 2006 is the cause of the die-back of Silver Maples in the Appleton wetland.
- To avoid further forest destruction, the current water management regime for Reach 18 must be revised to lower the water levels during the wetland growing season.
- If action is taken now, we believe that it is possible to revive the wetland as an important silver maple swamp.

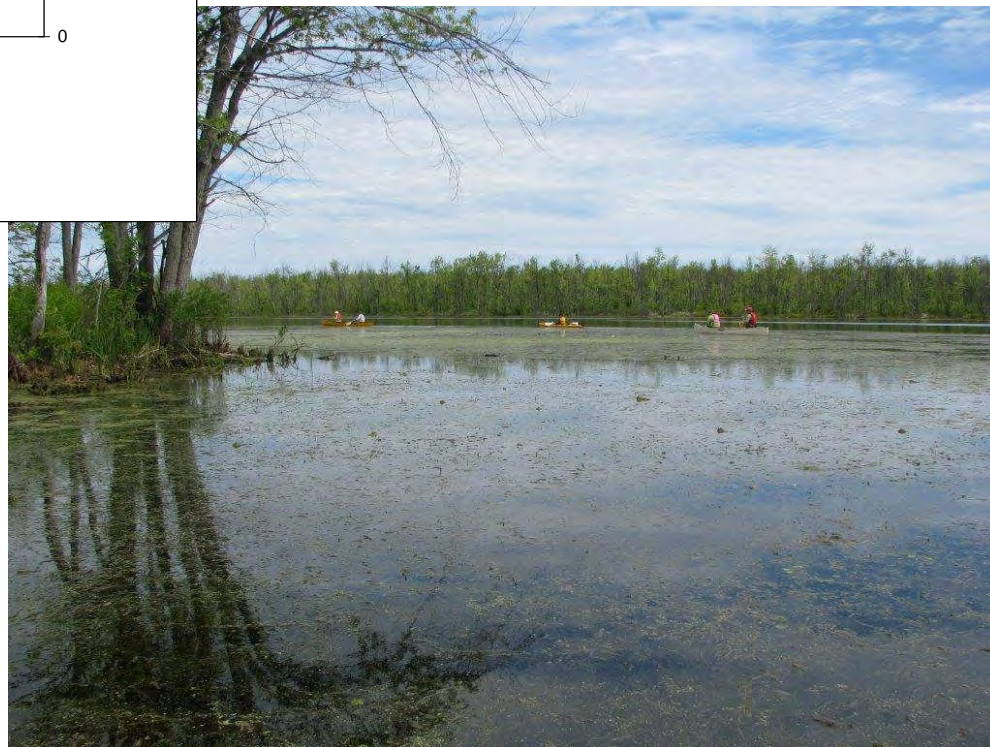
# Almonte Water Level at Bridge - 2010

Healthy growing season  
Recommended level

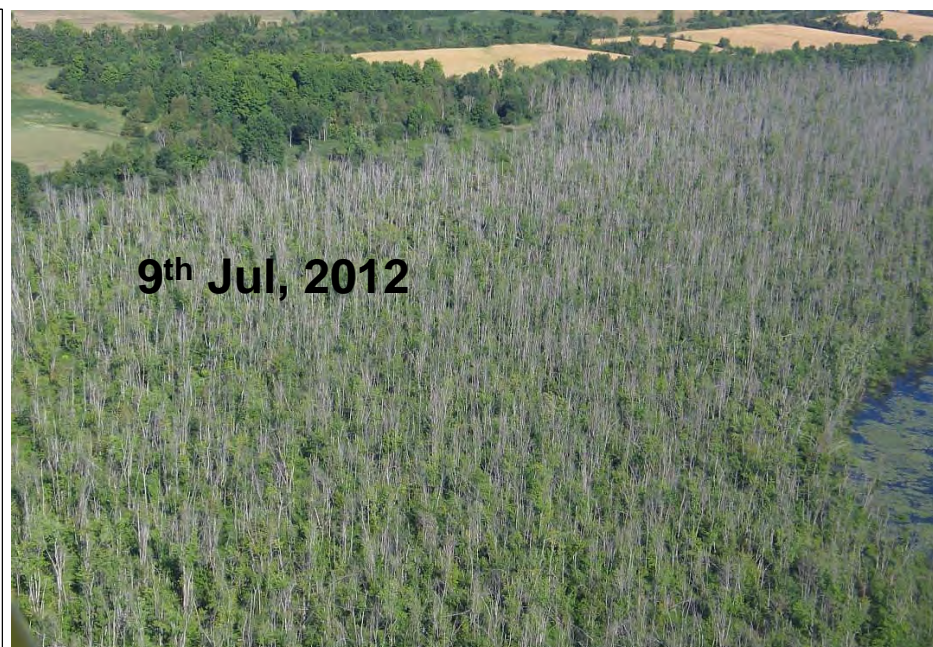
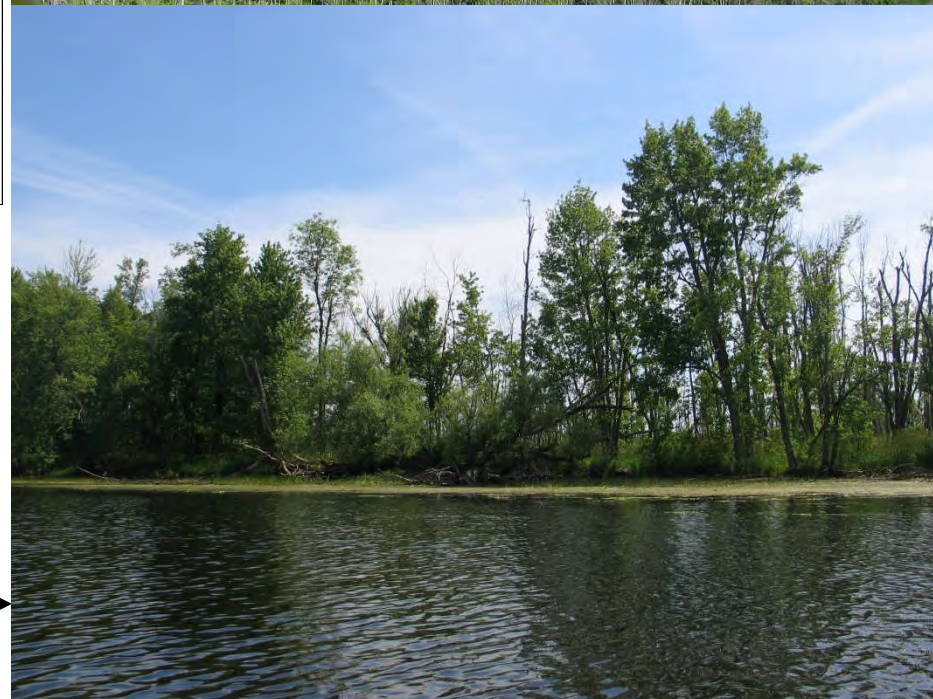
## Almonte Water Level at Bridge - 2013

16<sup>th</sup> Jun, 2012 →

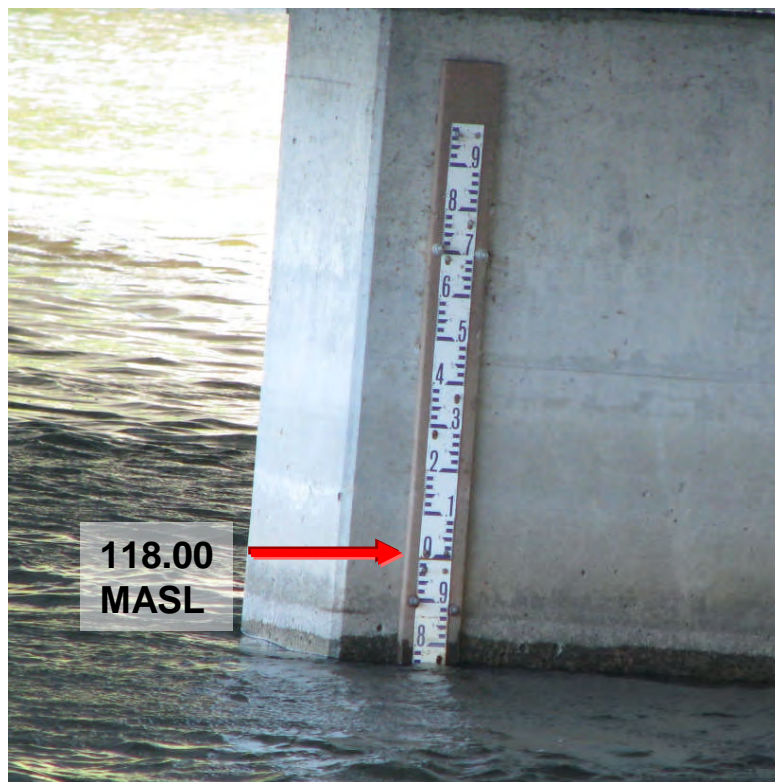
**Almonte Bridge gauge at 117.76 MASL  
Established in 2006 by MVC**
