The Appleton Wetland; Its Decline, Cause and Recommended Action

Report prepared by

**Appleton Wetland Research Group
of the
Mississippi Valley Field Naturalists**

August 11, 2014

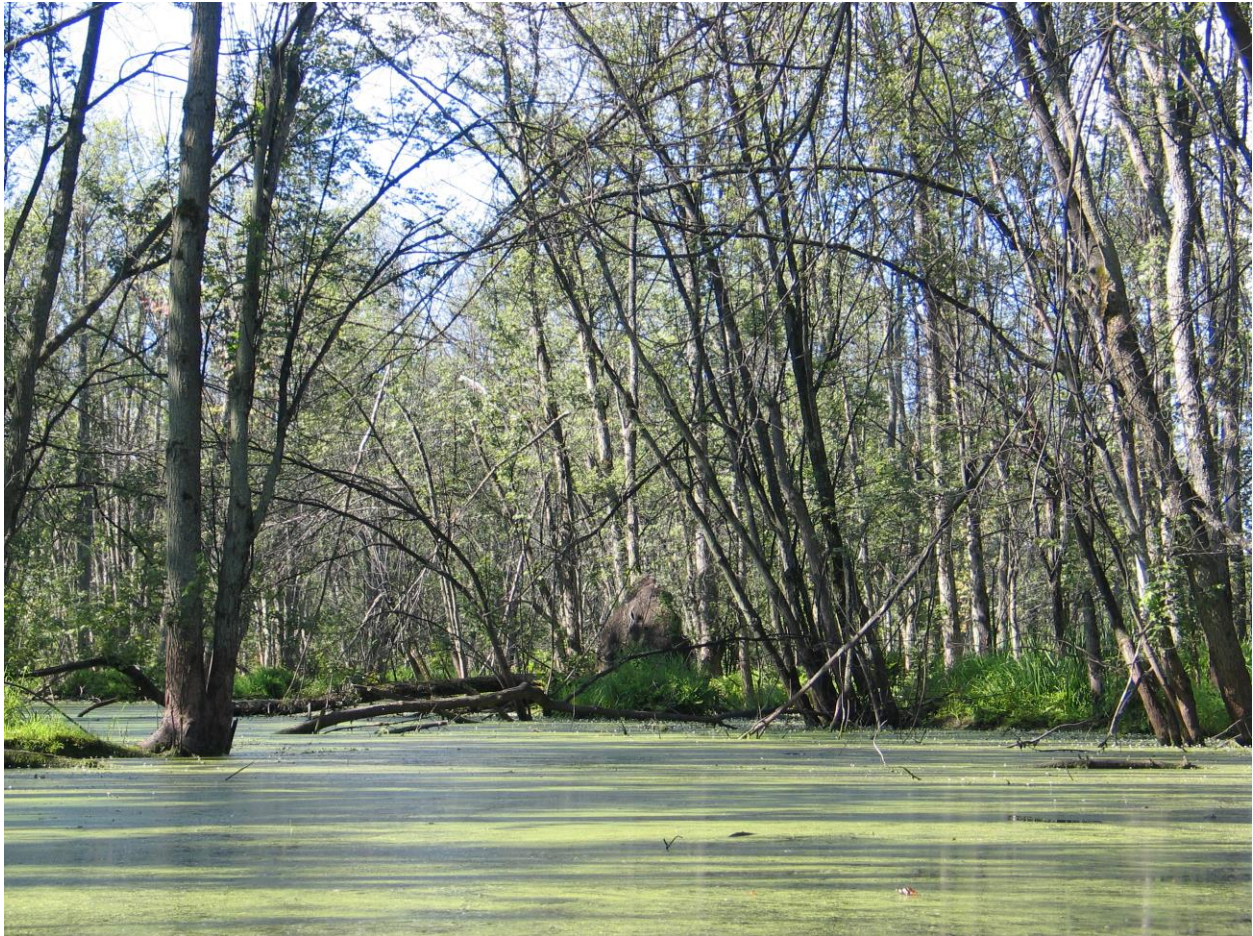
Figure 1 Appleton Wetland, August 8, 2006, from kayak

Note that the water level is high and the bases of all the visible trees are submerged below the water surface. In addition there are many dead branches and the surviving leaf canopy is quite sparse. A silver maple swamp that is drowning

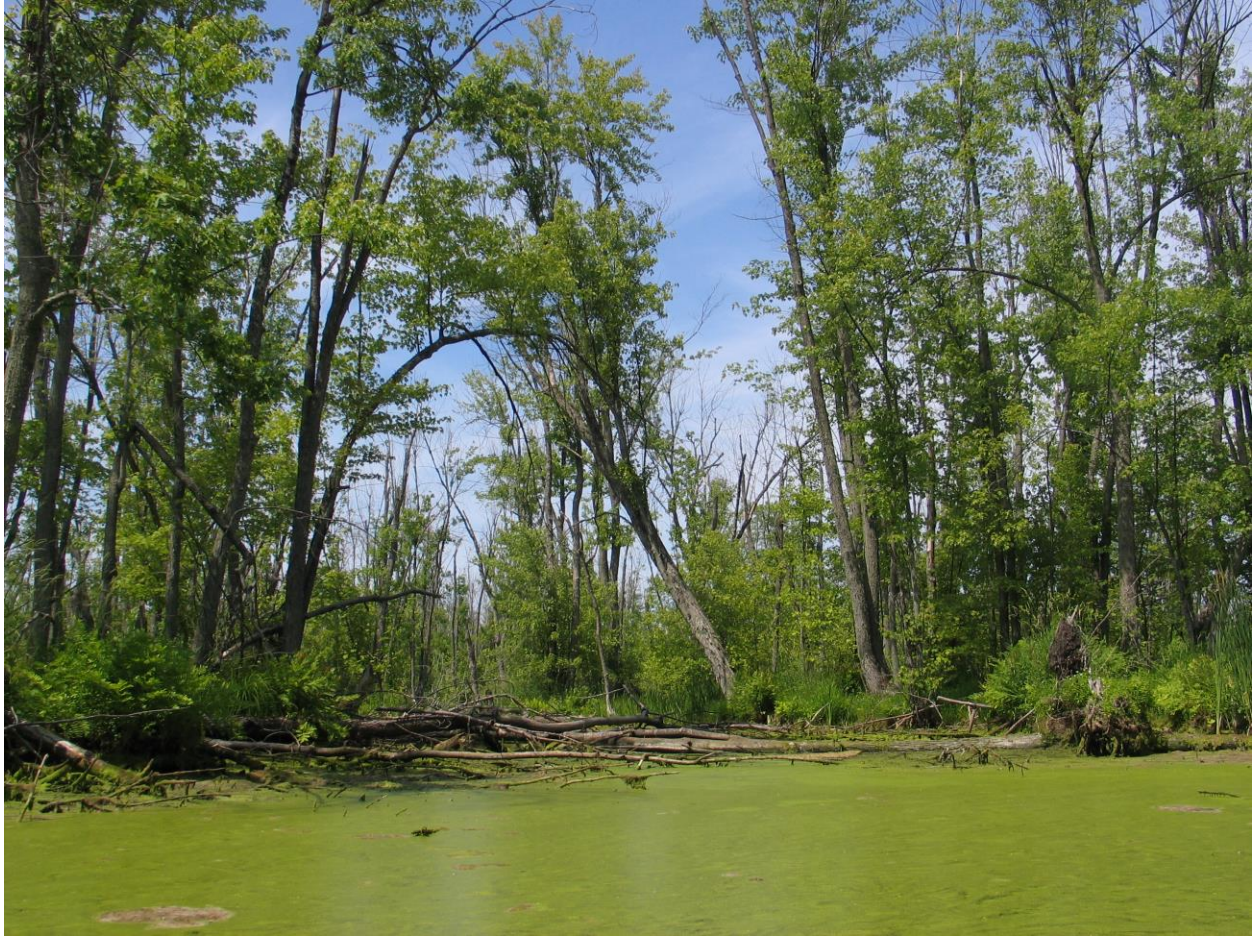
Figure 2 Appleton Wetland, June 16, 2012, from kayak

The general appearance is similar to that in 2006 – many dead trees, and the tree canopy is quite sparse. Also note the accumulation of fallen tree trunks at the water's edge.

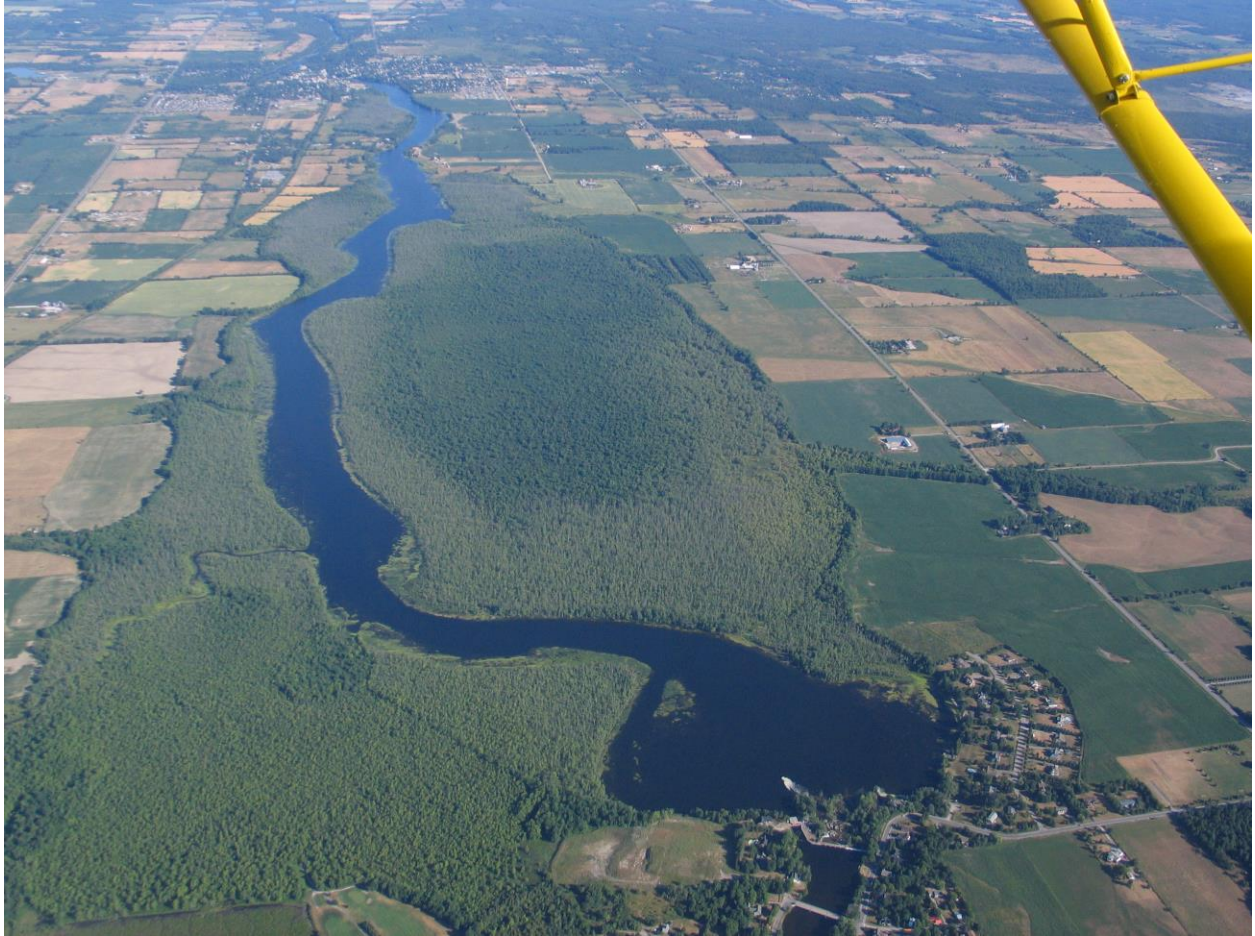
Figure 3 Aerial view of Appleton Wetland from 5000 ft., July 9, 2012

A view of the Appleton Wetland looking northwest along the river to Almonte in the distance. The lighter green portions indicate areas of dead and stressed trees, and the darker green portion is swamp at a slightly higher elevation that is still healthy. It is estimated that 60% of the total wetland area is now in the dead and stressed category.

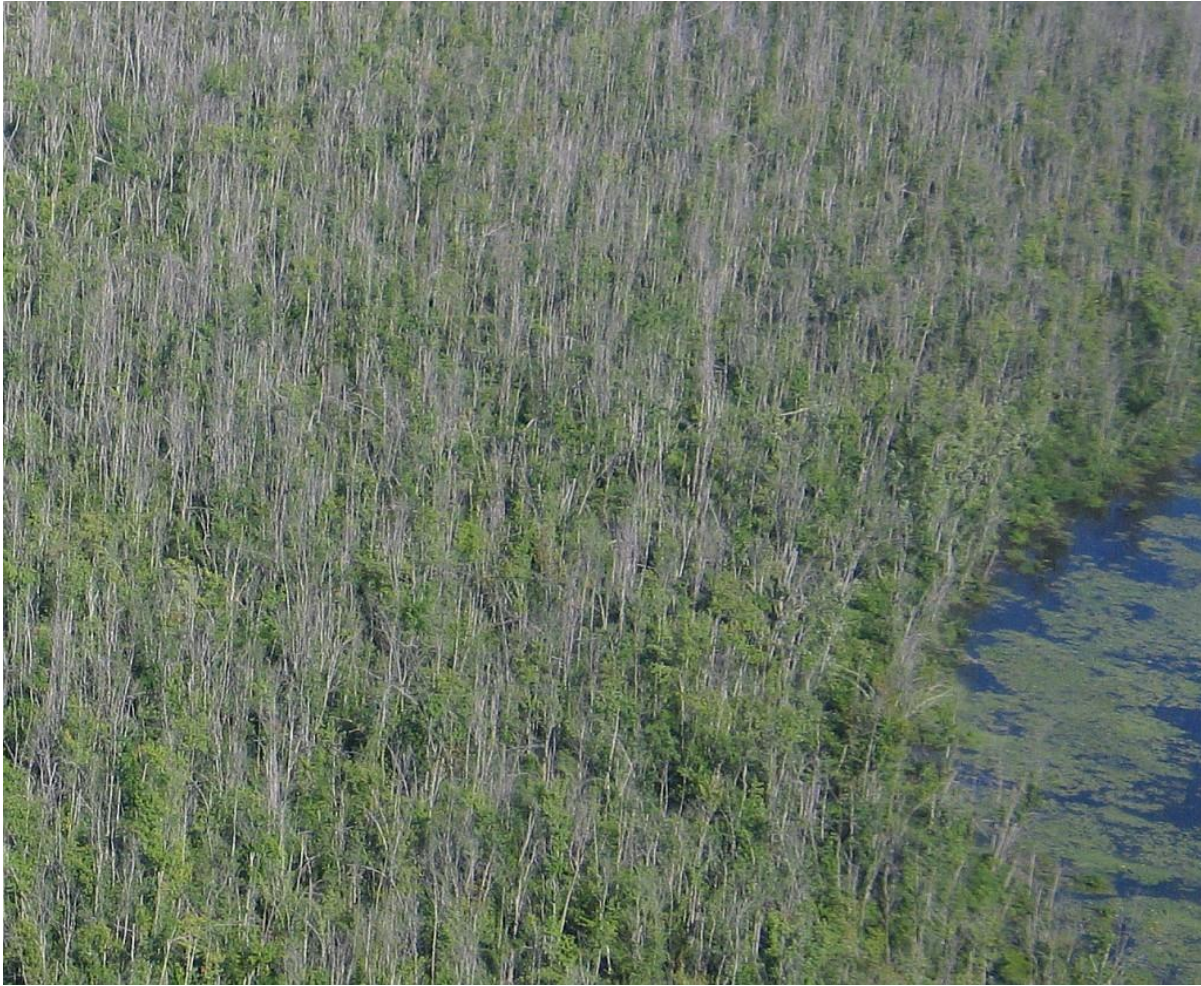
Figure 4 Appleton Wetland from airplane at lower altitude, July 9, 2012

A further view from low elevation, with camera zoomed in, showing a closer view of the dead and stressed trees on the south bank of the river.

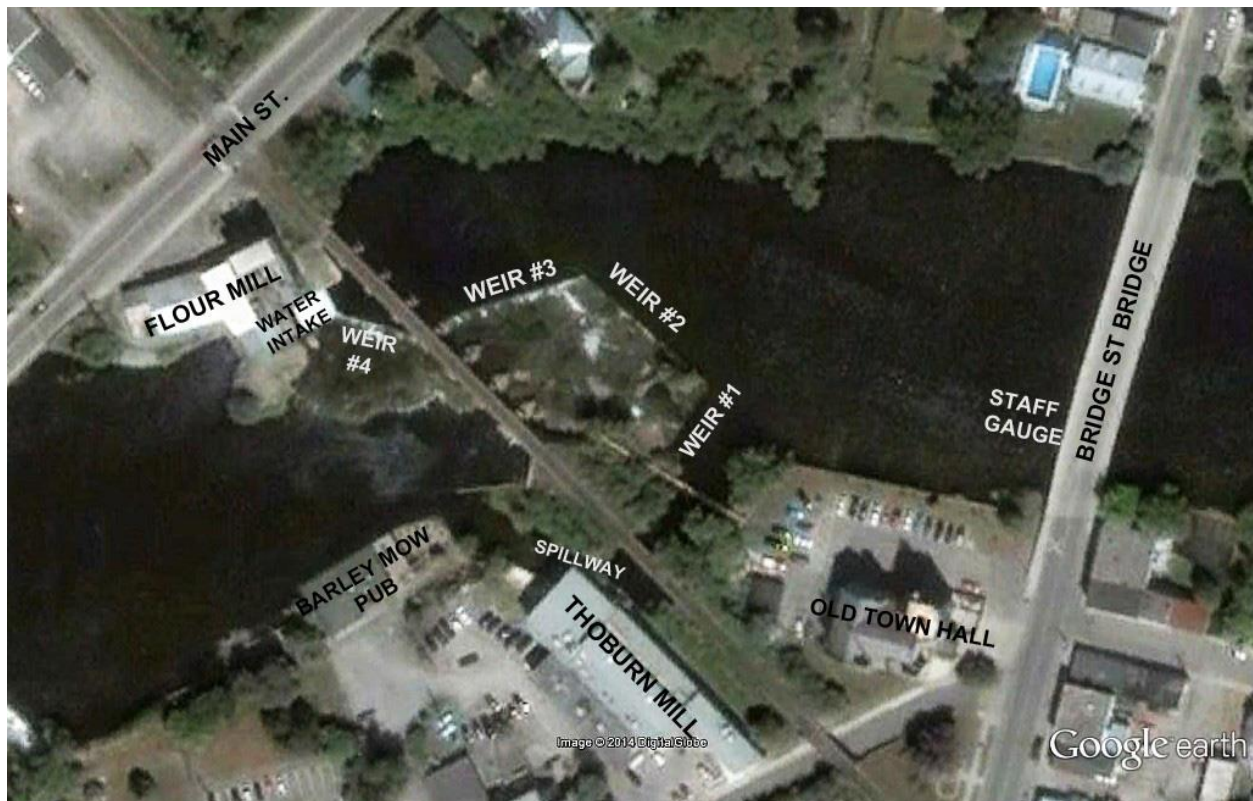
Figure 5 Google Earth image of the weir and surrounding area

Downstream from the bridge is a concrete weir with a top elevation of 117.20 masl. The weir is in four sections that start on a small island near the Old Town Hall, and continue in a semi-circle to the water intake of the old Flour Mill. For convenient reference in this report the sections have been numbered as shown on the image. There is a small side channel from the river leading to the former Thoburn Mill (now a condominium building) with a spillway at the side of that building.

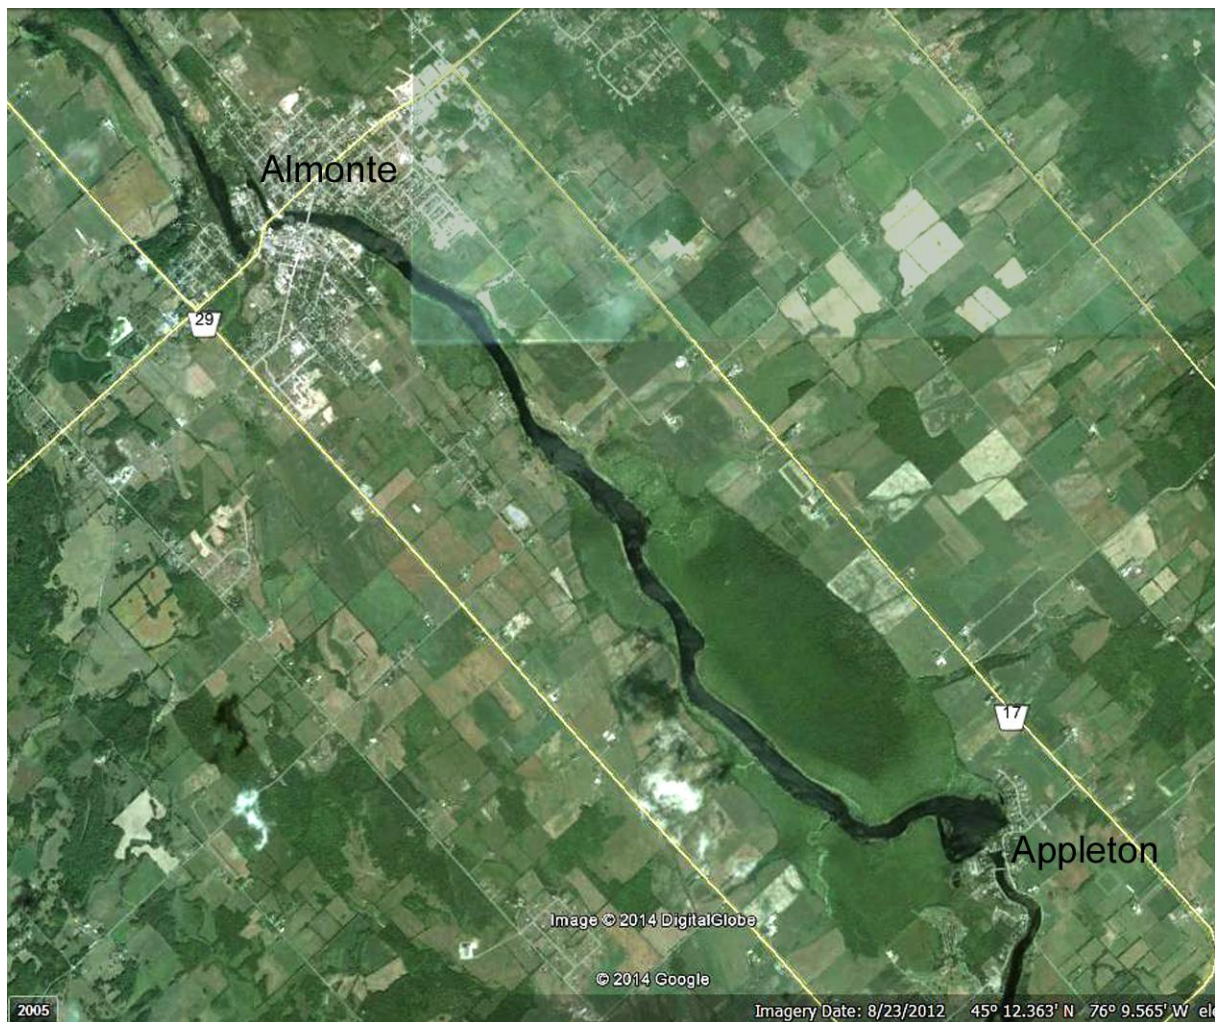
Figure 7 Google Earth image of Reach 18

To further illustrate the location of the Appleton Wetland, below is a satellite image from Google Earth of Reach 18. The green spaces along the river identify the four segments of the wetland. The major one is on the northeast bank of the river starting at Appleton and extending about half way to Almonte. There are three smaller pieces on the southwest bank that start at Appleton and continue most of the way to Almonte.

This satellite imagery is stated to originate from 2005 and it does show the same light green sections of stressed wetland contrasting with the dark green of healthy wetland that were observed in 2012 photographs from an airplane (see Appendix O). The beginning of the tree die-off appears to have started in or prior to 2005.

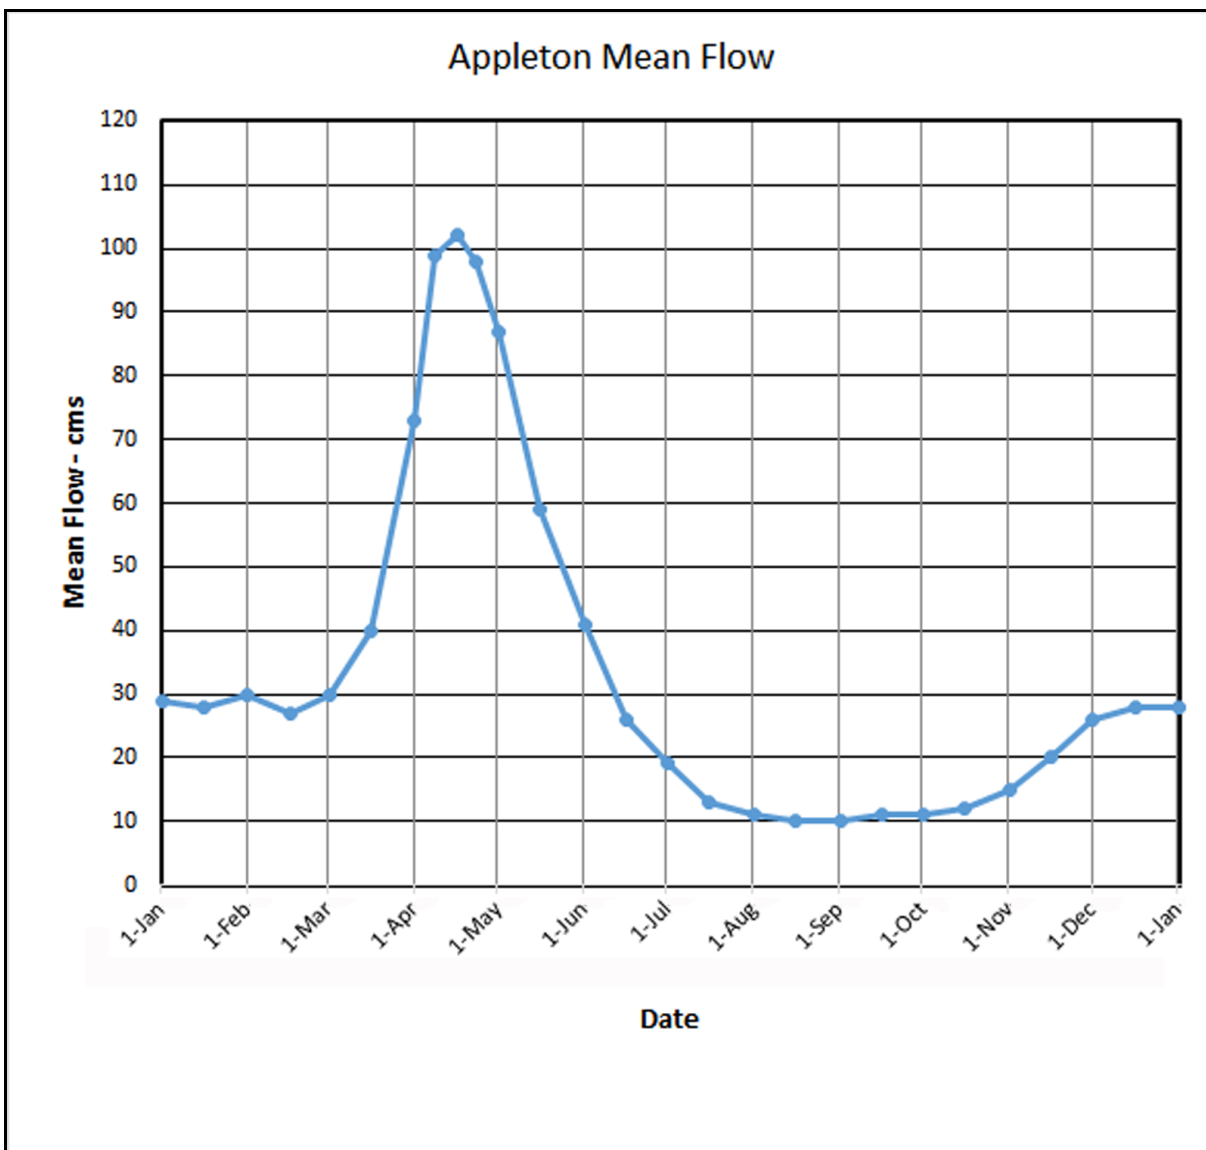
Figure 8 Mean flow as measured at Appleton, 1919 to 2012

(tsec = 194). These dates come from the Appleton Mean Flow chart below as derived in Appendix C.

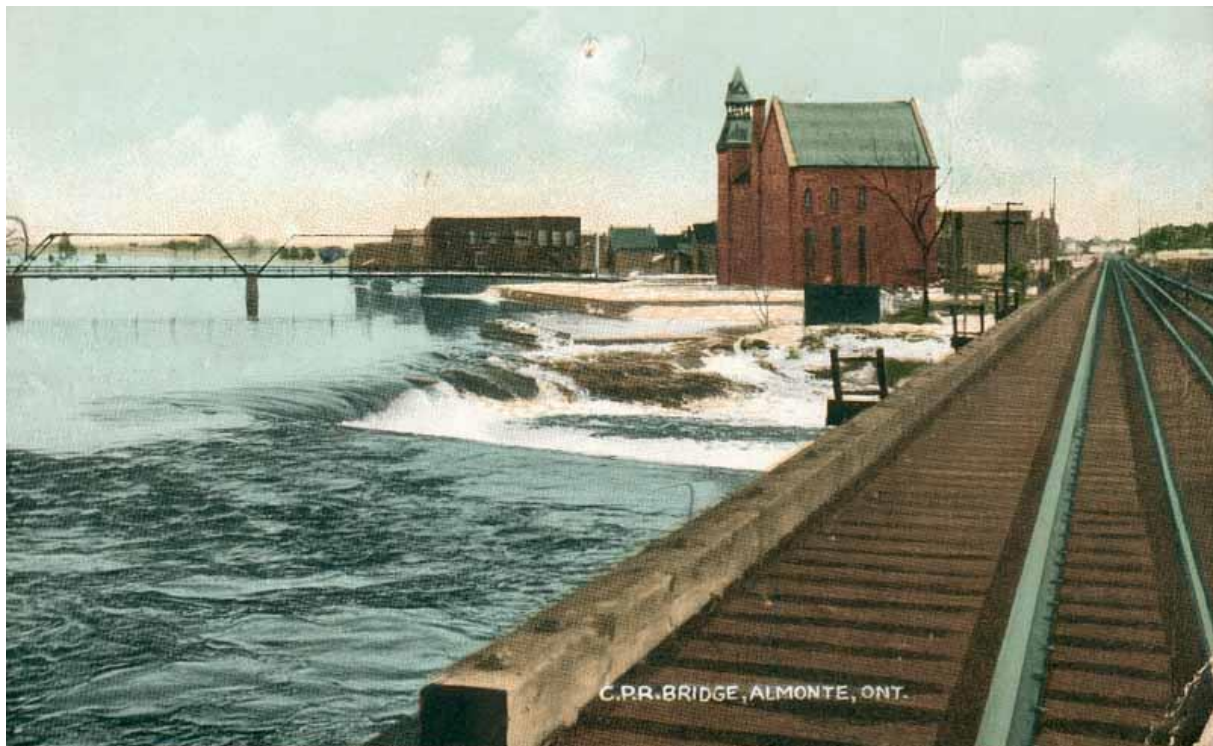
Figure 11 The upper falls and weir (Figure E-3)

flashboards were not a means of increasing hydraulic head. Weir 1 directed flow to the Thoburn Mill, and weir 3 directed flow to the Flour Mill, and any excess flow simply went through the gap where weir 2 now sits.

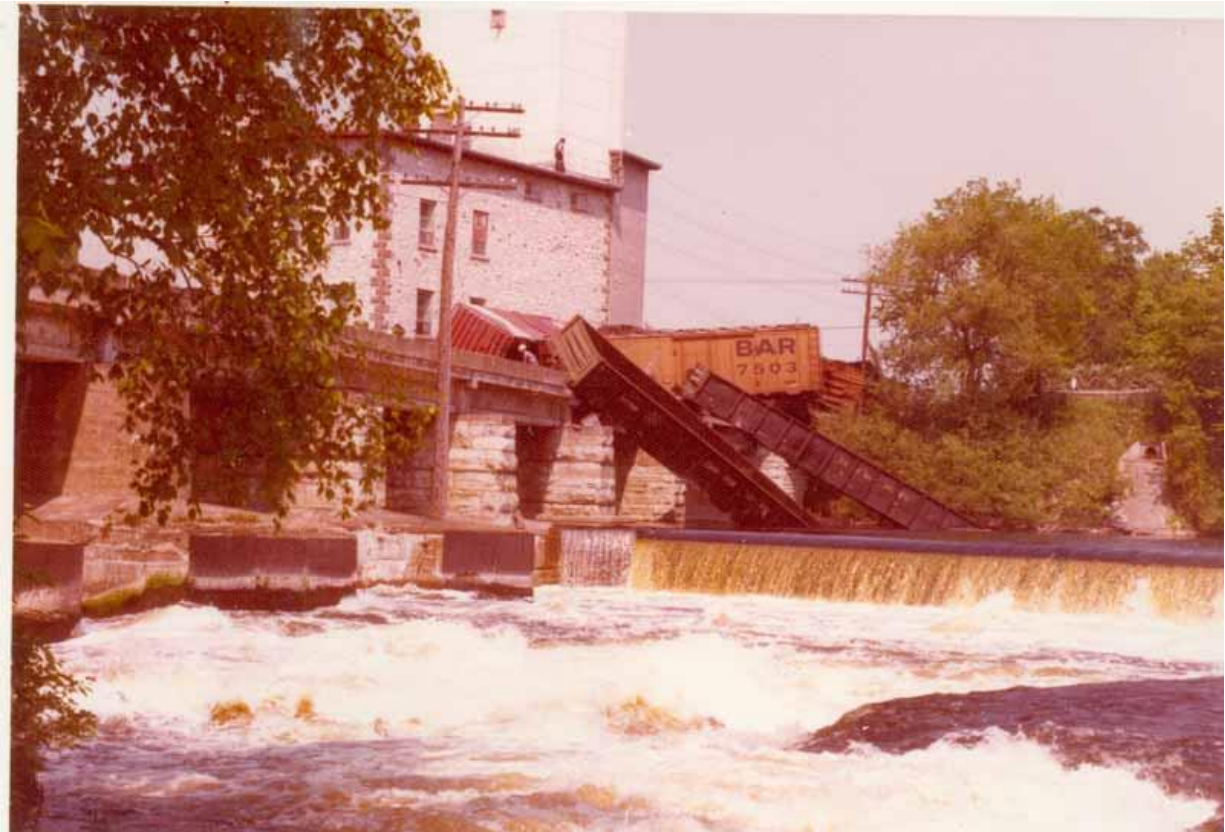
Figure 12 View of weir section 3 at the time of the 1974 train wreck (Figure E-4)

This image (identified as "train_wreck_1974_no2.jpg") was selected from the Michael Dunn collection and can be dated as very shortly after the train wreck of June 5, 1974. Environment Canada records show the river flow rate was 57 cms on June 5 declining steadily to 25 cms on June 12. The general appearance of the falls is in accord with that range of flows, and the appearance of the water going over weir section 3 suggests that flashboards were present on the weir. The water level at the junction of weir section 3 and the fourth pier of the bridge is consistent with the flashboard height being 12 inches as indicated by others as the board height used in the Flour Mill Era.

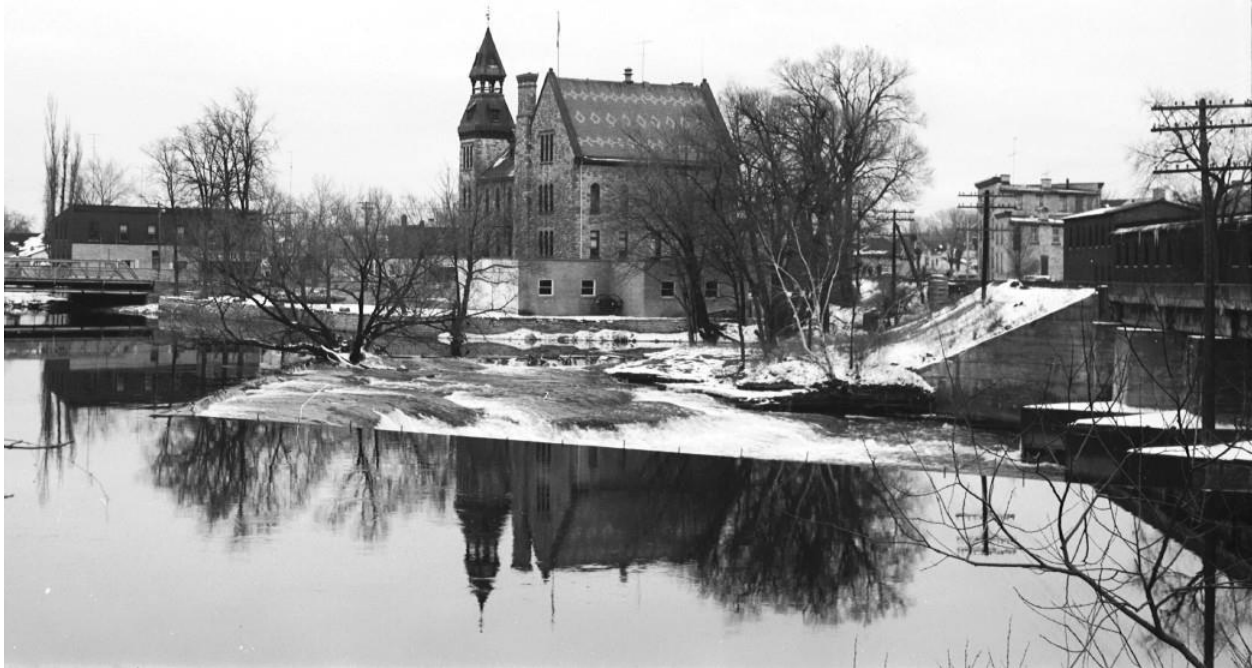
Figure 13 View of the upper falls and weirs in November 1973 (Figure E-5)

An enlargement of the junction of weir sections 2 and 3 indicates that the flashboards on section 3 are higher than section 2. That may be the result of missing boards or shorter boards. If the latter, it does raise a doubt about claims that section 2 had 14 inch boards while section 3 had 12 inch boards in this era.

An enlarged view of sections 1 and 2 was compared to (a) a similar view taken in the summer of 2013 when flashboards were missing from sections 1 and 2, and (b) a similar view taken in the summer of 2012 when fully intact 50 cm flashboards were installed. The 1973 image looks more like the no-boards 2013 image, although the differences in flow rate and perspective make that

comparison difficult. The 2012 image certainly indicates that if there are flashboards in the 1973 image they are much lower than 50 cm in height, and also lower than the claimed 14 inches.

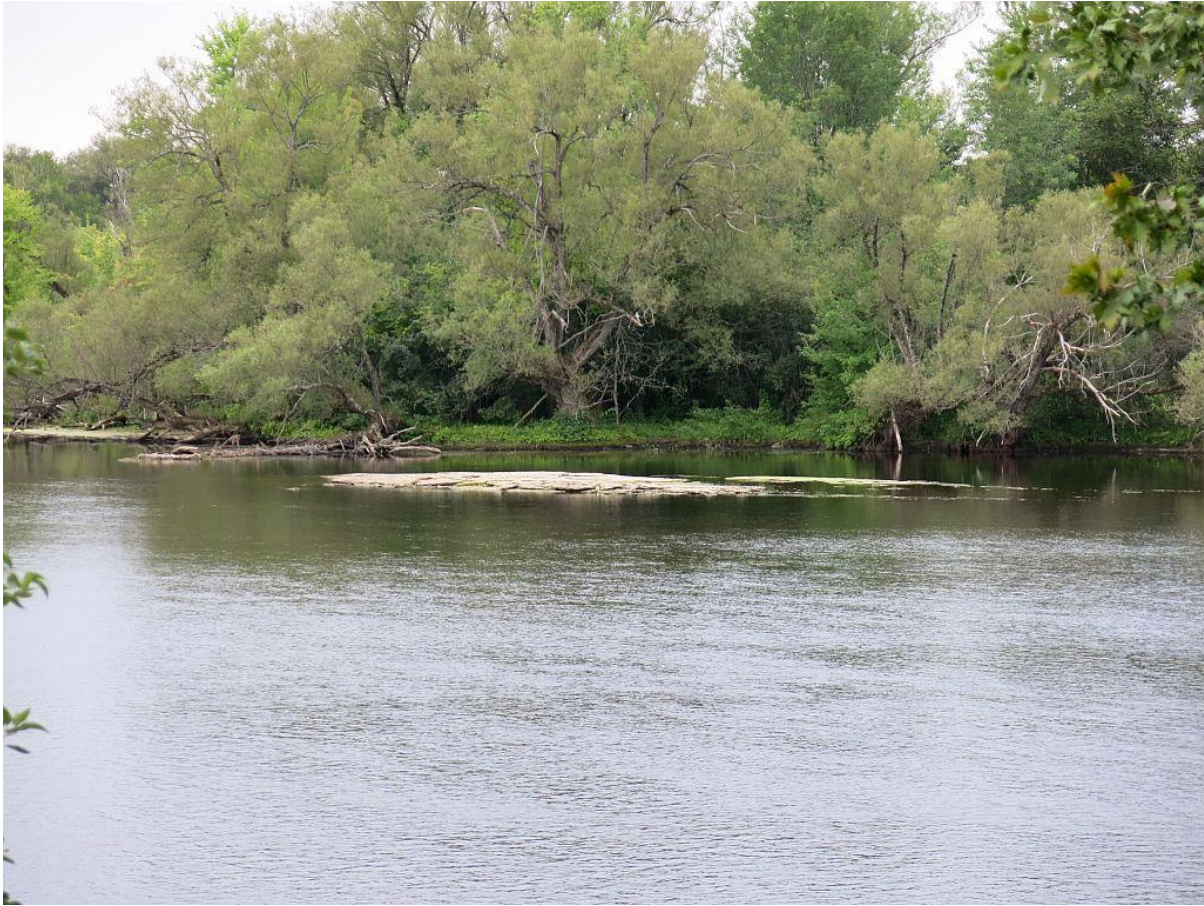
Figure 20 The island from 222 Spring Street (IMG_0396e.jpg, 25-Aug-2013)

In this image the island is quite visible, but it is not as high as it seemed to be from recollections of earlier years in the 1970s to 1990s. The estimate is that the water would have been about 30 cm lower with the result that the island would appear another 30 cm higher.

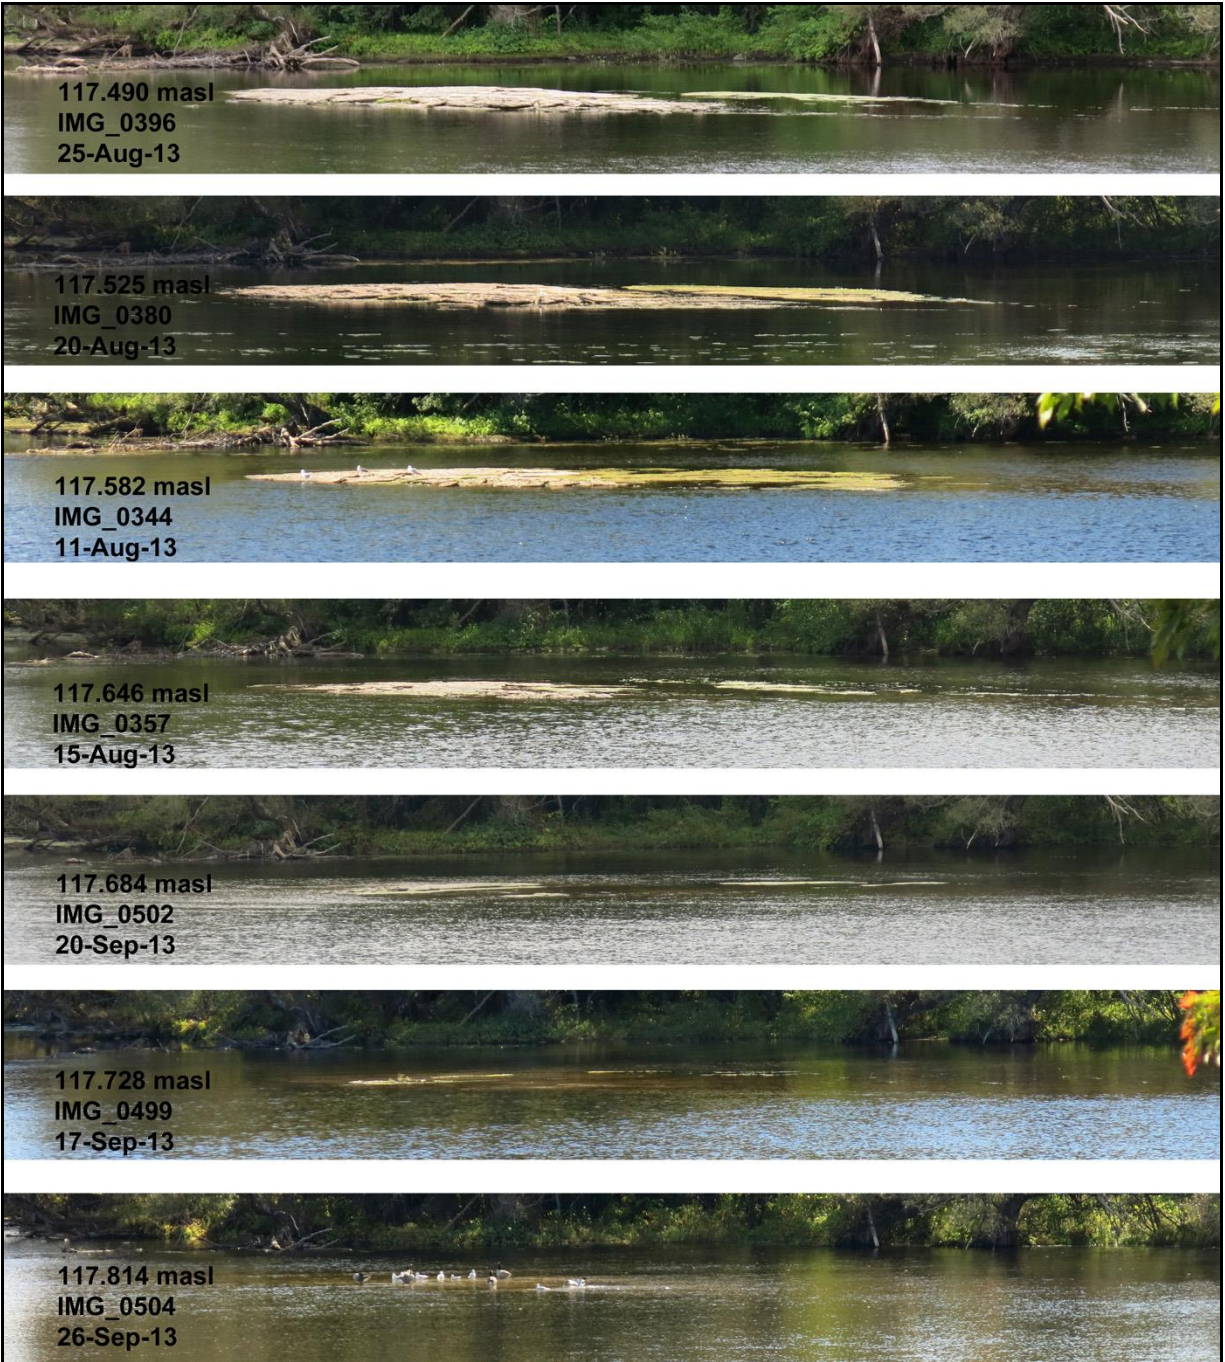
Figure 21 Composite image of the island with seven water levels

To illustrate the variation in island height, a composite photo was created by cropping a sample of the island from a series of seven images, taken from those available, and sorted in order as the water level varied from lowest to highest. All photos were taken from the same spot with the same camera and image zoom setting. Aside from changes in lighting and foliage, the only significant change between image samples is the water level. The composite image is below. Each of the seven components is labeled with the water level, the source image number, and the date of the original image.

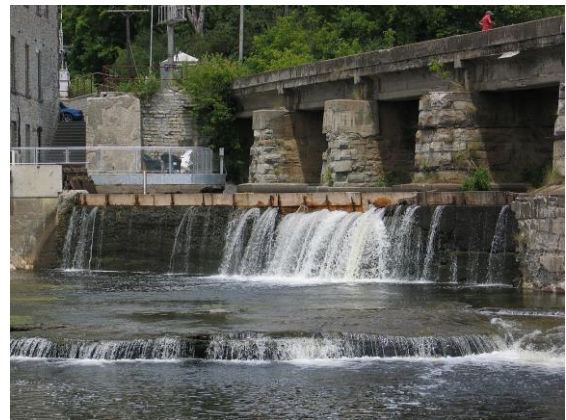
Figure 23 Reference Image 189_8924e of 2012

Figure 22 is derived from Figure E-14. It was provided by Mike Caughey and is dated May 31, 2001. Figure 23 is from Figure E-11. It was provided by Al Seaman and was taken during the summer of 2012 when these flashboards were known to be 40 cm in height.

During the Generator Station Era, the photographic evidence confirms that board heights of 50 cm were used on sections 1 and 2 and 40 cm boards were used on sections 3 and 4 as early as 2001. Around the beginning of this era (1990) when the GS was still using the old turbines and generators, the flashboards, if any, were probably the lower boards of the Flour Mill Era. There was a period around 1995 when the plant was idle while a new water intake and tailrace were built and the turbines and generators were replaced. Subsequently, around 1997, current operations as a GS began. It is not clear just when in the 1997 to 2001 interval that the flashboard height was increased.

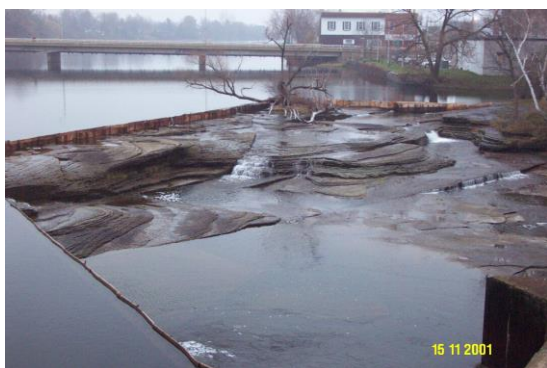
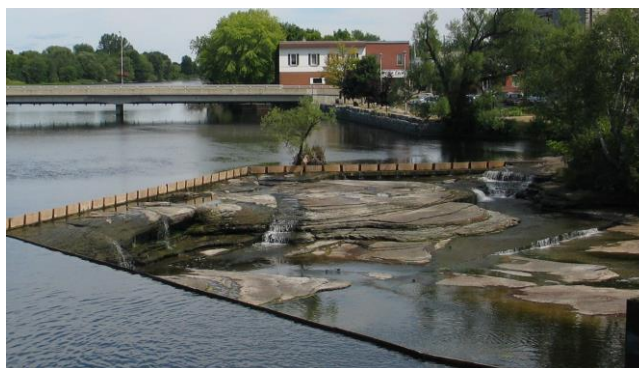
Subsequently, an image from 2001 that shows weir sections 1 and 2 was discovered by MNR. It is shown below along with a similar image from 2012 when the flashboards were known to be exactly 50 cm in height.

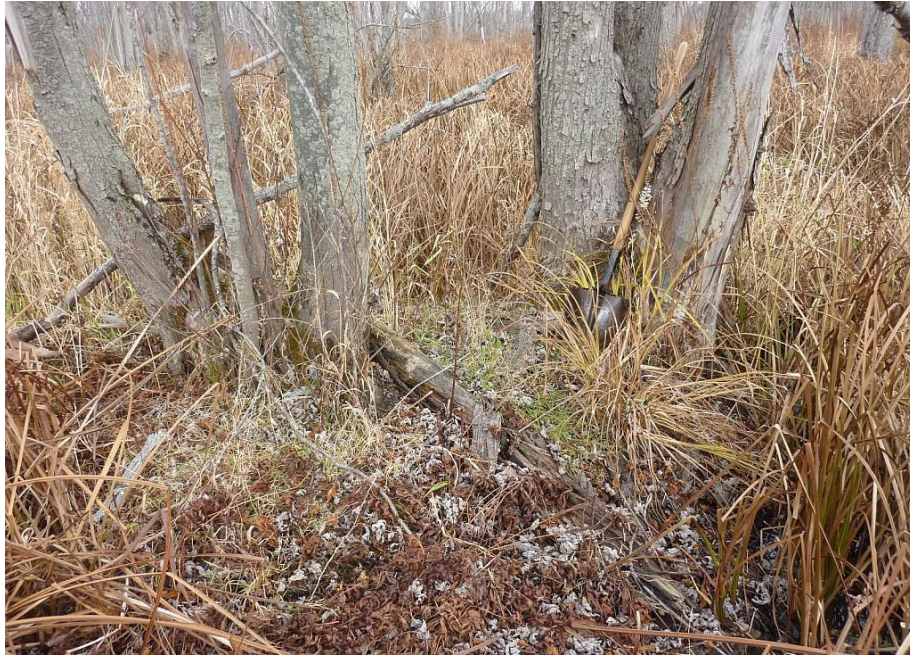
Figure 35 Large hummock at WP313

The recorded water level before and after the excursion was measured as 117.80 masl. At each waypoint we typically found a very small hummock rising slightly above the water with a few trees on it. The trees were usually a mix of dead and stressed trees. Although this was late fall with all the leaves gone from the trees, the individual tree health was obvious; the tops of very dead trees had broken off, recently dead ones were missing the fine tips of the remaining branches, and the stressed trees had abnormally small crowns with branches still ending in fine tips. At each waypoint photographs were taken of the trees, and measurements of ground level and water level were recorded. The images below illustrate typical trees. More photographs can be found in Appendix K.

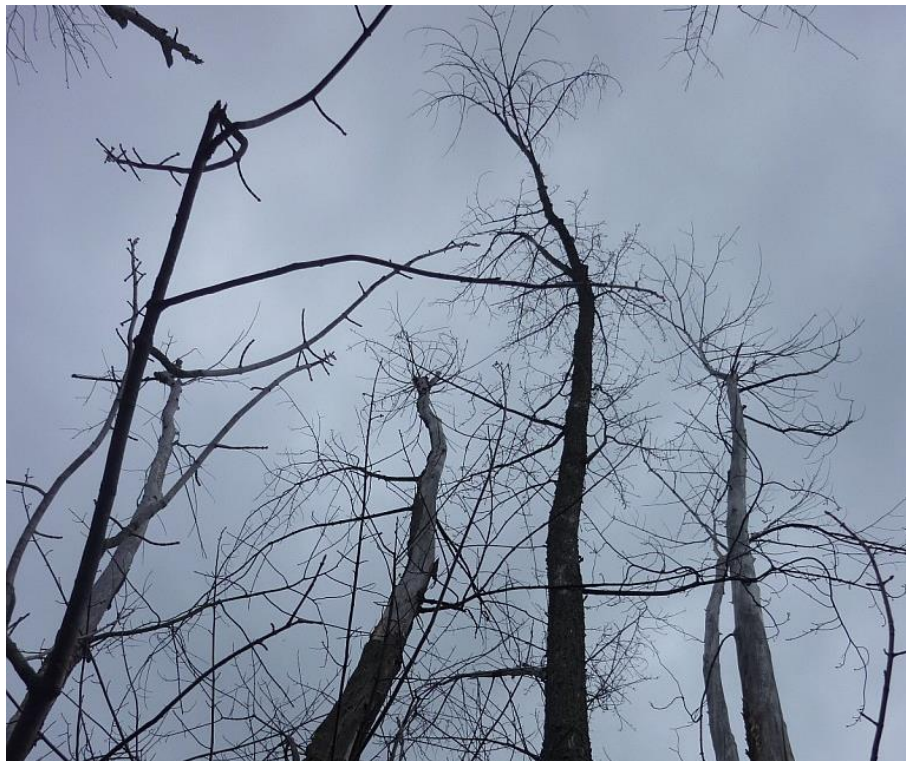
Figure 36 Tree crowns at WP313 – dead on left, stressed on right

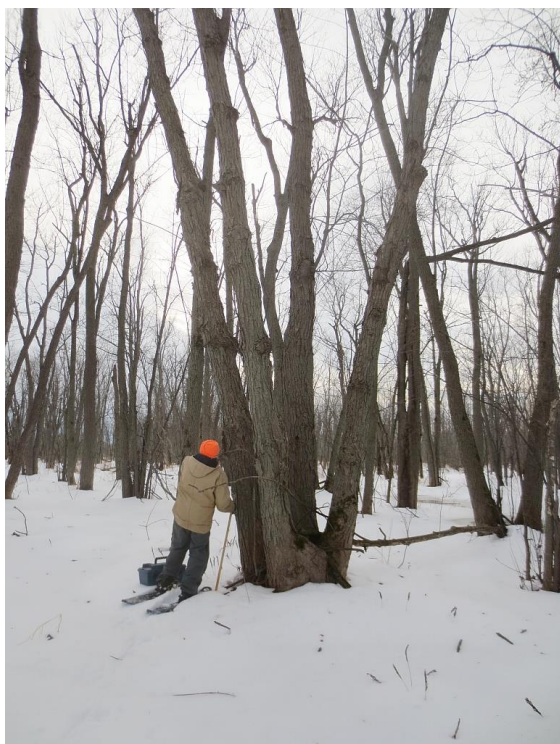
Figure 38 Tree group at first sample point

Cores were taken from two healthy trees located on the northern margin of the wetland above the current summer high water levels. Further cores were taken from trees lower down in the wetland where stressed and dead trees predominate. Two samples were collected from stressed trees, and two from dead trees. The images below show the first sample point on a healthy tree, with a view of the tree crown above.

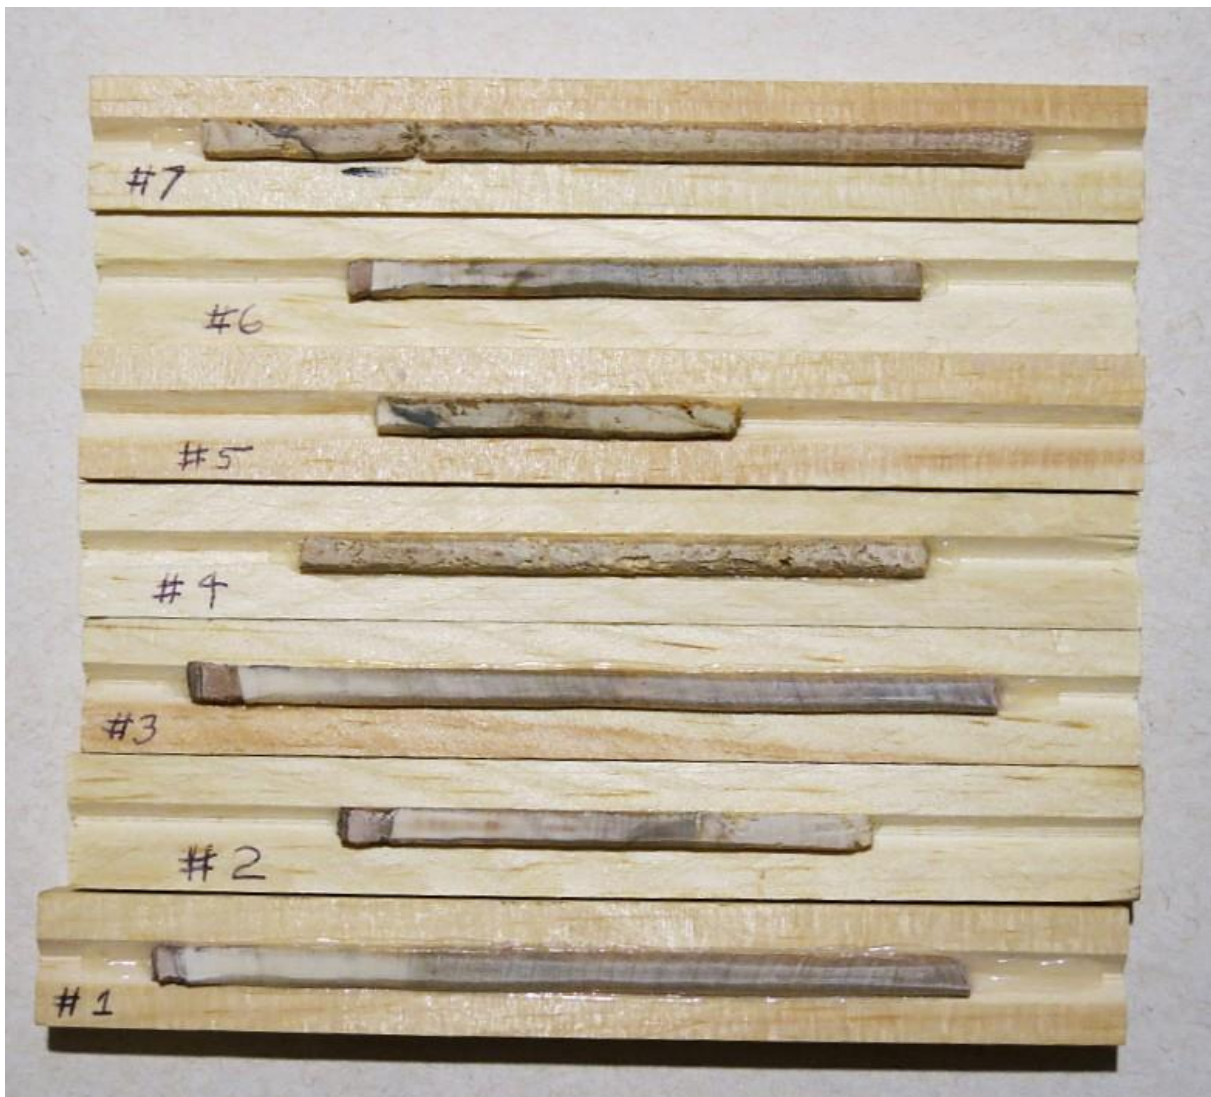
Figure 40 The seven cores as mounted

Subsequently the samples were glued to grooved backing boards and then the front face of the sample was sanded to create a flat face, and then polished with progressively finer sand paper to reveal the core structure. The image below shows the mounted cores.
