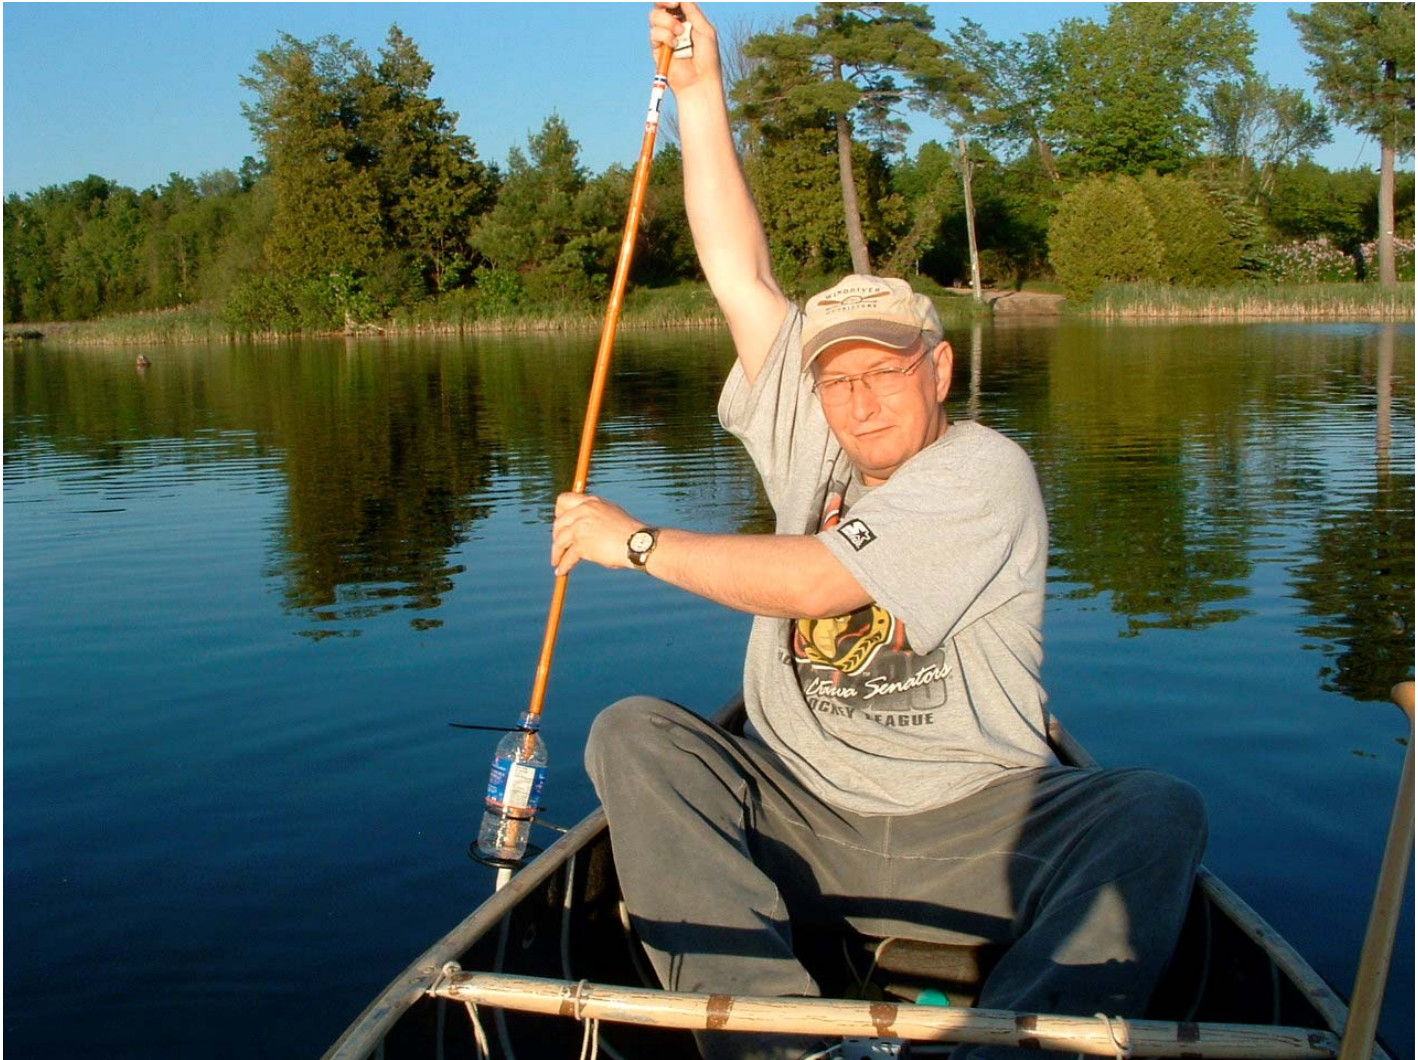
Figure 1 - Volunteer, collecting water at 1 m depth prior to taking a temperature reading.

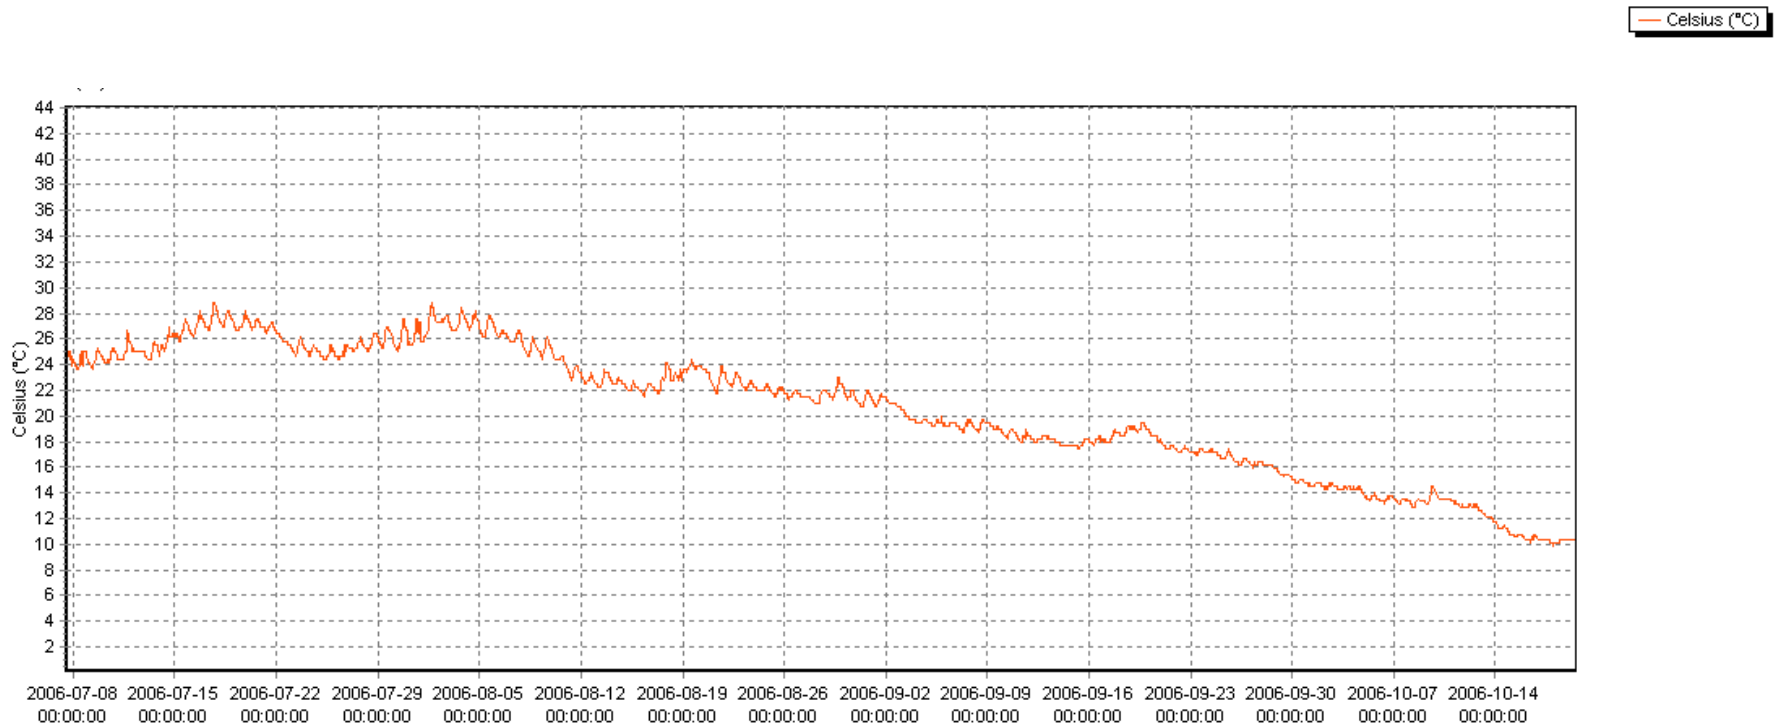
Figure 5: Temperature data 1m depth, Clayton Lake, eastern Mississippi Watershed, 2006
